Inspection Report

Professional Building Report Services Pty Ltd

Sample Street

COMBINED BUILDING & PEST INSPECTION

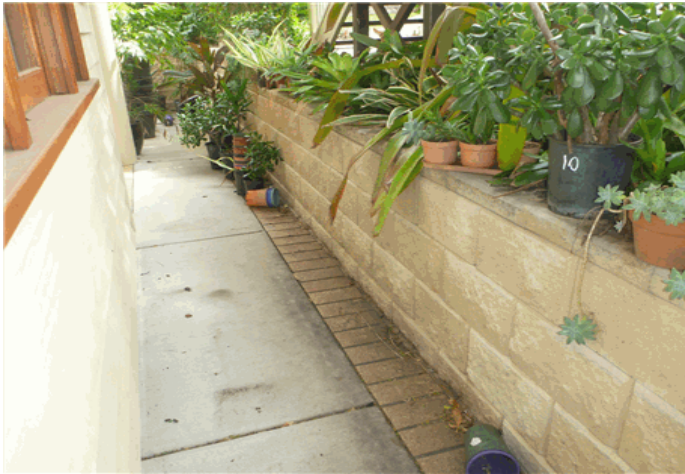
On visual inspection, the general condition of the Retaining Walls is Acceptable for the age.

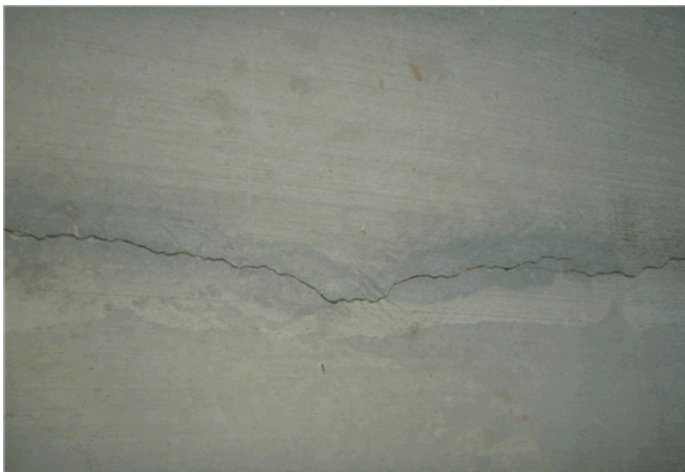
6) Driveway

COMMON CRACKS AND SETTLEMENT WERE OBSERVED ON THE DRIVEWAY. This does not have any effect on the actual structural integrity of the dwelling itself - Maintenance is recommended. Note: Whilst these cracks appeared to be minor at the time of inspection, we strongly recommend you monitor these cracks and if worsening occurs contact a concreter for further advice.

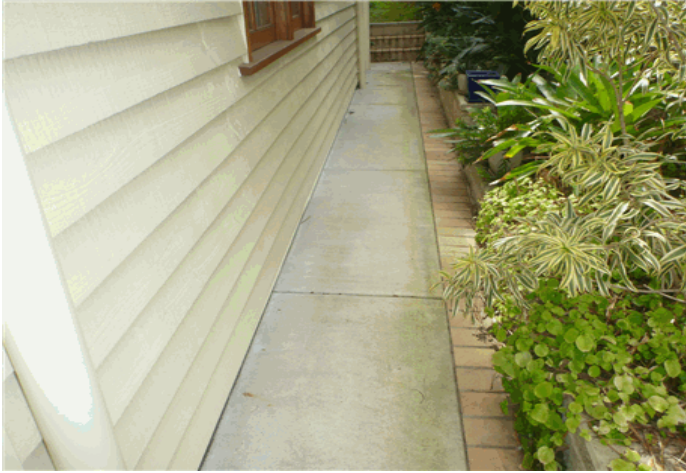
7) Pathways

The paths around the home are in reasonable condition for the age of this dwelling with no major defects visible.

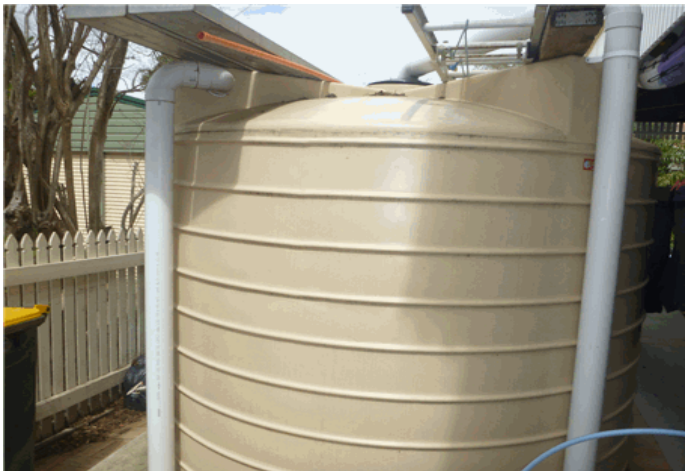
15) Tank 2 x 10,000 Litre above ground Poly Tanks with Pump connected to 3 outlets under constant pressure

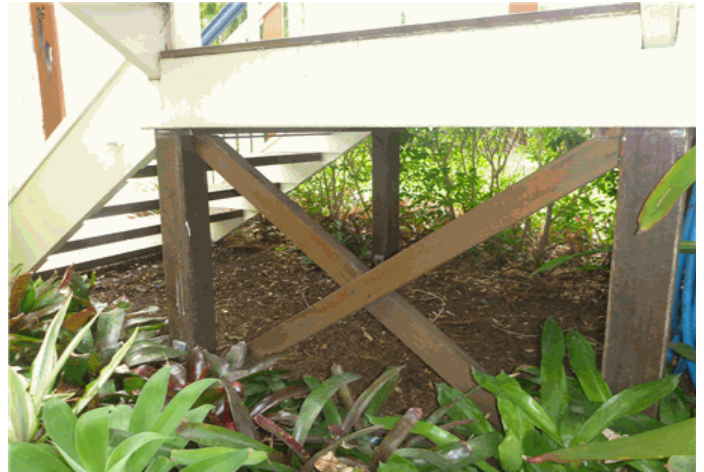
The Steps/Stairs appear to be functional with no notable defects

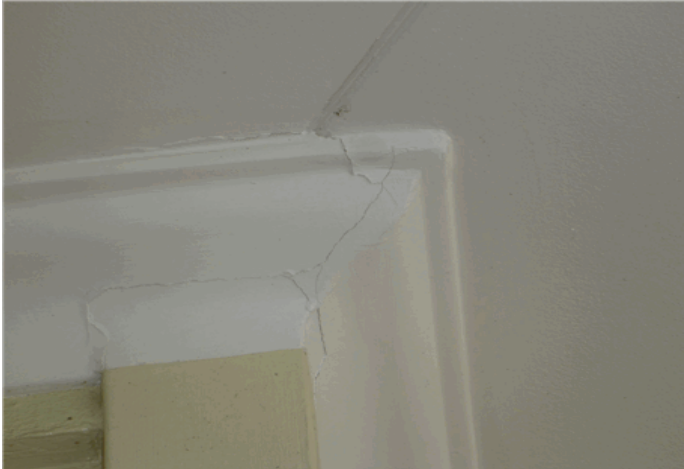
65) Verandah Ceiling

CEILING LINING JOINT CRACKS - Minor (hairline to 5mm) ceiling joint cracks visible. Recommendations: I recommend you contact a licenced plasterer for further advice and recommendations.
