Inspection Report

Professional Building Report Services Pty Ltd

Sample Street
BRISBANE QLD 4999

BUILDING REPORT

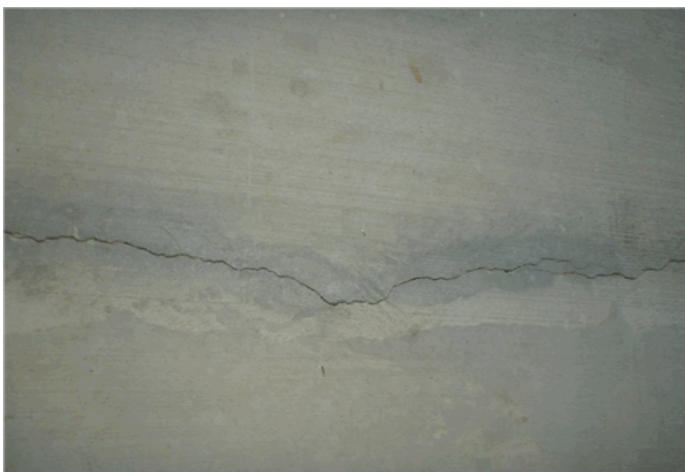
**DRIVEWAY****6) Driveway**

COMMON CRACKS AND SETTLEMENT WERE OBSERVED ON THE DRIVEWAY. This does not have any effect on the actual structural integrity of the dwelling itself - Maintenance is recommended. Note: Whilst these cracks appeared to be minor at the time of inspection, we strongly recommend you monitor these cracks and if worsening occurs contact a concreter for further advice.

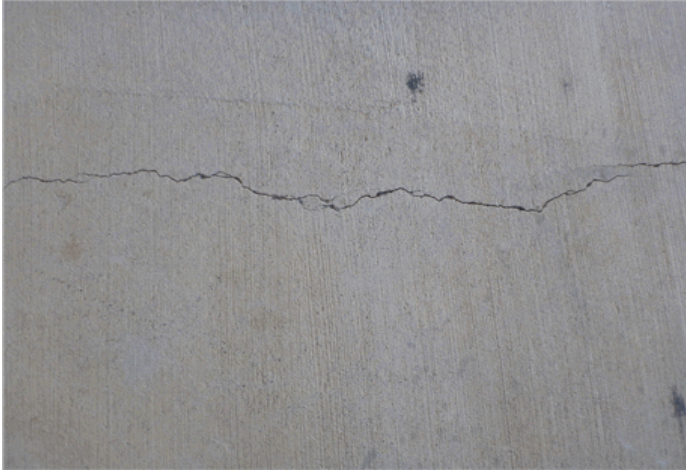
MINOR HAIRLINE TO 1 MM SLAB CRACKS - Note. Whilst these cracks appeared to be minor at the time of inspection, we strongly recommend you

monitor these cracks and if worsening occurs contact a licensed Structural Engineer or qualified concreter for further advice.

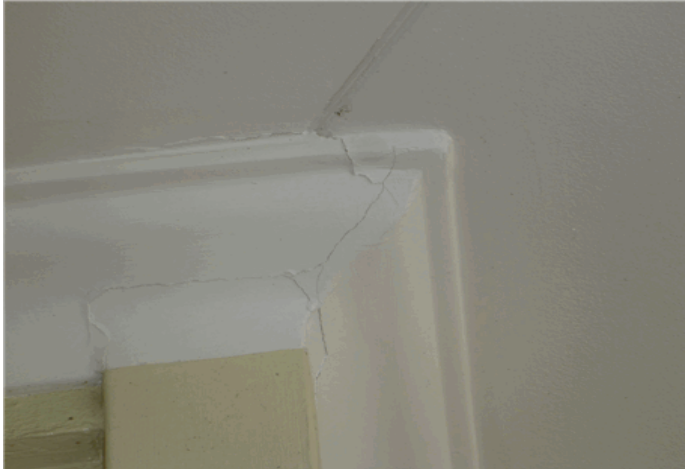
65) Verandah Ceiling

CEILING LINING JOINT CRACKS - Minor (hairline to 5mm) ceiling joint cracks visible. Recommendations: I recommend you contact a licenced plasterer for further advice and recommendations.
