Inspection Report

Property Address:
Sample Street
Ashgrove QLD 4060

Pool Safety Inspection

3687143

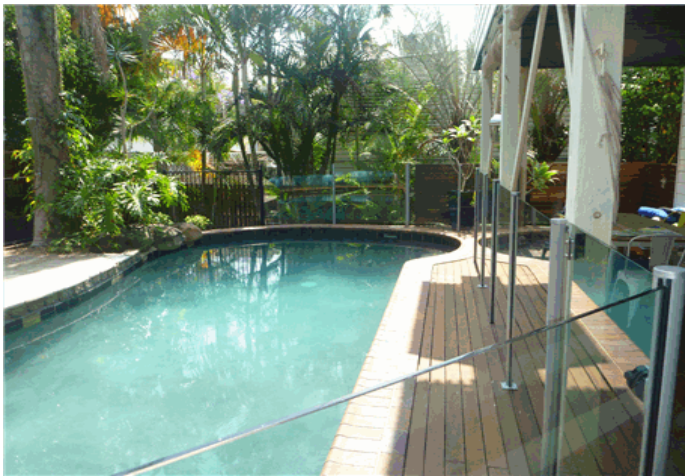
1) Overall Condition

On visual inspection, the general condition appears reasonable.

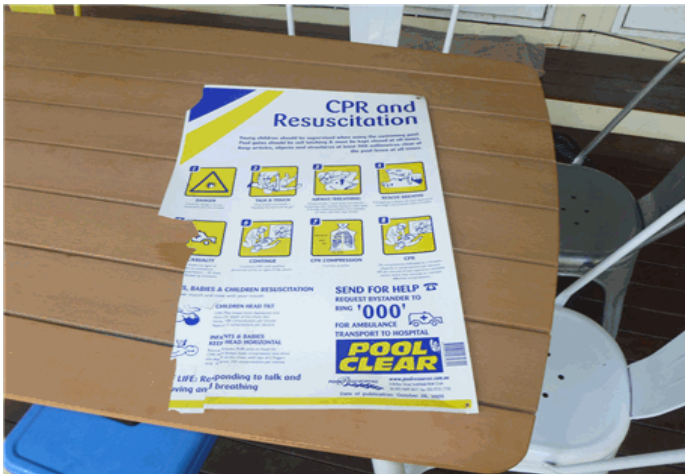
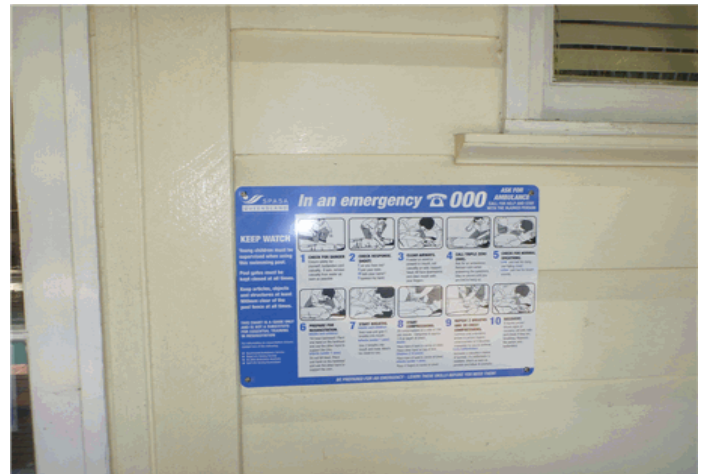
2) CPR Signage Compliance and Location

CPR Signage was found to be in very poor condition and as such was replaced.

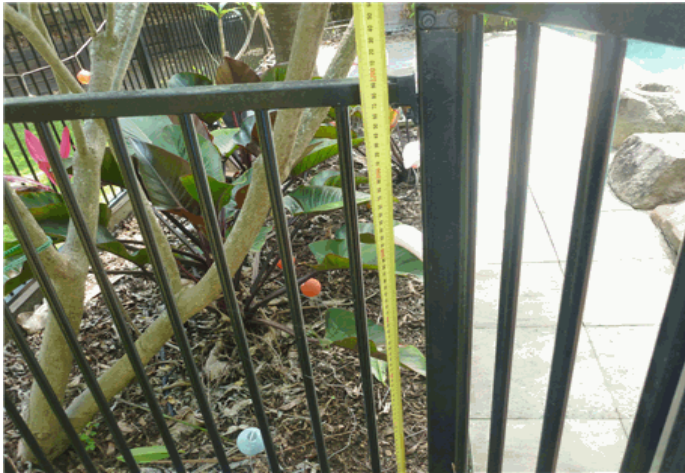
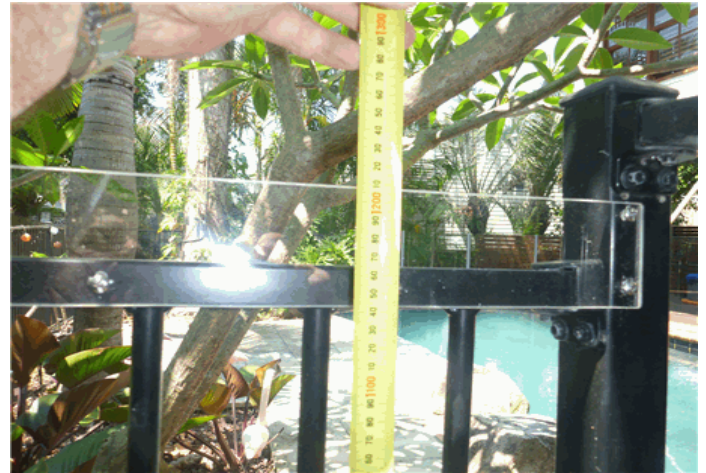
3) Fence Height ground to top of fence - 1200mm

Fence height was checked and height was OK, after corrective actions were taken to obtain correct height on a fence panel on the northern side of the fence gate.

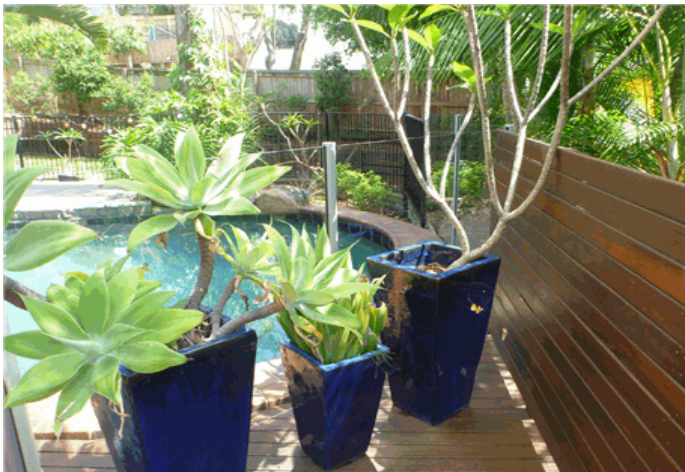
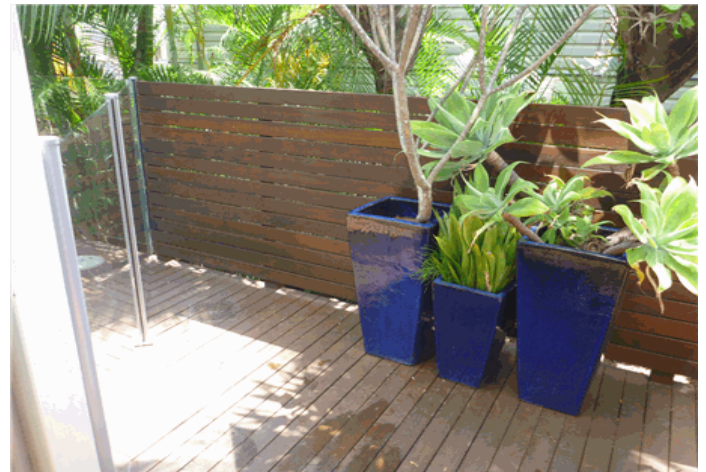
6) Less than 1800mm - NCZ as upper 900mm quadrant

NCZ was found to be compliant with the standards after removal of some pot plants that were located within the NCZ.

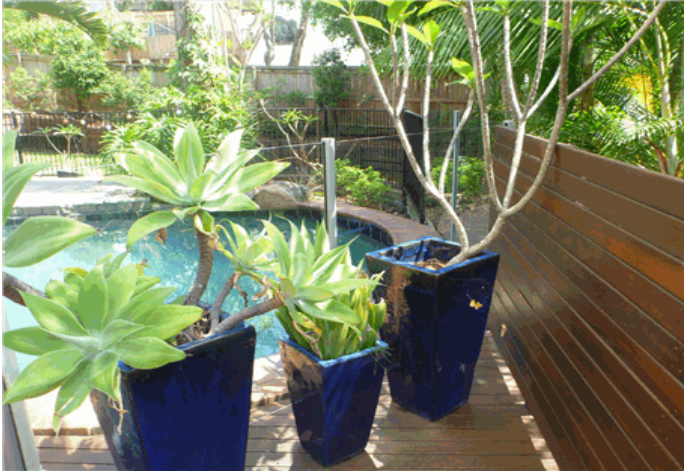
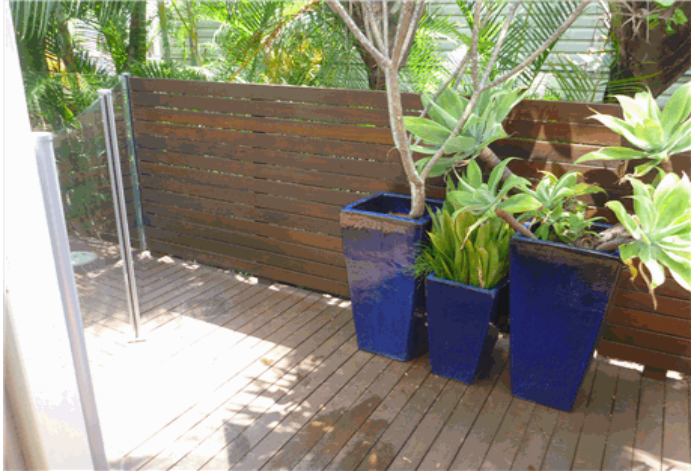
8) Identify Additional Clear Area 1200mm to NCZ arc

Additional Clear Area was checked and found compliant, after removal of some Pot Plants from the Area.

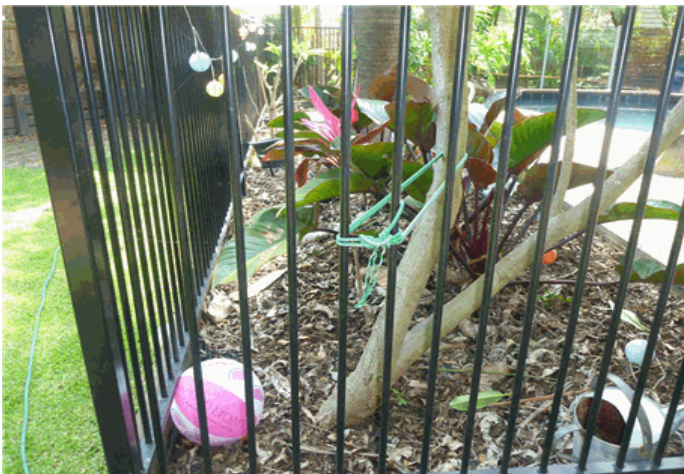
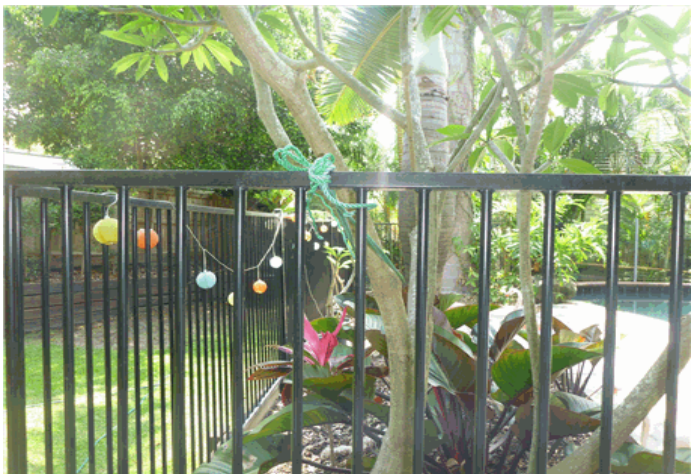
**9) Verticals more than 10mm
Inside Clear Zone 300mm**

Additional Clear Area is necessary due to vertical gaps greater than 10mm, all was found to be compliant after corrective action for a tree brace to be re-positioned to be outside of this Clear Area.

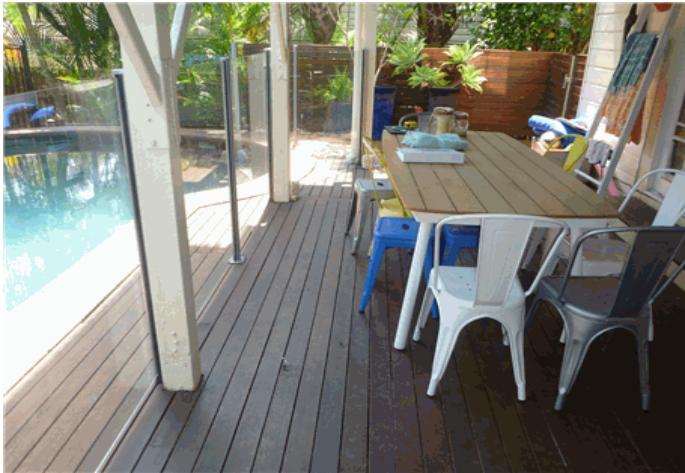
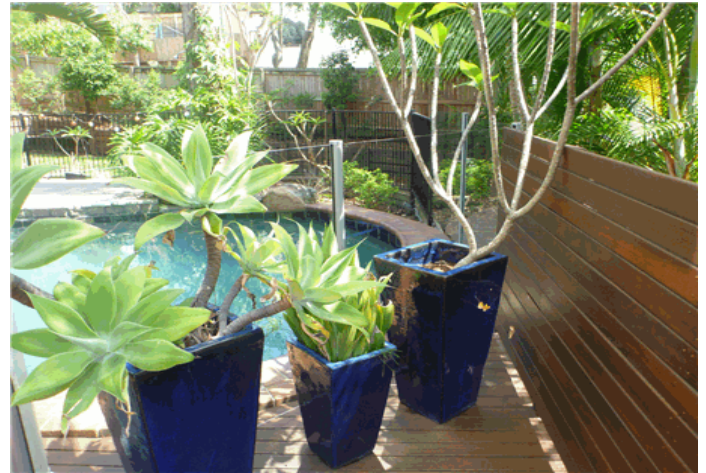
**12) Climbable objects in and
around the pool area**

On first observation there were items such as chairs, table and pot plants, however these were removed and the Tenant has been informed to keep these items back from the No Climb Zone

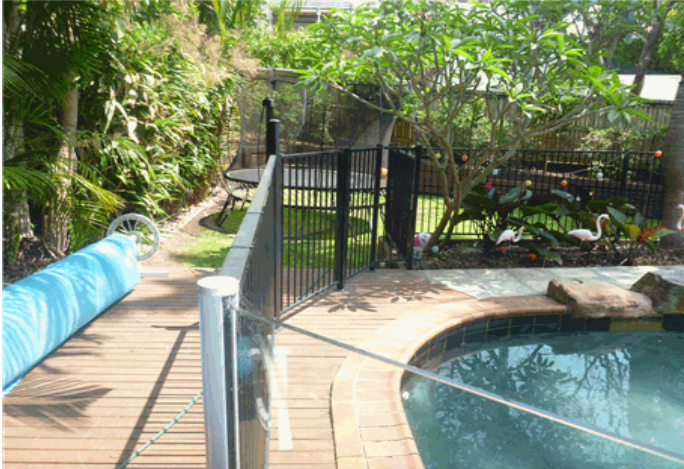
17) General Condition

On visual inspection, the general condition appears reasonable.
