Inspection Report

Professional Building Report Services Pty Ltd

PBRs Sample Report 2019

Report Number	PBRSSample2019
Inspection Type	The Inspection is a Pre-Purchase Building and Pest Inspection .
Inspection Date	September 2019
Inspection Time	9.00am
Weather Conditions	The Weather Conditions were Fine and Dry for the time of the Inspection.
Recent Weather Conditions	The Recent Weather Conditions were Showers & Rainy at the time preceeding the building Inspection.

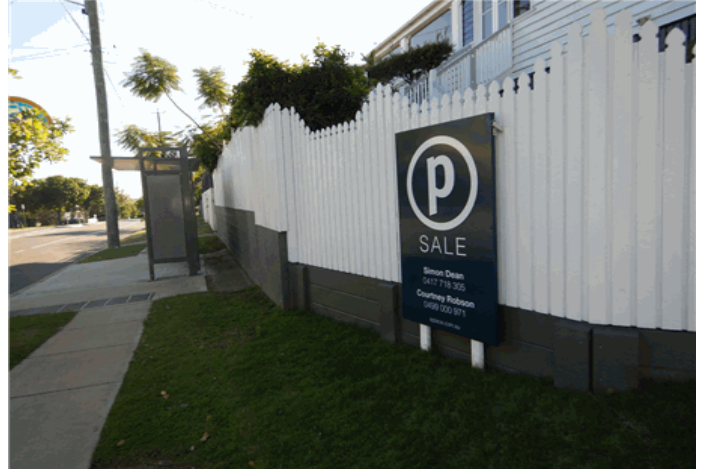
7) Overall Area

The Retaining Walls appeared to be in an acceptable condition at the time of Inspection.

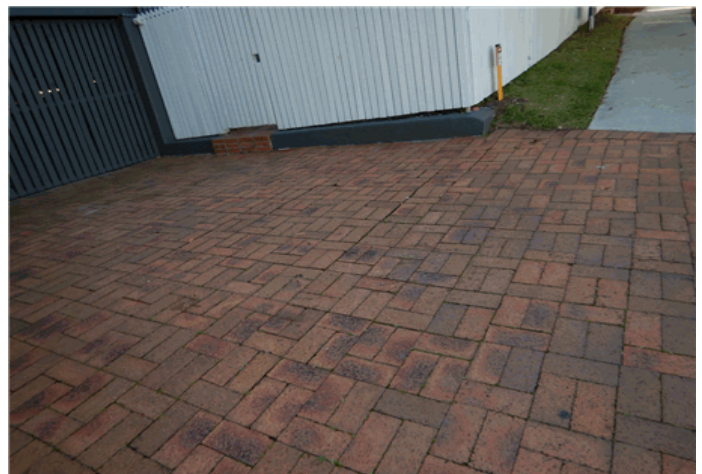
10) Overall Area

The Driveway was constructed of Pavers and there were some areas where pavers have begun movement, these areas will allow more water to enter the foundation system of the Driveway and this accelerates further deterioration.

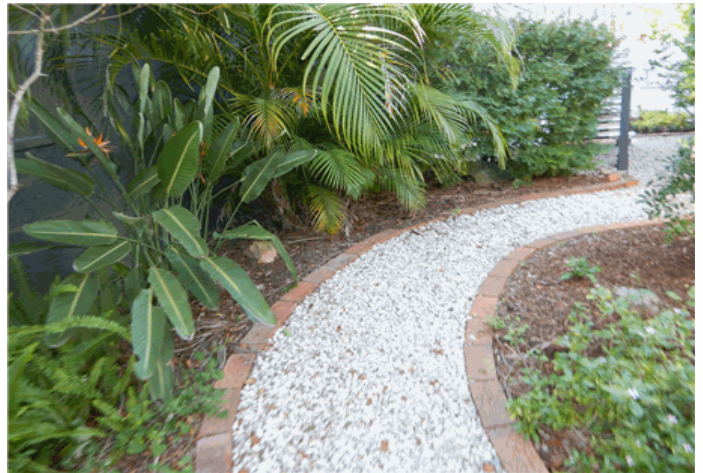
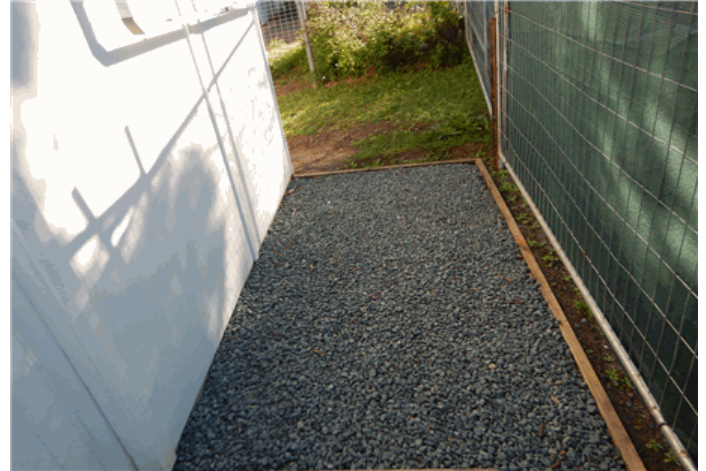
12) Overall Area

The Pathways are a mixture of materials around the Dwelling and all are in generally an acceptable condition at the time of Inspection, however, some Pavers were noted as shifting and these will need to be monitored and corrective actions taken if the condition worsens.

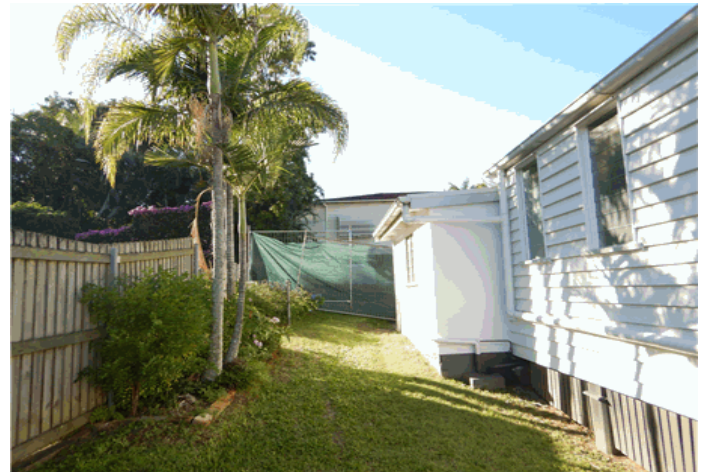
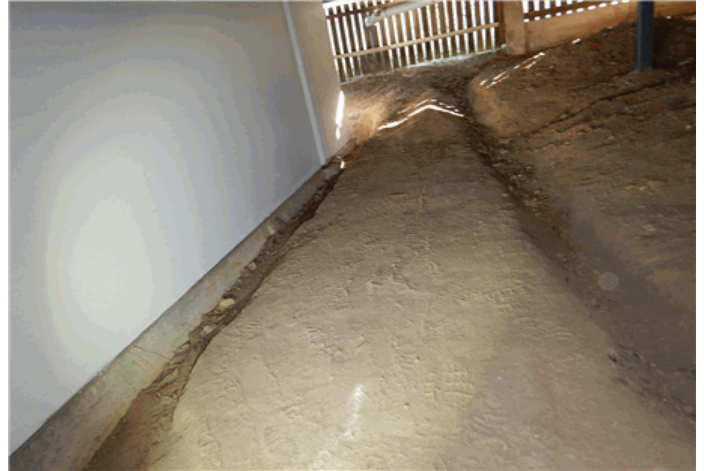
14) Overall Area

This property has issues with Surface Water, there are Drainage Systems of sorts in the Sub-Floor area. Surface Waters from the Western and Northern sides of the Property appear to have a path through into the Sub-Floor and Foundation areas of the Dwelling, and is a significant enough issue that I will report this as a **Major Defect** and these issues need immediate attention.

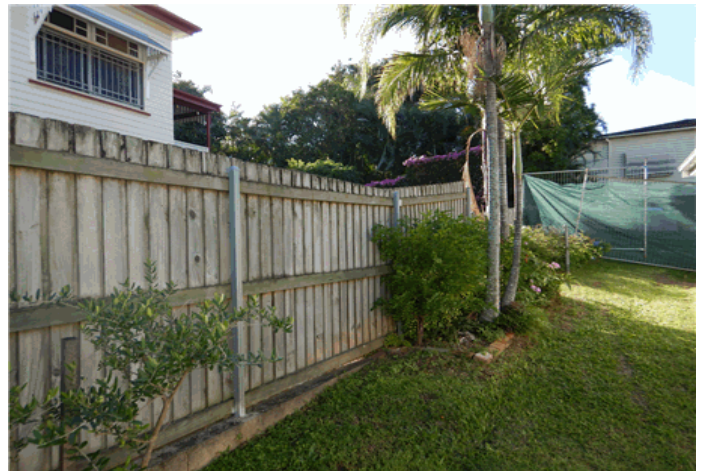
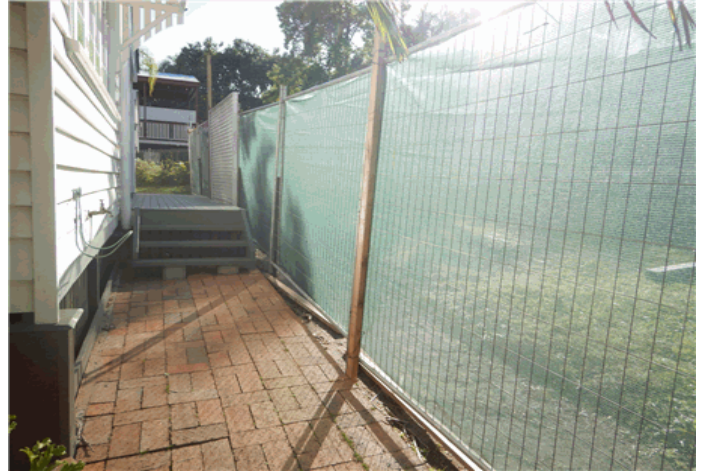
18) Overall Area

The Fences were considered to be generally in an acceptable condition, however, there is a section of temporary Fencing between the Dwelling and the Building Site that was once part of the Property.

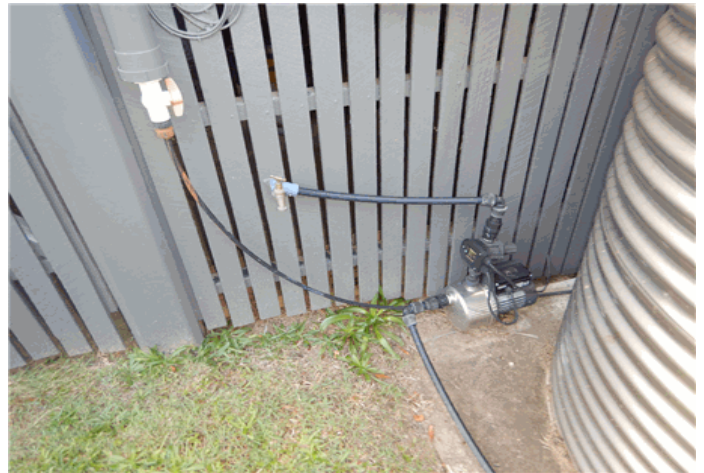
31) Overall Area

There is a Rainwater collection Tank and Pressure Pump and all appear to be in an acceptable condition.

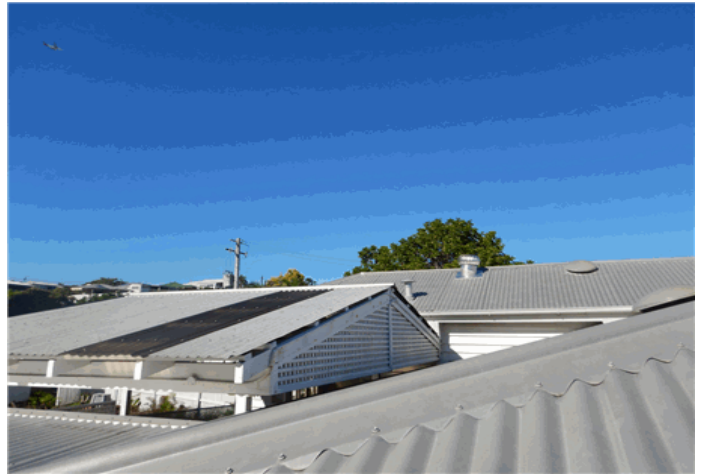
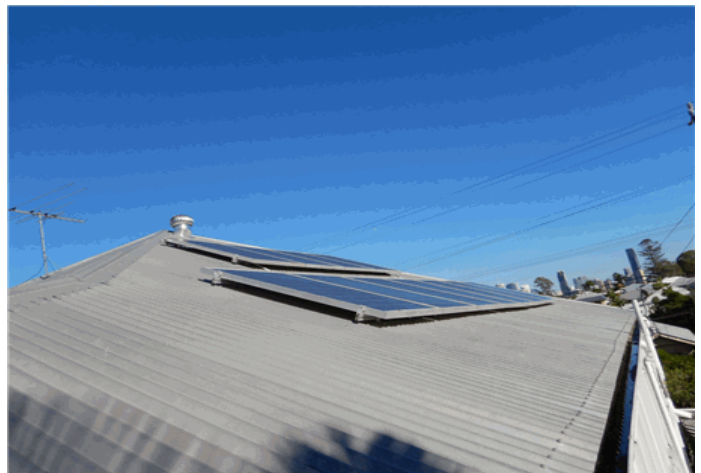
54) Overall Area

Of the visible areas, the general condition of the Roof is acceptable.

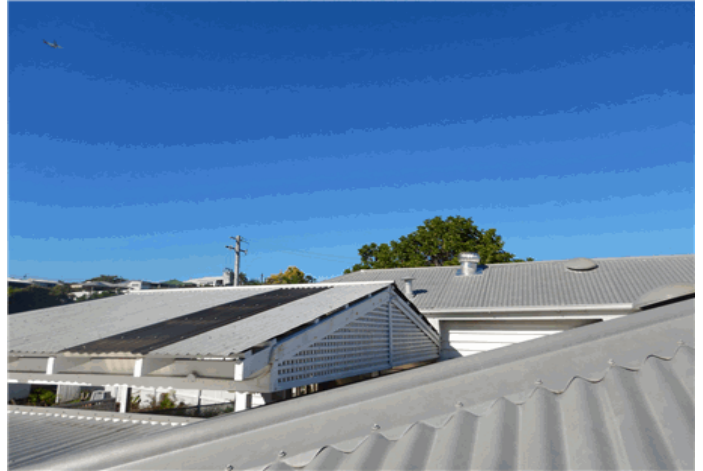
55) Gable Ends

On visual inspection, the general condition of the Gable Ends are considered to be acceptable.

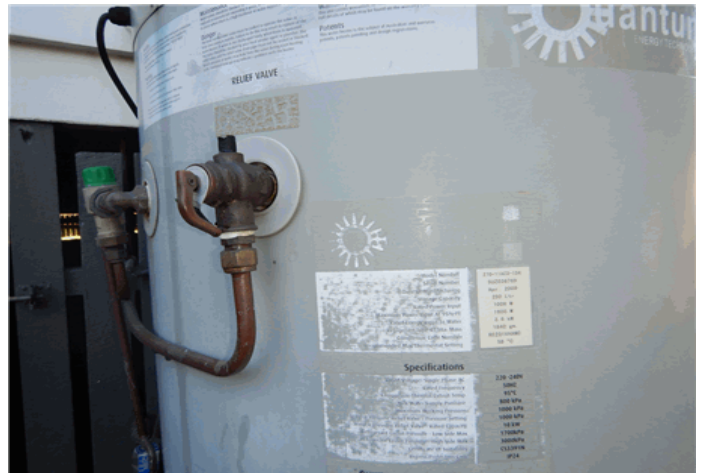
The Hotwater system appears to be in working condition. Operation of the relief valves were tested, no other specific tests other than running the hot water from a tap was carried out. No determination has been made as to the suitability or adequacy of the Hotwater system in relation to capacity or otherwise.

It was noted the Heat Pump was a little noisy when operational, this will require maintenance attention.

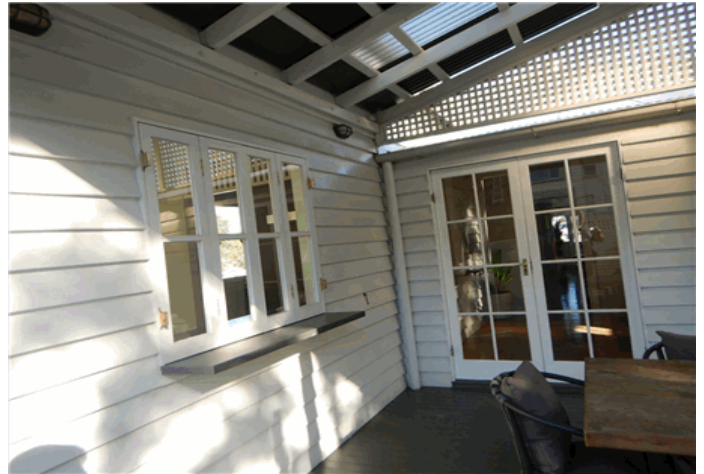
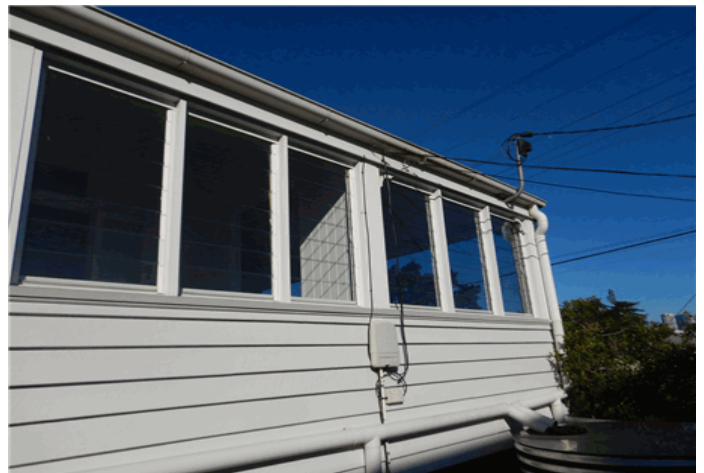
On Visual inspection the Downpipes appeared to be in an acceptable condition.

Note: Periodic maintenance checks should be carried out for rust penetrations and leaks.

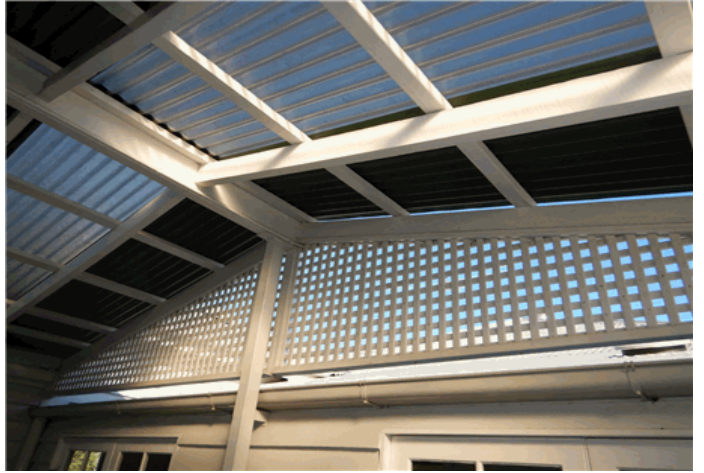
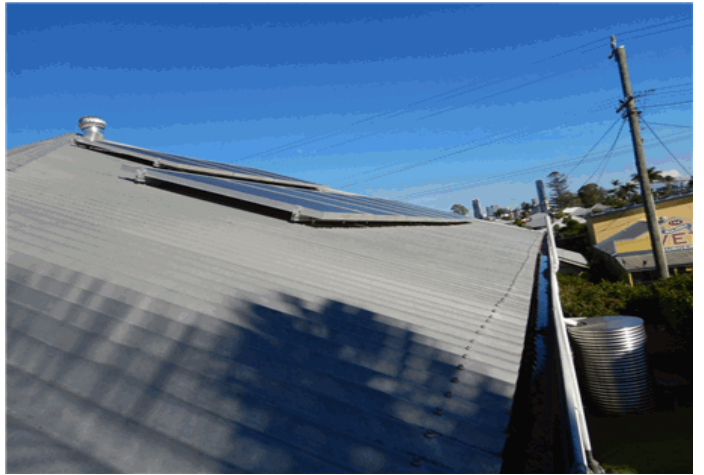
64) Guttering Overall Comment

All visible Guttering appears in reasonable and acceptable condition at the time of inspection.

NOTE Periodic maintenance checks should be carried out for rust penetrations, leaks and blockages caused by leaf litter.

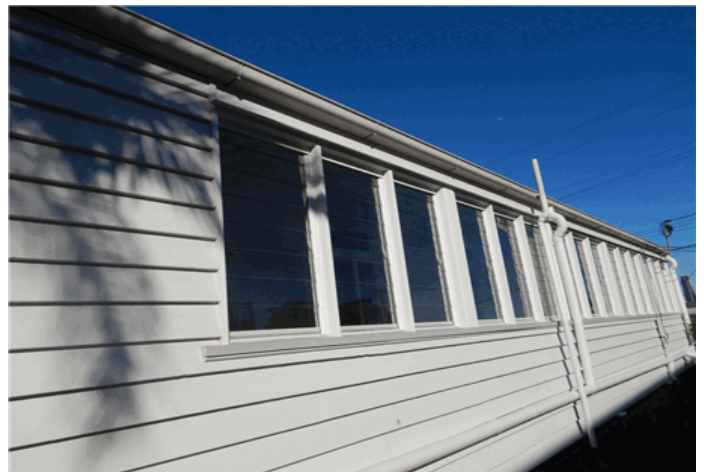
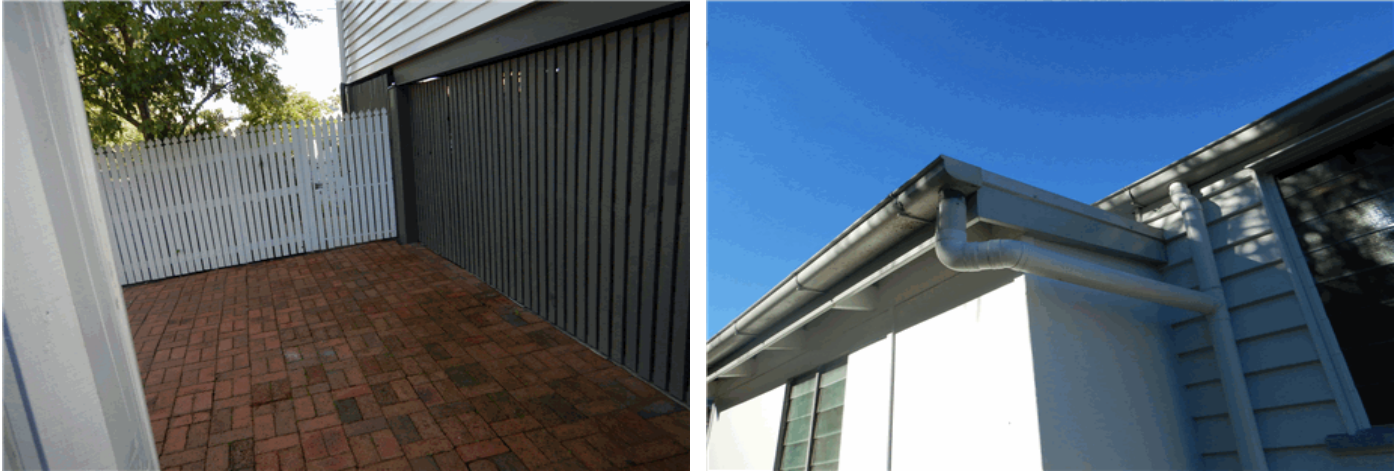
67) Overall Condition

Note: It is always difficult to establish if building materials actually contain Asbestos and it is advised that the only way to be certain, is to have suspected materials Tested by a NATA Accredited Laboratory. If the house was built before the mid 1980s and it has Fibrous Cement Sheeting as either internal or external Cladding, then there is a High Probability that the Sheeting contained Asbestos.

The probability of a Dwelling containing the presence of Asbestos requires this to be Reported as a **Major Defect** for Health and Safety reasons.

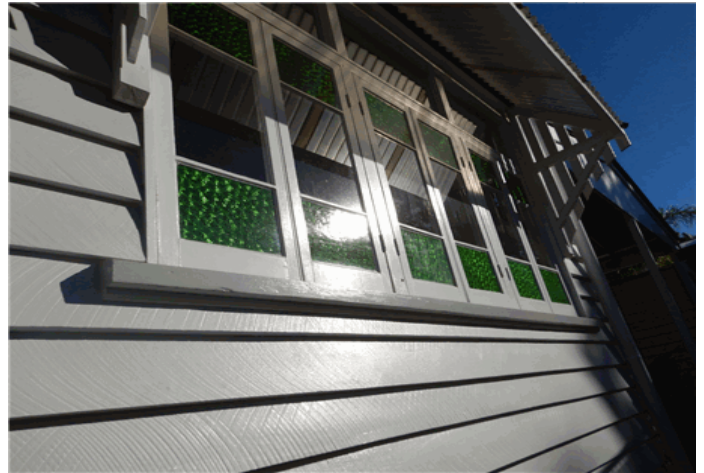
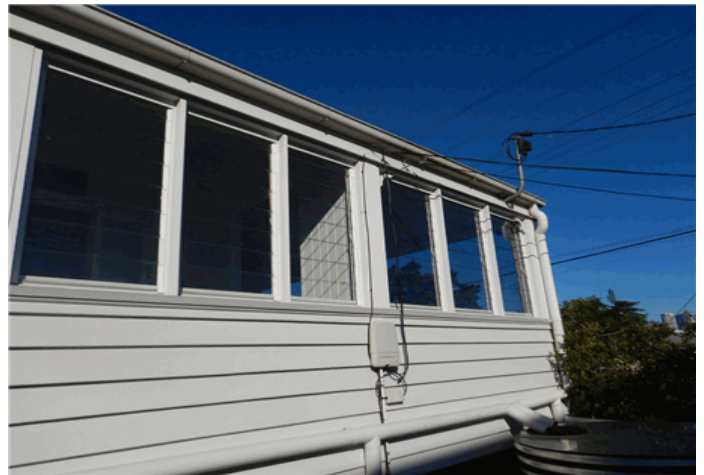
70) Windows

On visual inspection, the general condition of the Windows is Acceptable for the Age of the Dwelling, however, some windows are noted as binding, and some glass panels are cracked, and these will require maintenance attention.

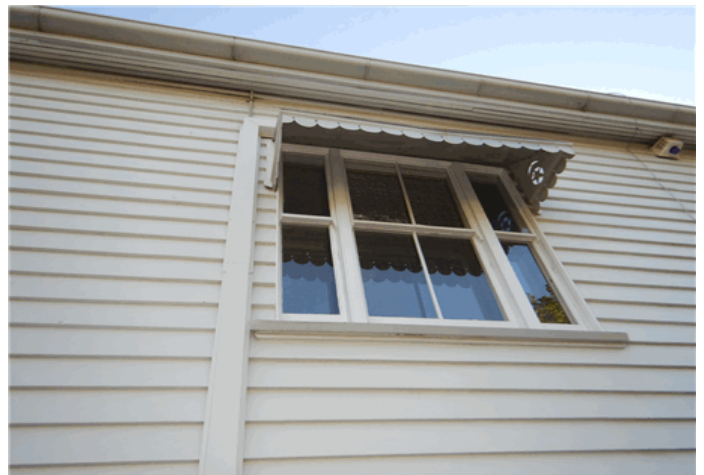
74) Overall Comment

The Eaves or Soffit are in an acceptable condition.

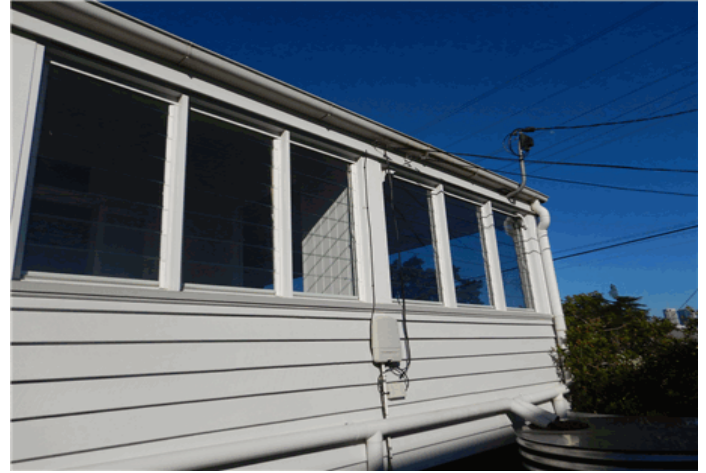
75) Overall Comment

On visual inspection, the general condition of the Fascia/Barge Boards is acceptable.

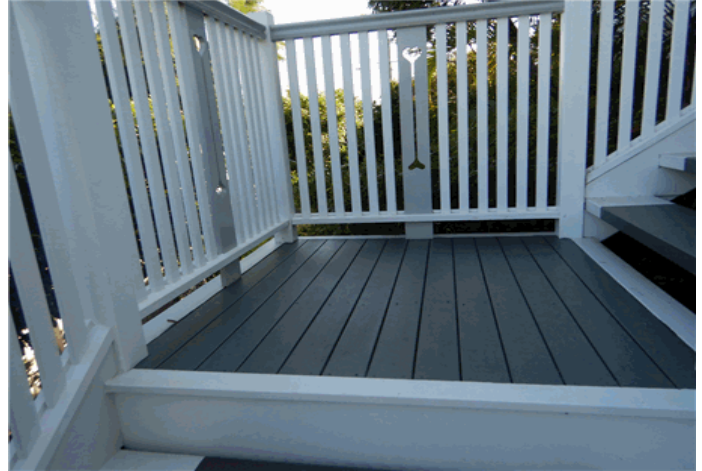
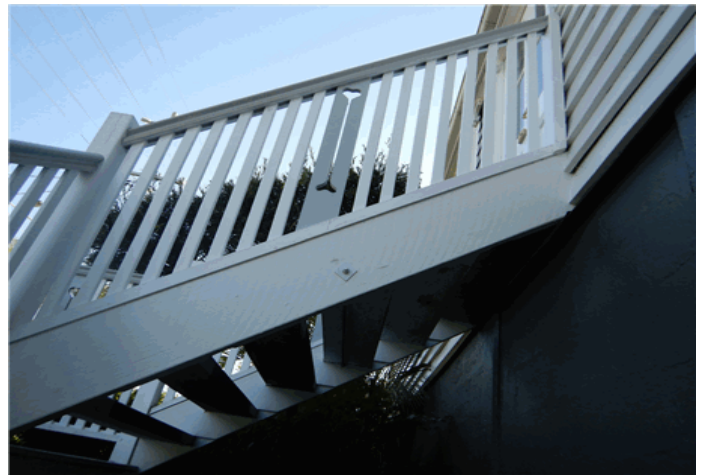
95) Front Stairs

The External Front Steps/Stairs are in an acceptable condition.

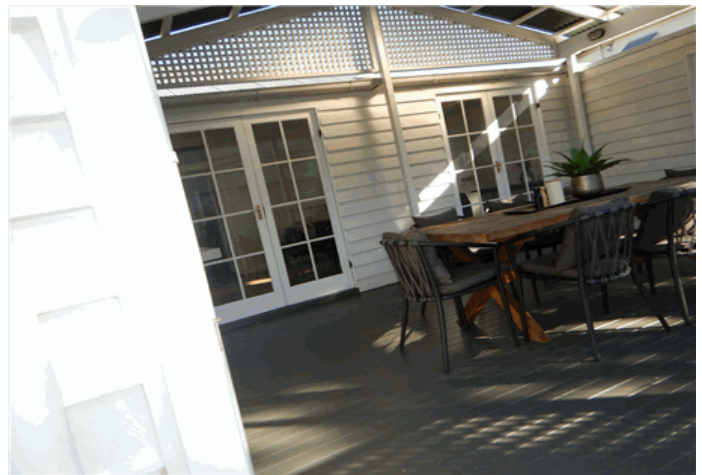
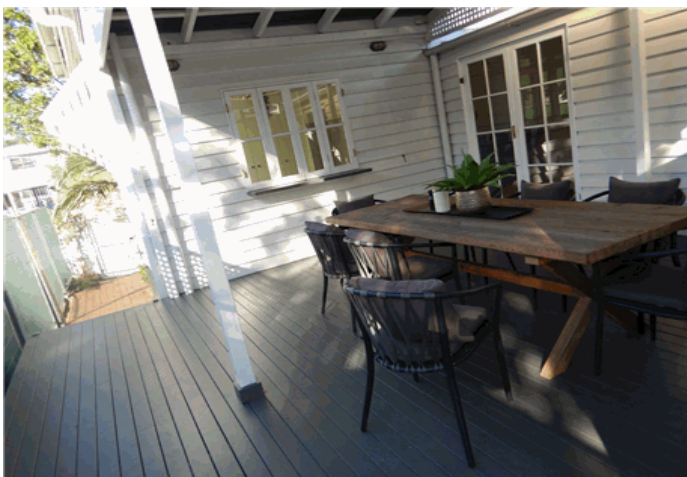
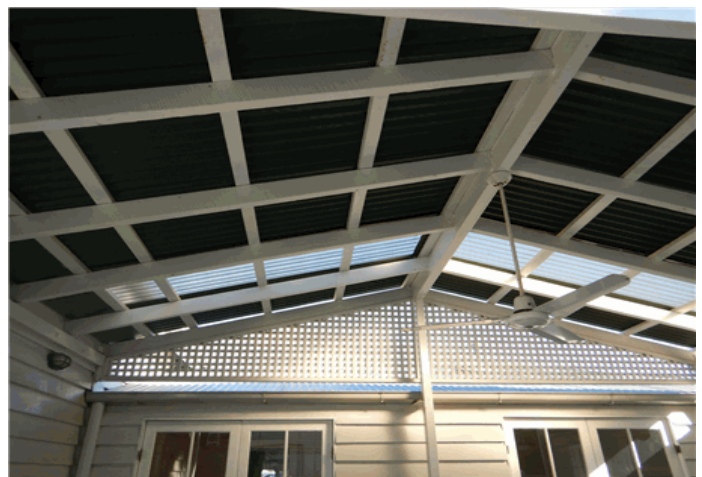
99) Overall Comment

The Deck areas are considered to be in an Acceptable condition, and it was noted there was a functional Ceiling Fan.

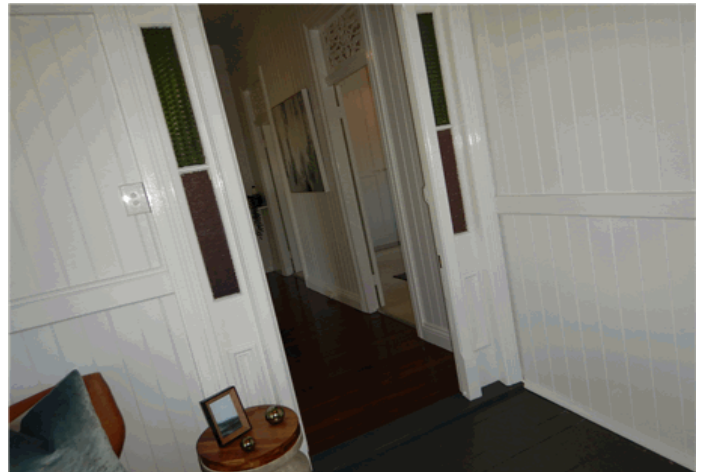
163) Overall Area

The Entry area is considered to be in an acceptable condition.

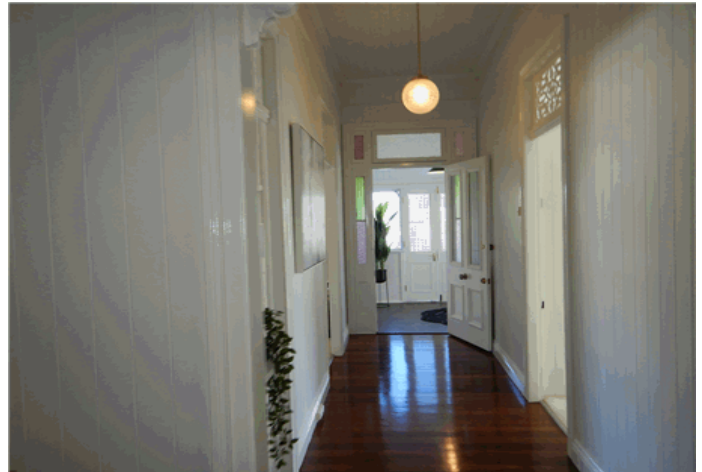
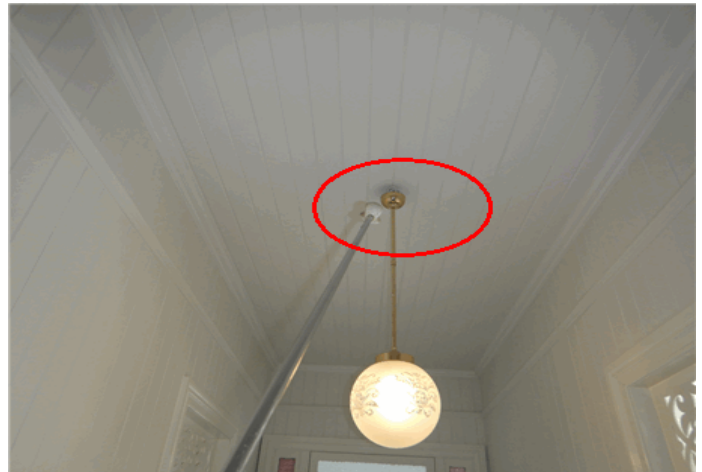
169) Overall Area

The Hallway is in an acceptable condition, however, there was a Light Pendant that has a cable connection cover that has slipped and will require maintenance attention.

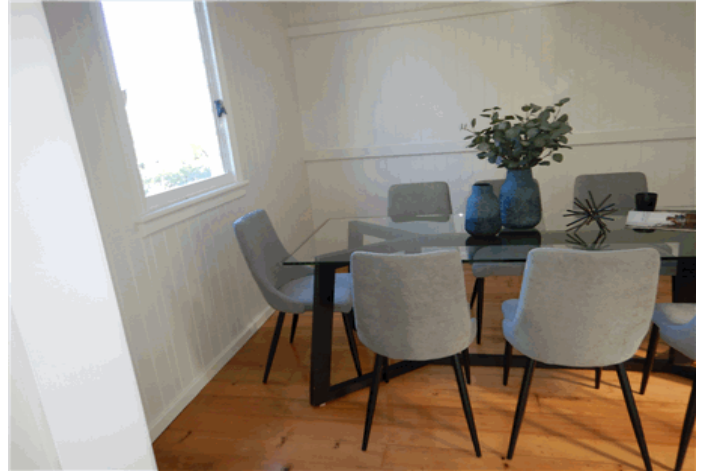
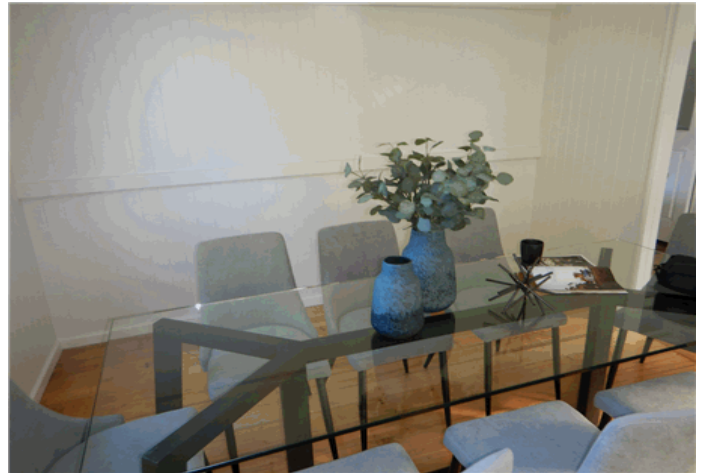
208) Overall Area

The Dining area is in an acceptable condition.

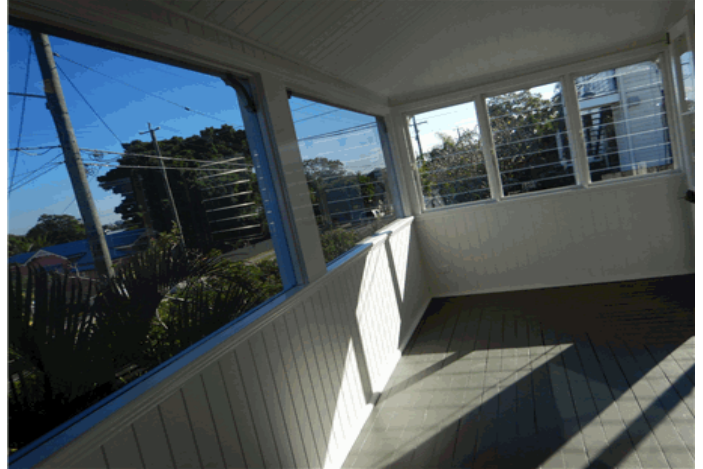
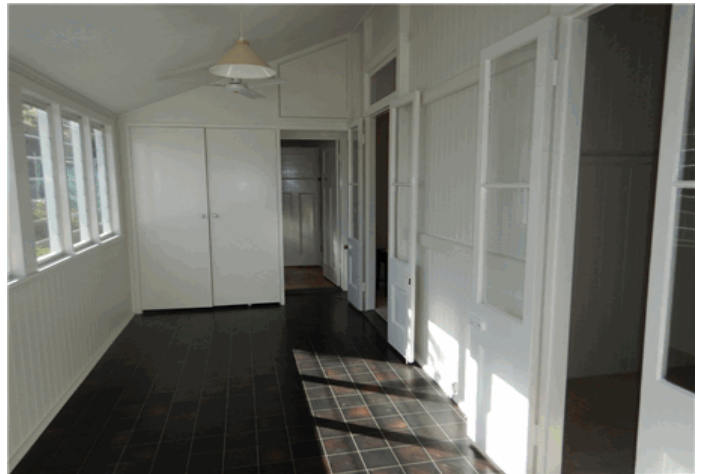
280) Overall Area

The Verandah areas are in an acceptable condition, however, please read the following area specific comments.

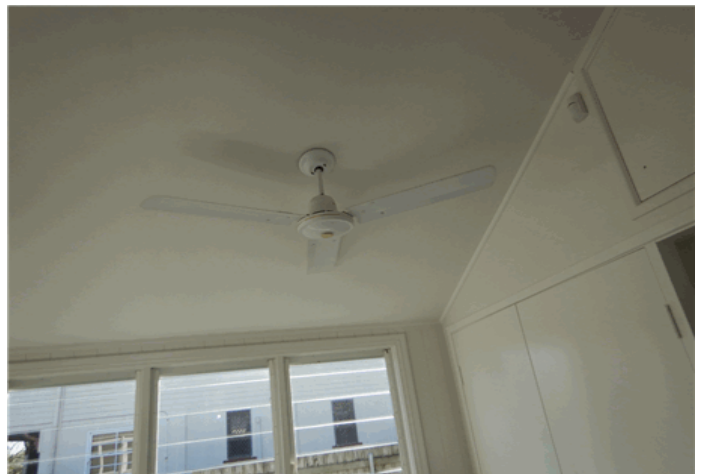
287) Ceiling Fan

The Ceiling Fans in the Verandah Areas are in an acceptable condition.

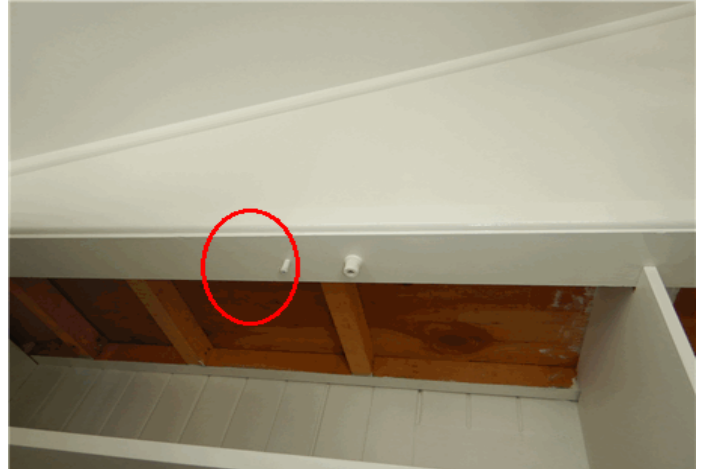
288) Storage

The Verandah Storage cupboards require maintenance attention to a broken Door Clip and to unfinished internal linings.

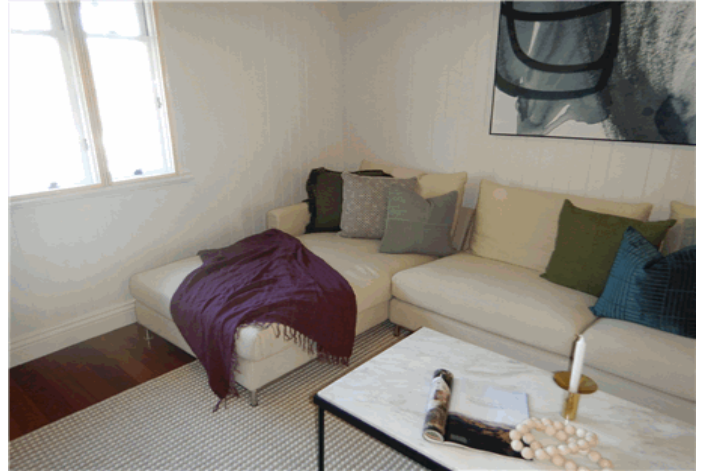
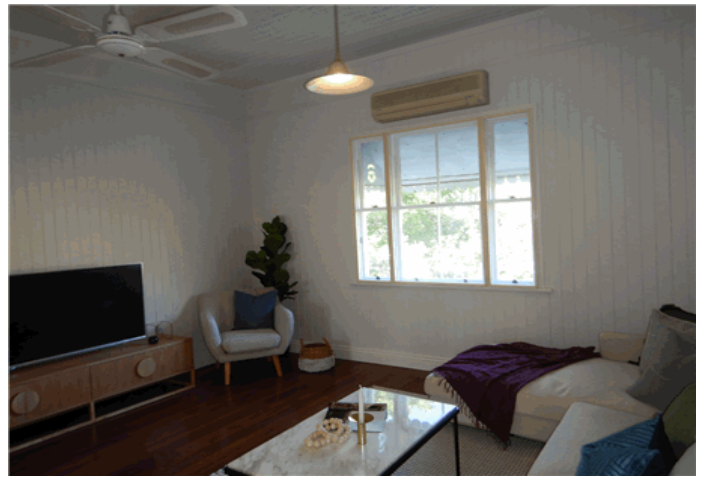
289) Overall Area

The general condition of the Sitting Room was acceptable, however, please read the following area specific comments.

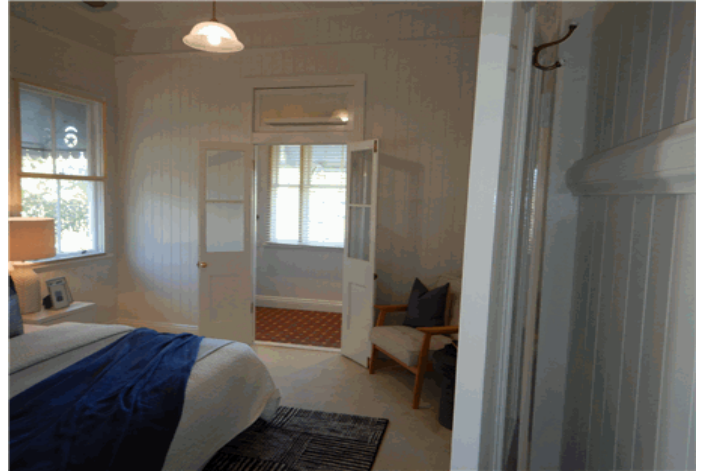
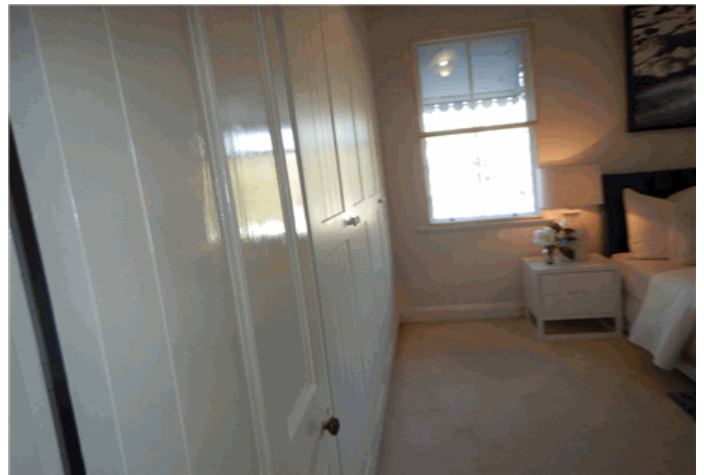
331) Overall Area

The Master Bedroom is generally in an acceptable condition, however, please read the following area specific comments.

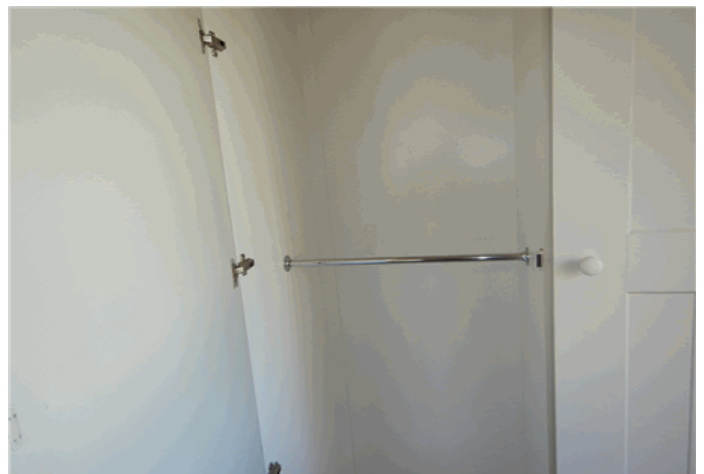
332) Robe

The Master Bedroom Robe is considered to be in an acceptable condition.

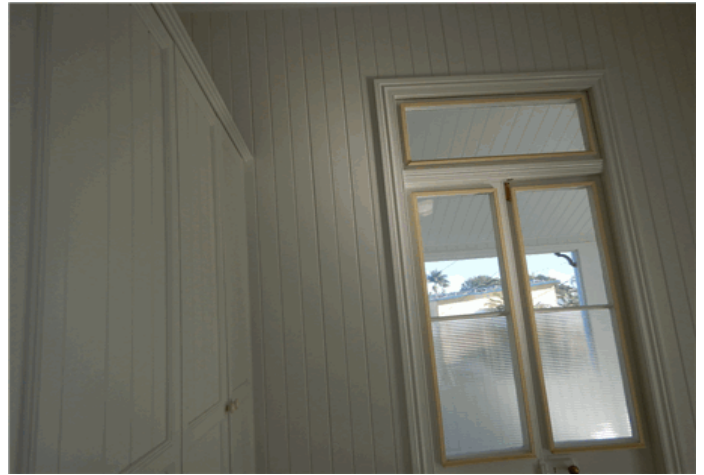
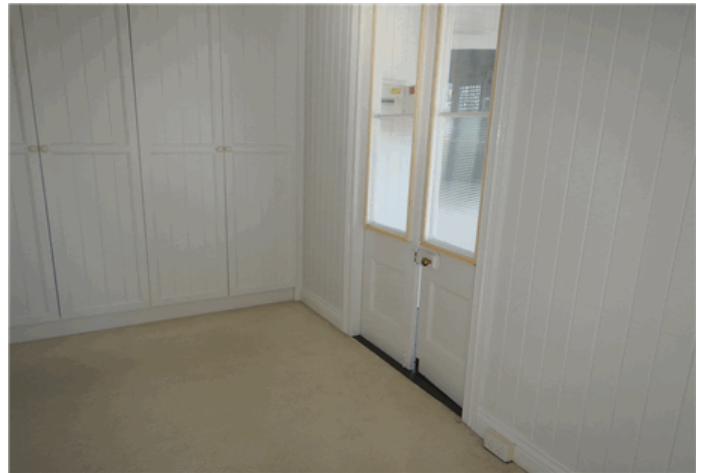
353) Overall Area

The general condition of Bedroom 2 is acceptable.

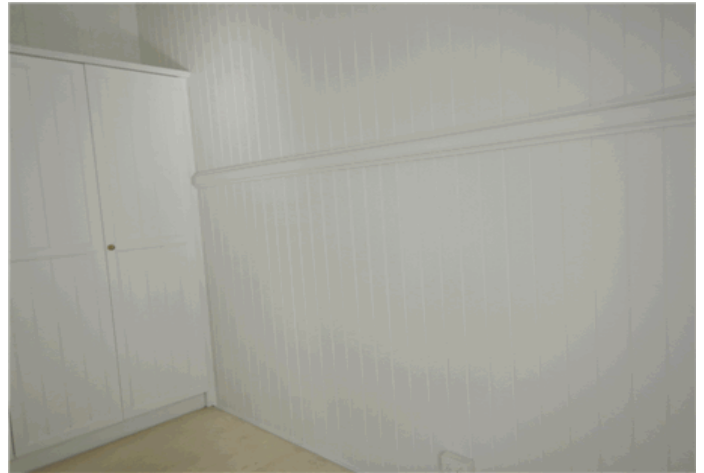
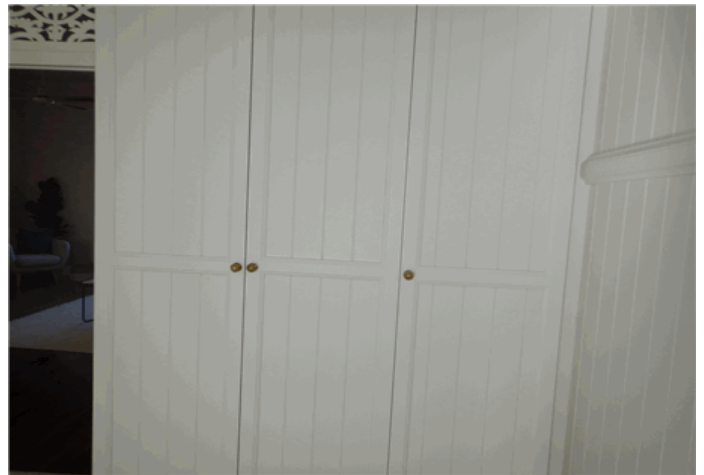
363) Overall Area

Of the visible areas, the general condition of Bedroom 3 is acceptable

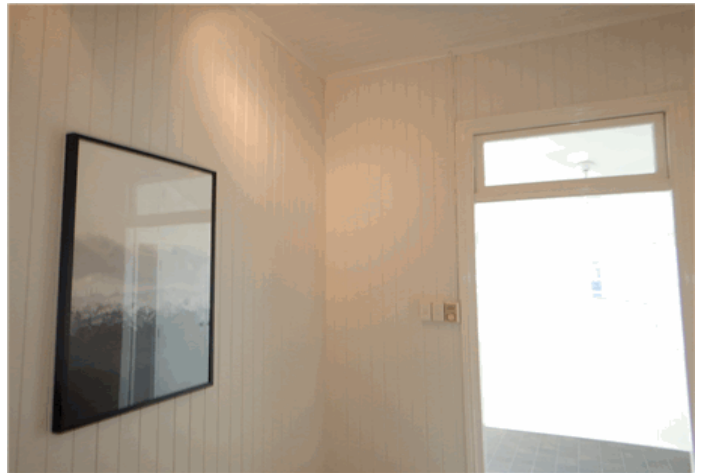
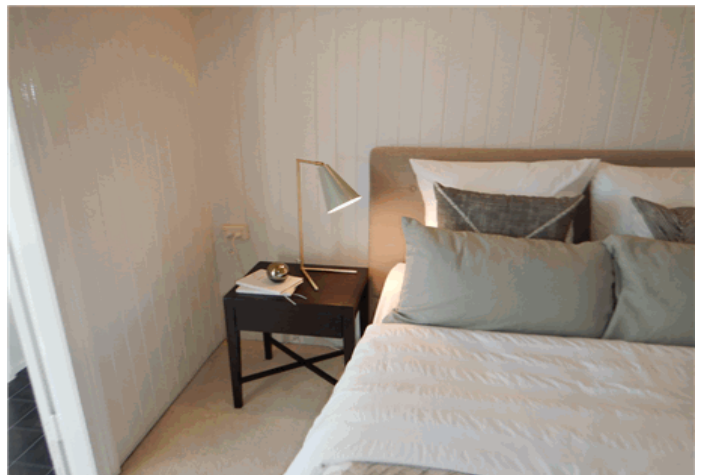
373) Overall Area

Of the visible areas, the general condition of Bedroom 4 is Acceptable.

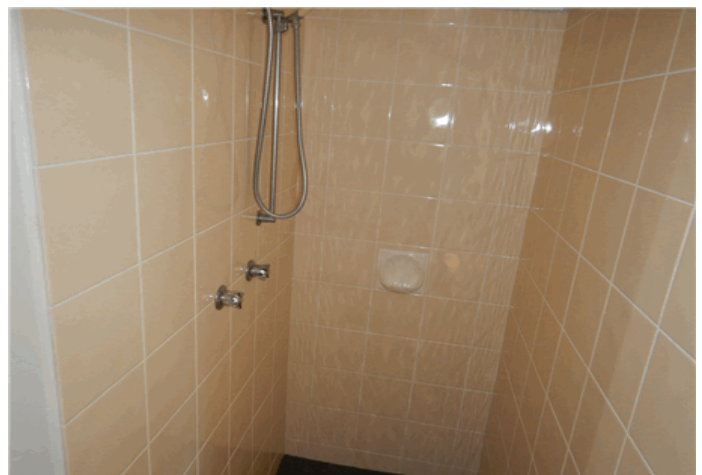
Note: It is always difficult to establish if building materials actually contain Asbestos and it is advised that the only way to be certain, is to have suspected materials Tested by a NATA Accredited Laboratory. If the house was built before the mid 1980s and it has Fibrous Cement Sheeting as either internal or external Cladding, then there is a High Probability that the Sheeting contained Asbestos.

The probability of a Dwelling containing the presence of Asbestos requires this to be Reported as a **Major Defect** for Health and Safety reasons.

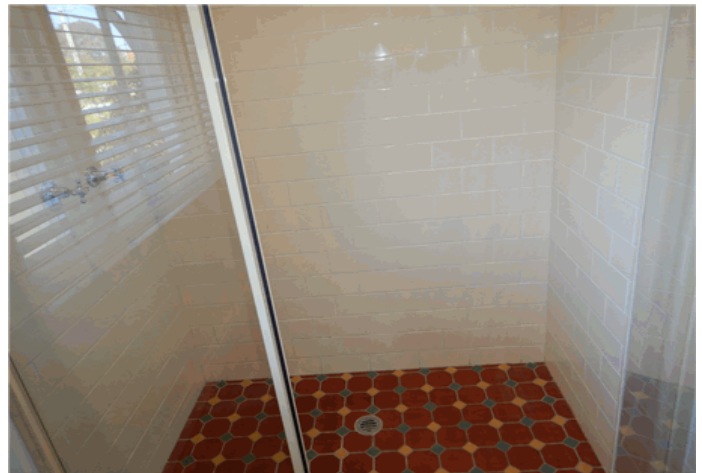
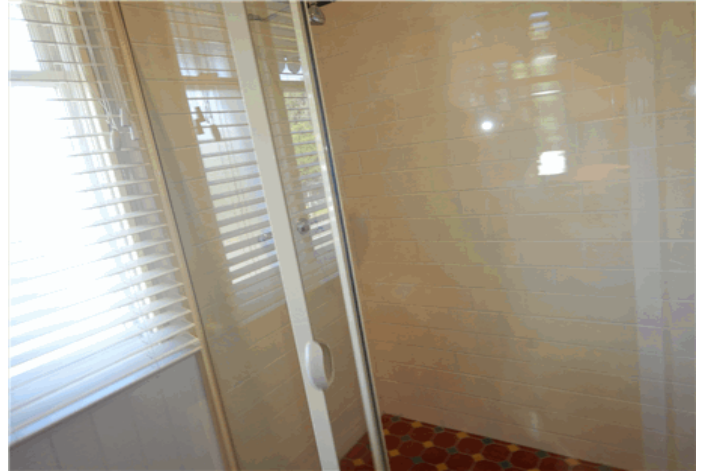
420) Overall Area

The general condition of the Ensuite is acceptable, however, please read the following area specific comments.

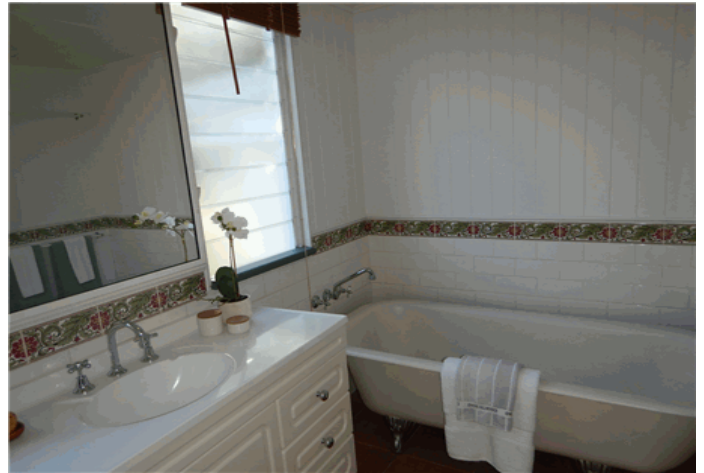
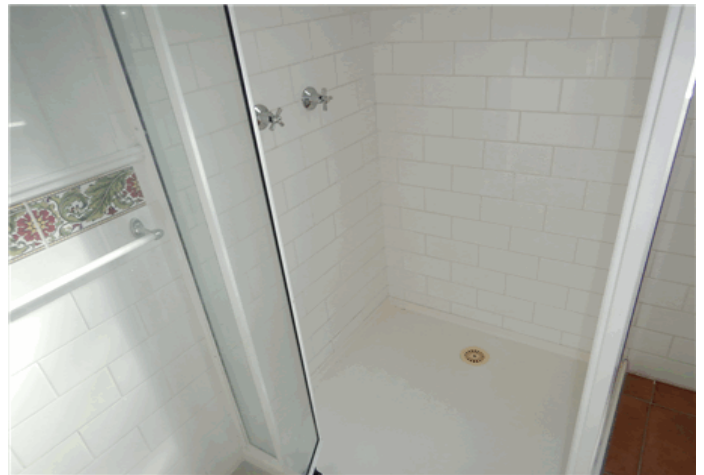
Note: It is always difficult to establish if building materials actually contain Asbestos and it is advised that the only way to be certain, is to have suspected materials Tested by a NATA Accredited Laboratory. If the house was built before the mid 1980s and it has Fibrous Cement Sheeting as either internal or external Cladding, then there is a High Probability that the Sheeting contained Asbestos.

The probability of a Dwelling containing the presence of Asbestos requires this to be Reported as a **Major Defect** for Health and Safety reasons.

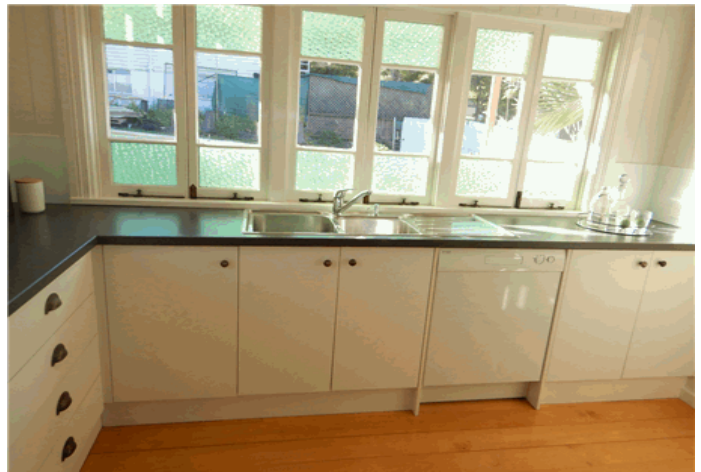
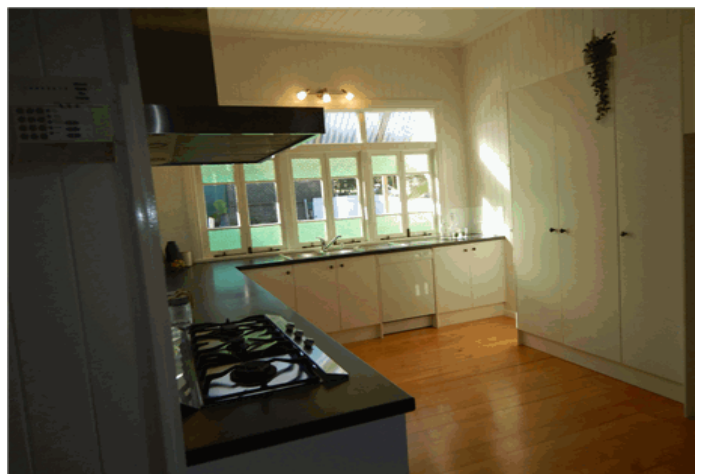
525) Overall Condition

On visual inspection, the general condition of the Kitchen is acceptable, however, please read the comments in the area specific sections to follow.

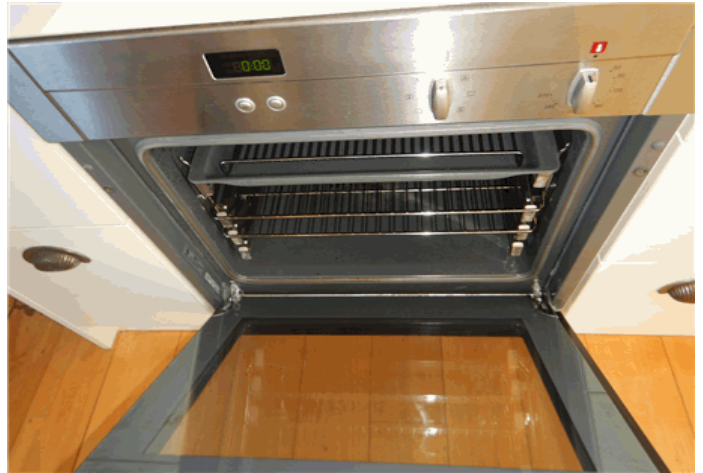
The Gas Hotplates appear to be in an acceptable condition at the time of Inspection, the Oven as well appears to be in an acceptable condition.

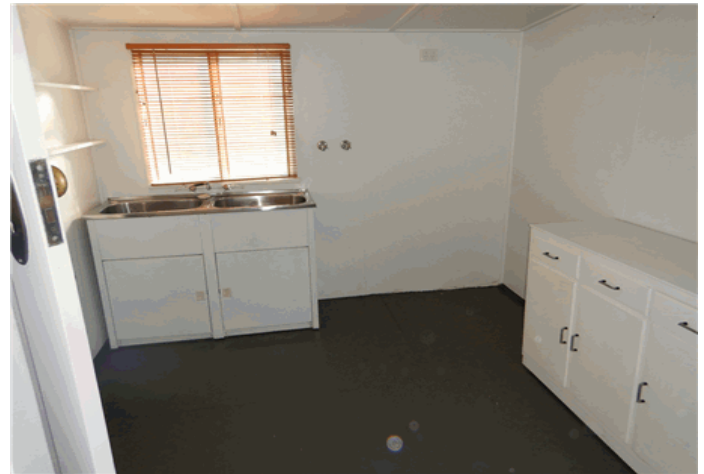
Note: It is always difficult to establish if building materials actually contain Asbestos and it is advised that the only way to be certain, is to have suspected materials Tested by a NATA Accredited Laboratory. If the house was built before the mid 1980s and it has Fibrous Cement Sheeting as either internal or external Cladding, then there is a High Probability that the Sheeting contained Asbestos.

The probability of a Dwelling containing the presence of Asbestos requires this to be Reported as a **Major Defect** for Health and Safety reasons.

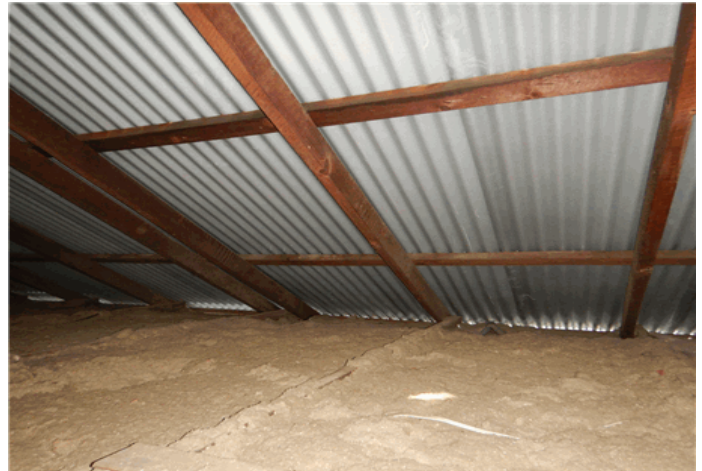
558) Roof

The Roof Frame appears to be in an acceptable condition with no indications of moisture or structural defects.

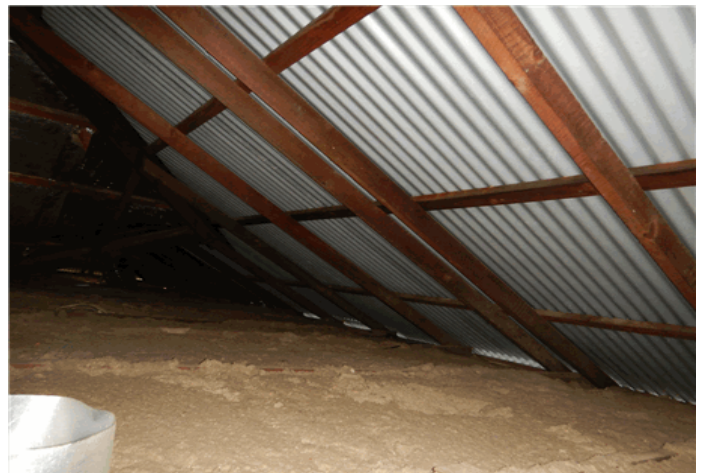
561) Insulation

The Roof Void had Loose Cellulose Spray applied Insulation.

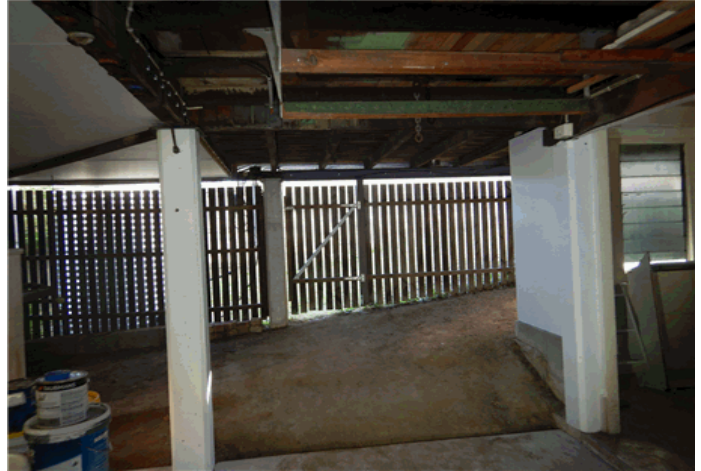
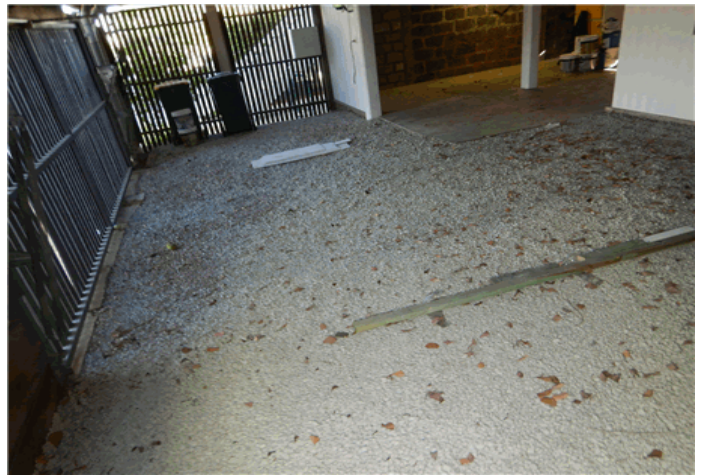
564) Overall Area

On visual inspection, the general condition of the Sub-Floor is acceptable, however, please read the following area specific comments.

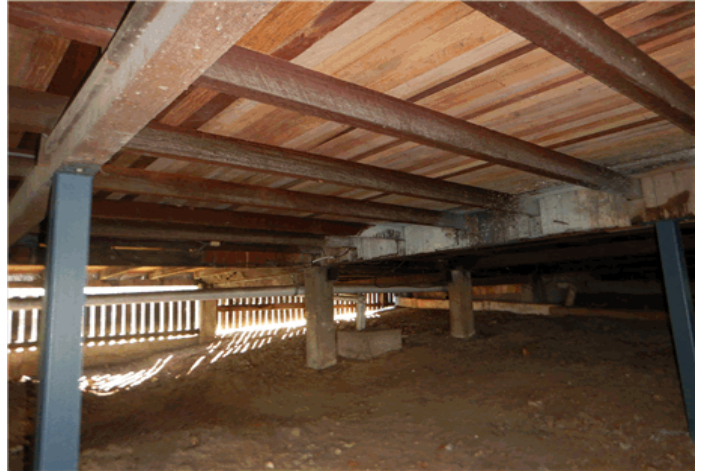
565) Floor Timbers

On visual inspection, the general condition of flooring is acceptable.
