Inspection Report

Professional Building Report Services Pty Ltd

PBRs Sample Report 2019

Report Number	PBRSSample2019
Inspection Type	The Inspection is a Pre-Purchase Building and Pest Inspection .
Inspection Date	September 2019
Inspection Time	9.00am
Weather Conditions	The Weather Conditions were Fine and Dry for the time of the Inspection.
Recent Weather Conditions	The Recent Weather Conditions were Showers & Rainy at the time preceeding the building Inspection.

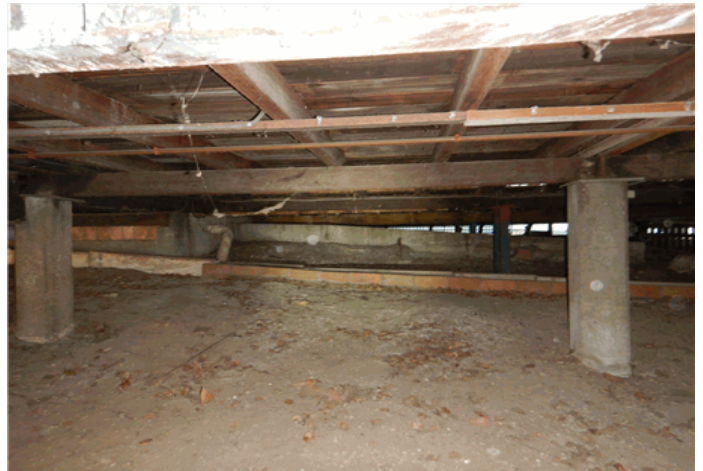
566) Joists and Bearers

All floor Joists and Bearers appeared to be in sound condition.

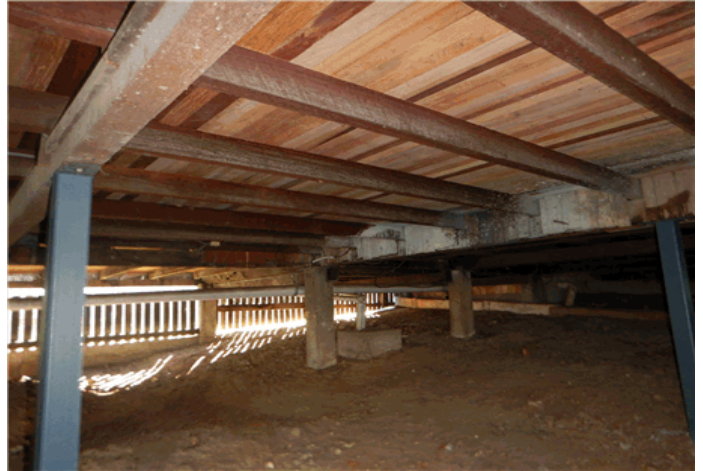
567) Piers and Foundation Walls

The general condition of the Concrete and Steel Post Piers is acceptable for the age, however it is still advised that the Steel Posts will require monitoring and further actions as they suffer any corrosion issues.

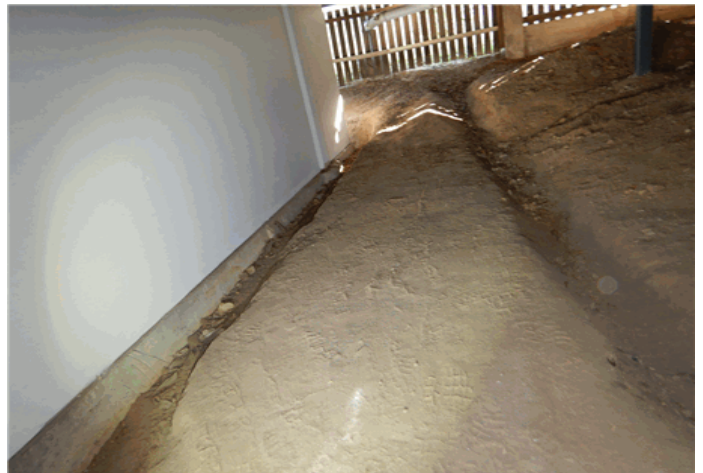
569) Dampness

There are indications of Drainage issues in the past, this will need to be monitored and corrective actions taken when necessary. Drainage Issues are discussed elsewhere in this Report and are reported as a **Major Defect**.

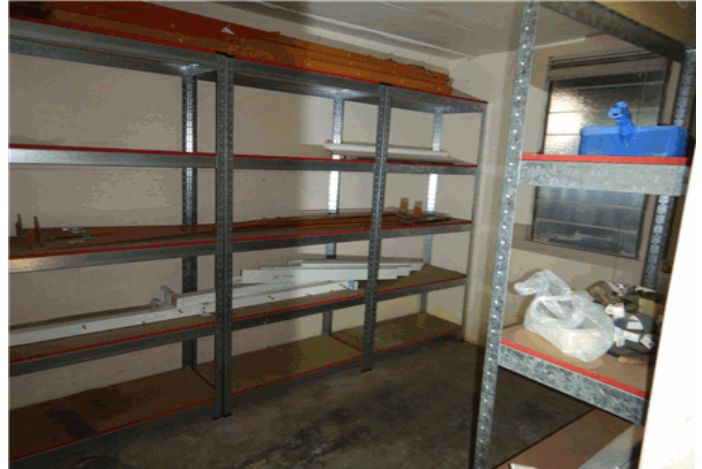
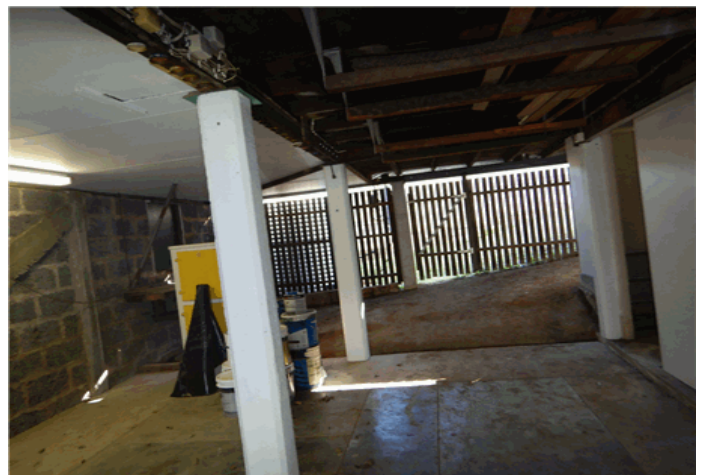
571) Storage

The general condition of the Sub-Floor Storage areas was acceptable.

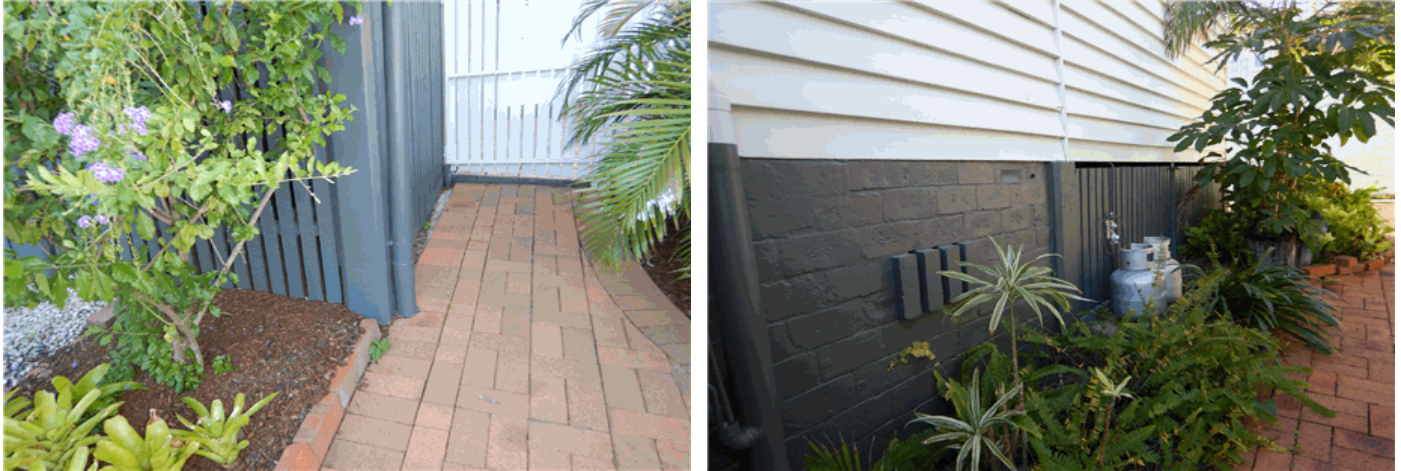
693) The Termite Shields Appear to be The Termite Shield practices are generally Adequate, however, there are situations where Garden Beds are next to the Dwelling Foundations where it appears this property/dwelling can be at risk of Termite attack.
