Deck, balcony and window safety

A guideline for the use, inspection and maintenance of decks, balconies and windows

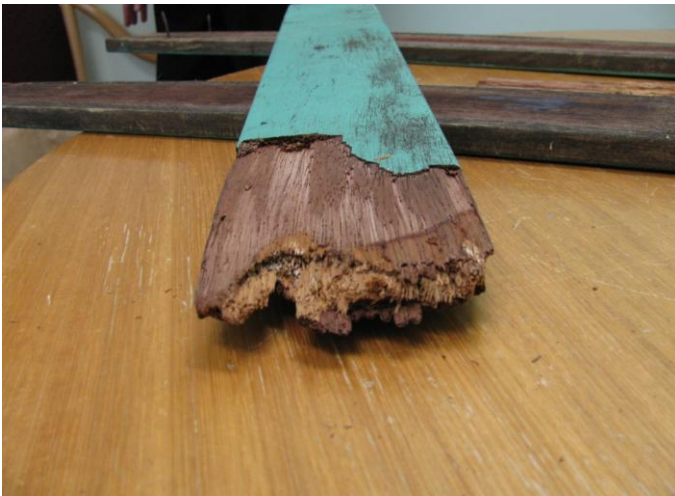
One of the decayed decking boards from the accident.

In September 2012, the Rockhampton Coroner released findings from an investigation into a death caused by a decayed decking board.

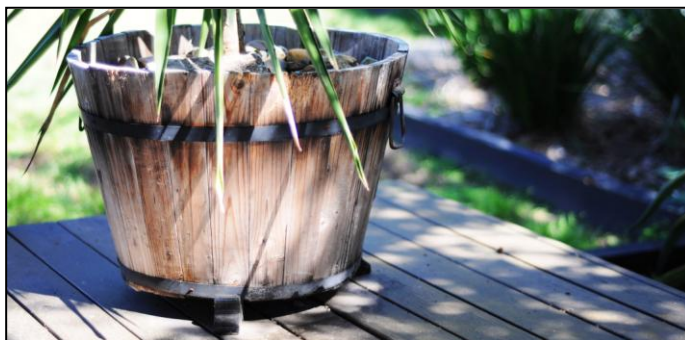
Keep trays or feet under pot plants to reduce moisture on decking

To reduce the likelihood of decay, any areas of the deck or balcony that are frequently damp should be addressed immediately. Dampness can occur when pot plants without bottom plates or feet are placed on the deck or balcony. Soil and other debris should also be cleared away from the deck or balcony, bearers or joists (if it is a low deck or balcony), and posts or supports.

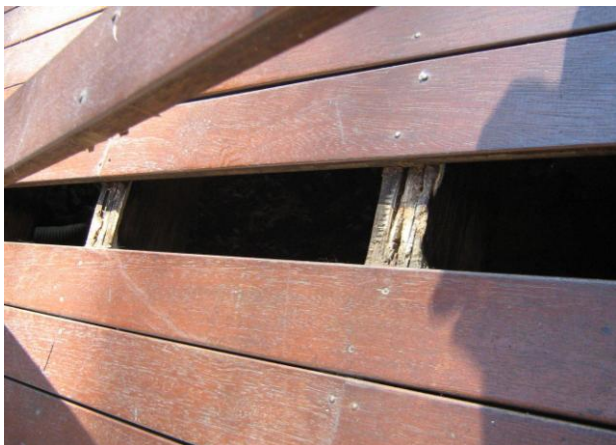
Removing this decking board has revealed a decayed joist

Care should be taken to inspect these sections for decay and to do this adequately may require temporarily removing decking boards.

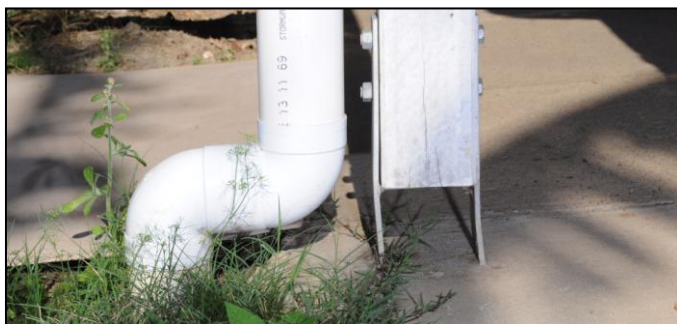
Inspect post brackets for bending or stressing

- Bending or stress of post brackets—in most cases these brackets will be above ground level, which will make visual inspection easier.
- Deterioration of nuts, bolts, screws or nails—these fasteners can be integral to the deck or balcony and need to be free from deterioration. Rusting metal may be easier to find as it may leave a mark on the connecting timber or paint. Identify, repair and replace these areas as soon as possible.

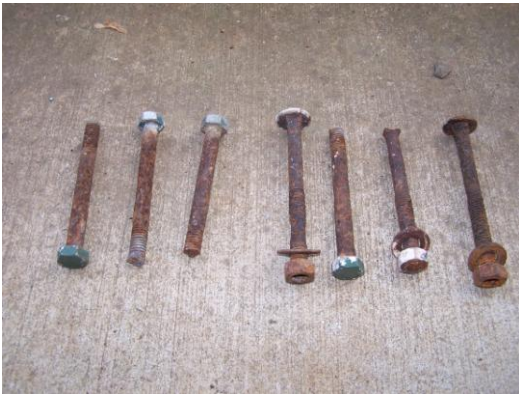
During inspections it is good practice to remove bolts to see their internal condition

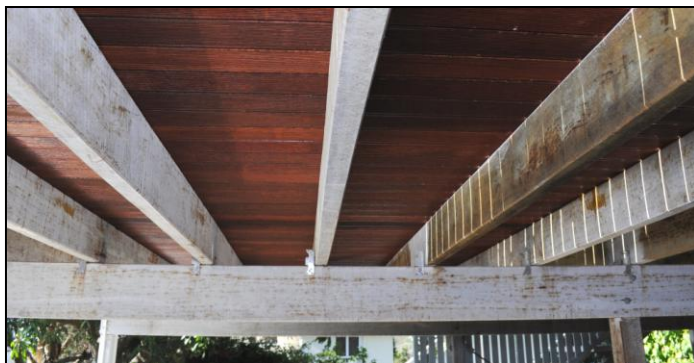
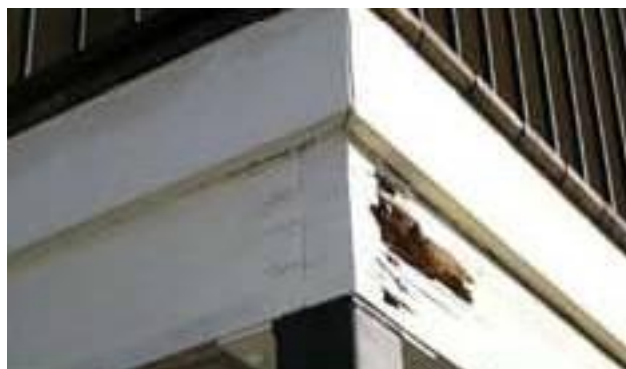
Check bearers and joists for warping or cracking

- warped, cracked or damaged bearers or joists.
- decay and looseness at butt joints and termite damage

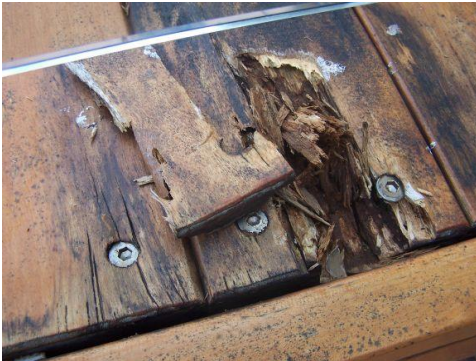
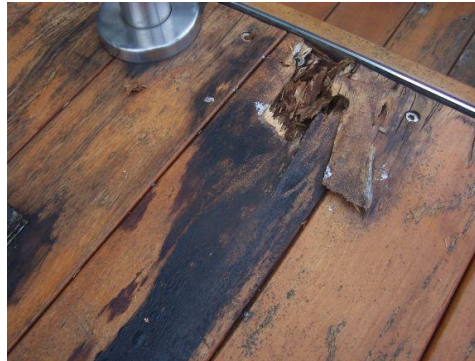
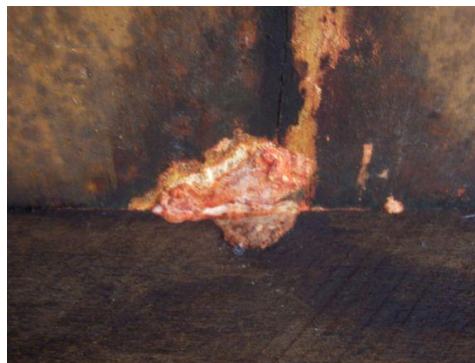
Examples of decking board decay

- warped, cracked or damaged decking boards.
- signs of decay in timber.

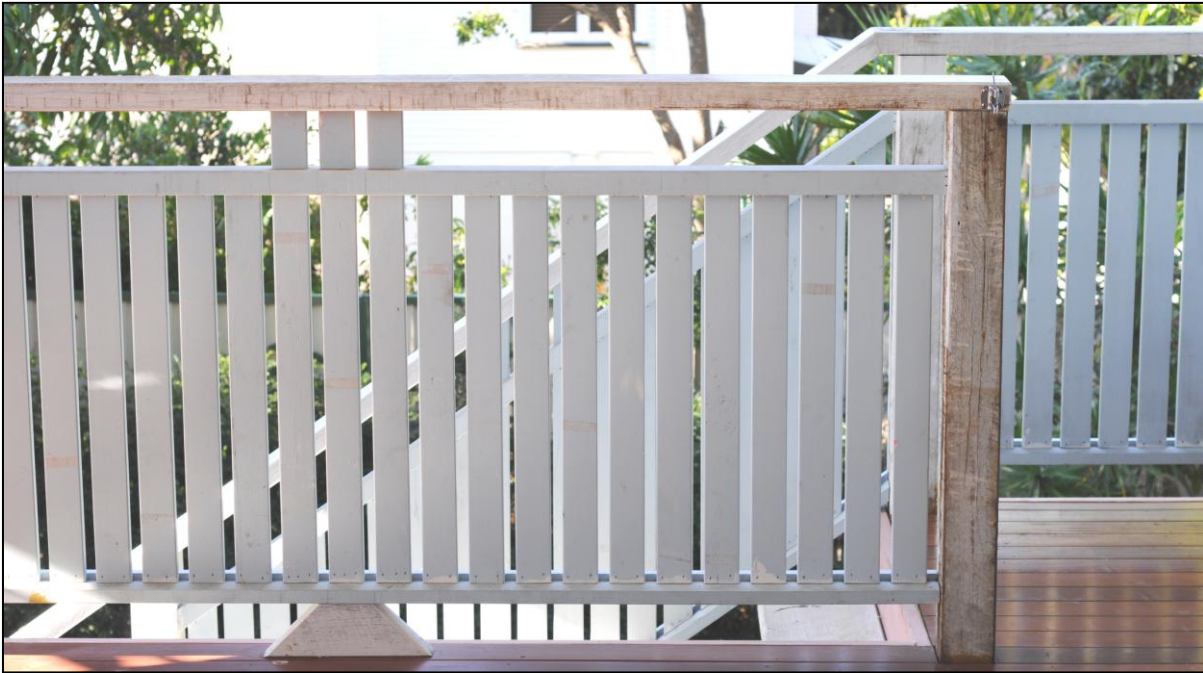
Weakened anchors for balustrades could cause them to fail if people lean against them

Anchor points of the balustrade should be inspected regularly to ensure these are free from deterioration. Any weakening of these anchors could cause them to fail if a load was applied to the balustrade, such as a person leaning against the balustrade.
