Inspection Report

Professional Building Report Services Pty Ltd

Sample Street

COMBINED BUILDING & PEST INSPECTION

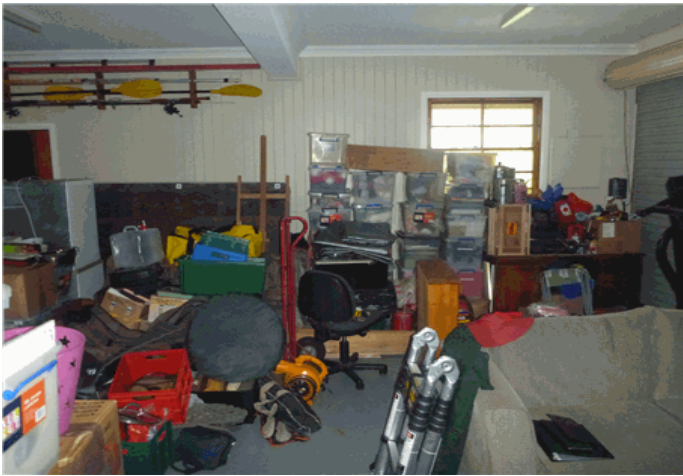
Type	Attached Garage
Areas Restricted	Areas within the Garage were not Reasonably Accessible due to Storage of cupboards and other goods.
40) Overall Area	The Overall Area was acceptable for where no access restrictions existed, however there were areas that could not be reasonably accessed.

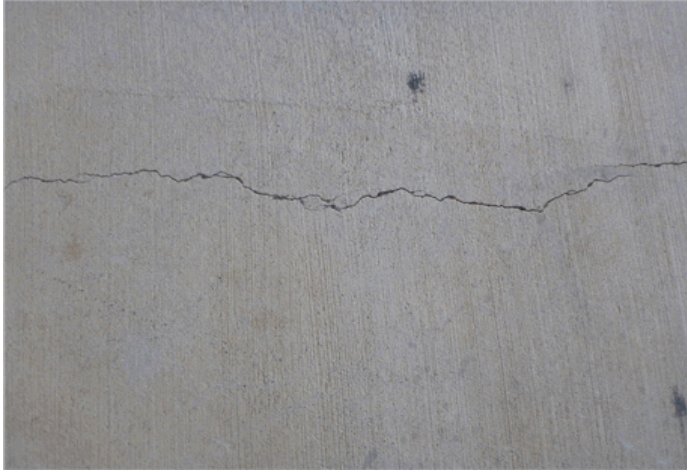
42) Wall Claddings	On visual inspection, the general condition of this area is Acceptable for the age.
43) Doors	On visual inspection, the general condition of this area is Acceptable for the age.
44) Ceilings	On visual inspection, the general condition of this area is Acceptable for the age.
45) Internal Walls	On visual inspection, the general condition of this area is Acceptable for the age.
46) Windows	GENERAL AGE DETERIORATION - The window frame/components showed evidence of ageing and wear. <u>Recommendations</u> : General maintenance works required.
47) Floors	MINOR HAIRLINE TO 1 MM SLAB CRACKS - Note. Whilst these cracks appeared to be minor at the time of inspection, we strongly recommend you

monitor these cracks and if worsening occurs contact a licensed Structural Engineer or qualified concreter for further advice.

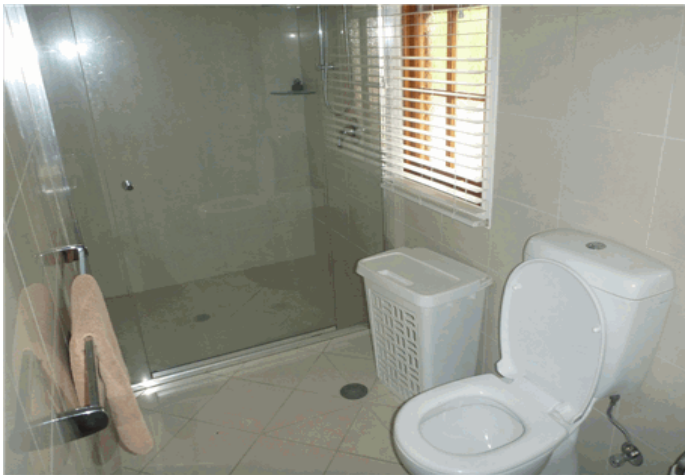
169) Overall Area Of the visible areas, the general condition of this Bathroom is acceptable or in reasonable condition for age of dwelling.
