Inspection Report

Professional Building Report Services Pty Ltd

Sample Street
BRISBANE QLD 4999

BUILDING REPORT

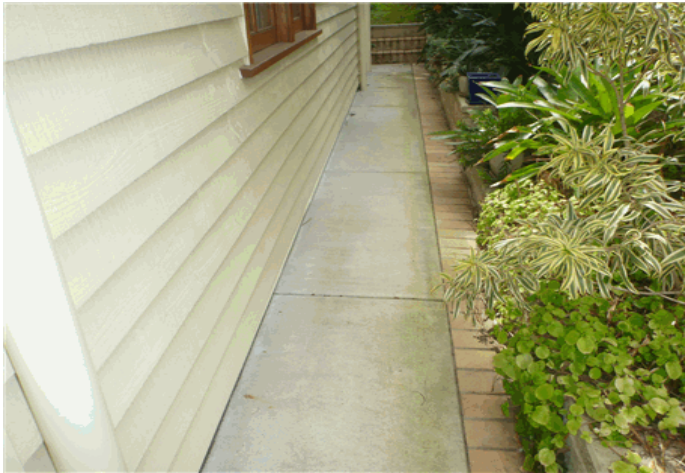
7) Pathways

The paths around the home are in reasonable condition for the age of this dwelling with no major defects visible.

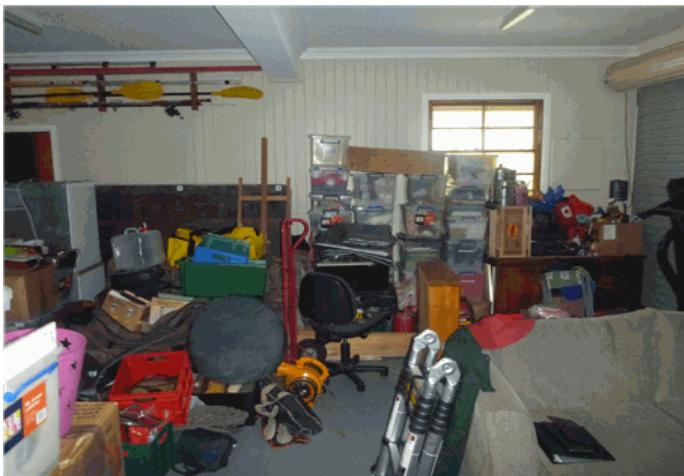
40) Overall Area

The Overall Area was acceptable for where no access restrictions existed, however there were areas that could not be reasonably accessed.

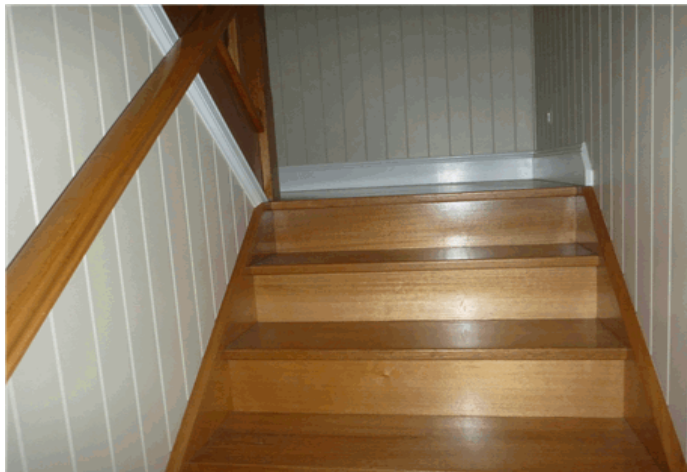
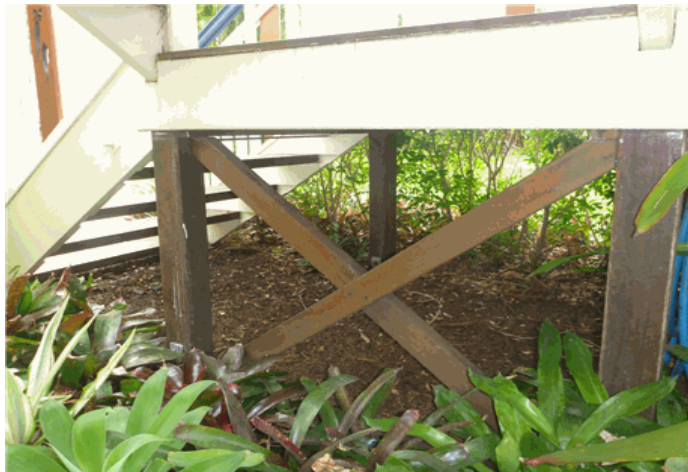
48) Overall Stairs - Steps

The Steps/Stairs appear to be functional with no notable defects

Rise and Going within acceptable standard

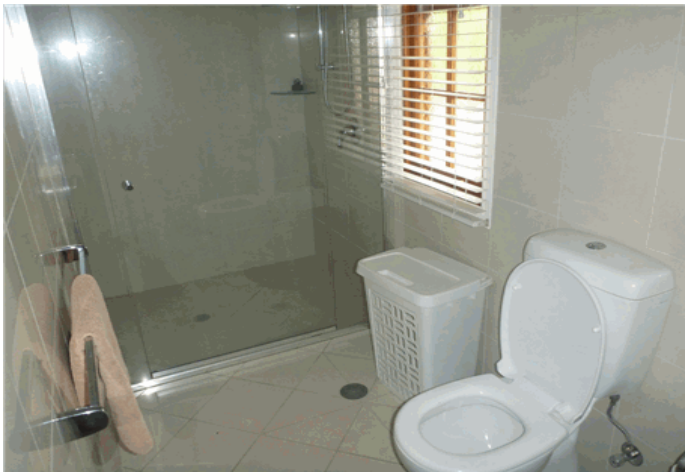
169) Overall Area Of the visible areas, the general condition of this Bathroom is acceptable or in reasonable condition for age of dwelling.
