# Subterranean termite infestation in buildings

## protecting timber, buildings and furniture

### Termites 3

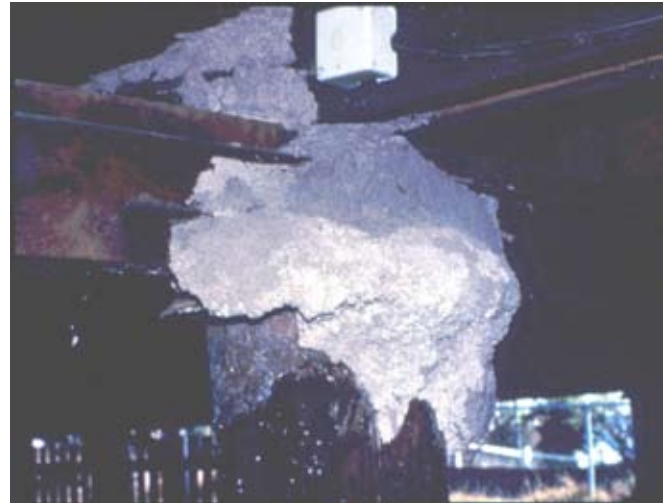
Figure 1. Physical barrier (termite shield) bridged by subterranean termites.

Methods employed in the erection of physical barriers during building construction are detailed in the Australian Standard AS 3660 series. These barriers impede and discourage termite entry into buildings. Termites can build around physical barriers (Figure 1), but are more readily detected during routine inspections.

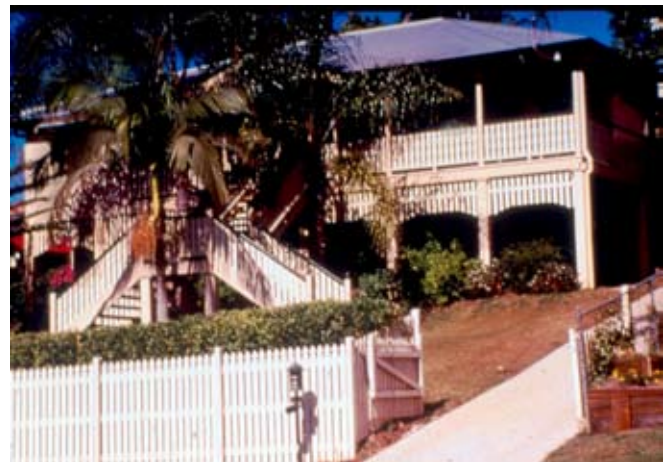
Figure 2. For suspended timber floors, termite shields and routine inspections provide adequate protection.

For suspended floors, termite shields (caps or strip shielding) have, for many years, been placed on foundation walls, piers, stumps, and other substructures to isolate the upper parts of the building from the substructure (Figure 2). Care should be exercised when enclosing the substructure area not to bridge termite shields superstructure. Stainless steel mesh can be used to provide these physical barriers (Figure 3).

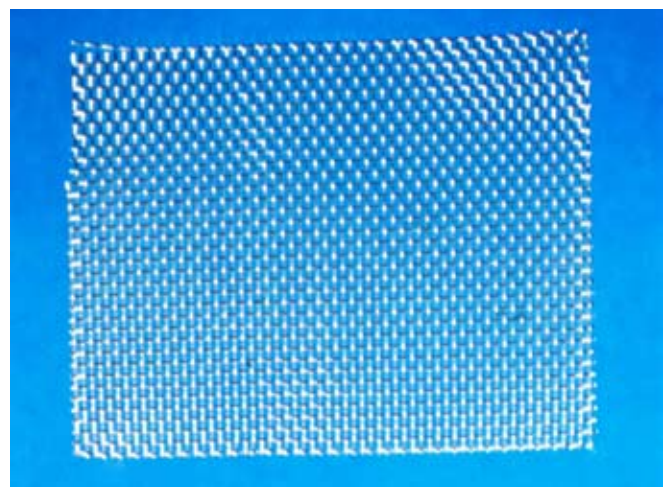
Figure 3. Stainless steel mesh can be used to provide physical barriers.
