Inspection Report

Professional Building Report Services Pty Ltd

PBRs Sample Report 2019

Report Number	PBRSSample2019
Inspection Type	The Inspection is a Pre-Purchase Building and Pest Inspection .
Inspection Date	September 2019
Inspection Time	9.00am
Weather Conditions	The Weather Conditions were Fine and Dry for the time of the Inspection.
Recent Weather Conditions	The Recent Weather Conditions were Showers & Rainy at the time preceeding the building Inspection.

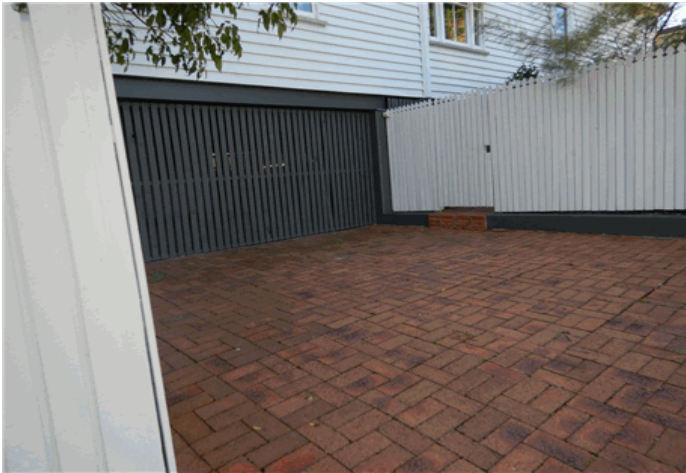
12) Overall Area

The Pathways are a mixture of materials around the Dwelling and all are in generally an acceptable condition at the time of Inspection, however, some Pavers were noted as shifting and these will need to be monitored and corrective actions taken if the condition worsens.

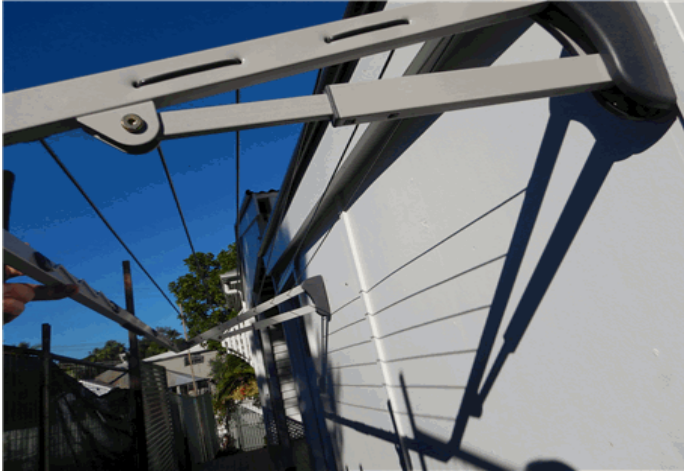
35) Overall Comment

The Clothesline appeared to be in an acceptable condition at the time of the Inspection.

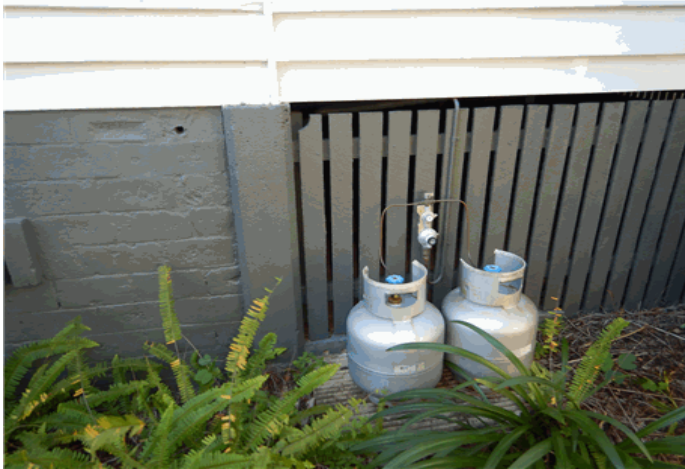
50) Overall

This Property has Gas 9kg Cylinders for a Gas Service.

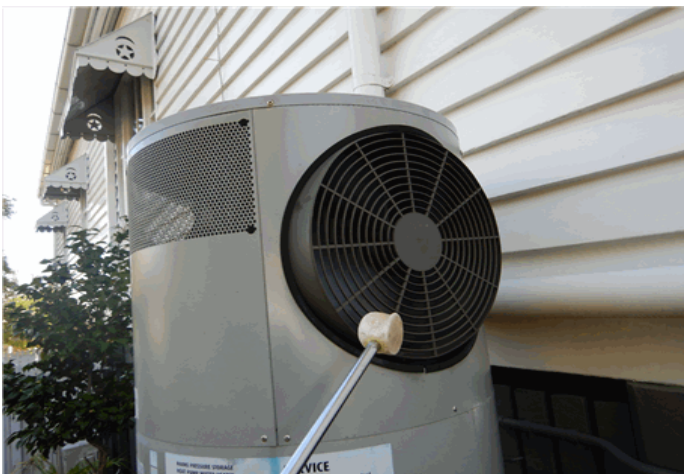
The Hotwater system appears to be in working condition. Operation of the relief valves were tested, no other specific tests other than running the hot water from a tap was carried out. No determination has been made as to the suitability or adequacy of the Hotwater system in relation to capacity or otherwise.

It was noted the Heat Pump was a little noisy when operational, this will require maintenance attention.

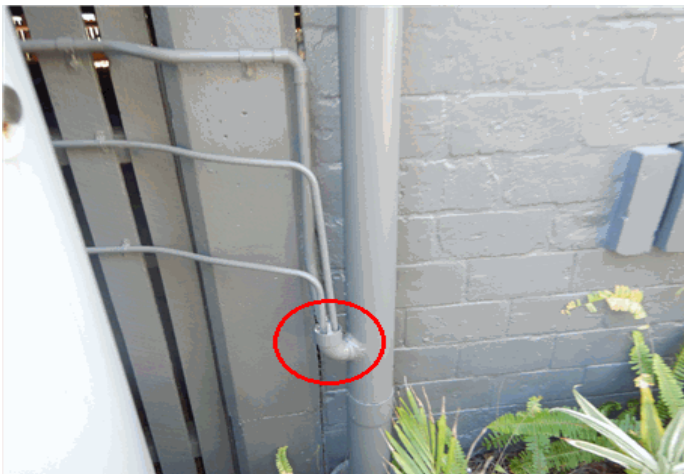
59) Overflow Condition The general condition of the Hotwater Overflow, was considered to be acceptable as the Overflow was found to be directed into a Drain.

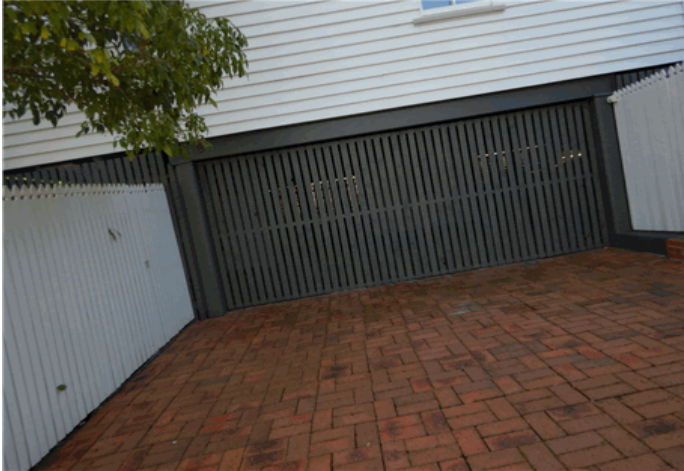
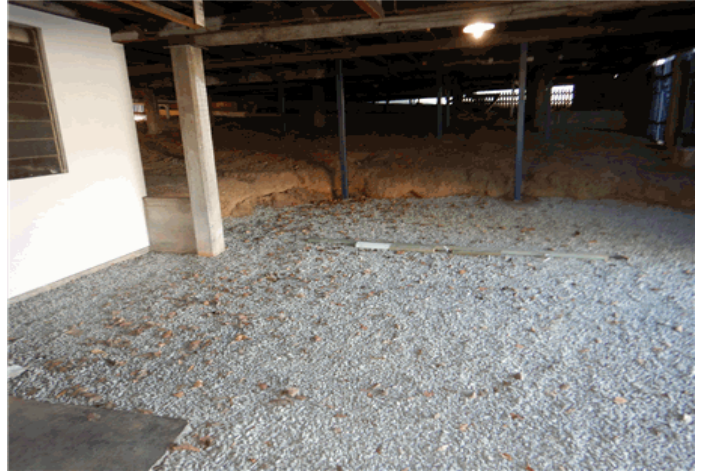
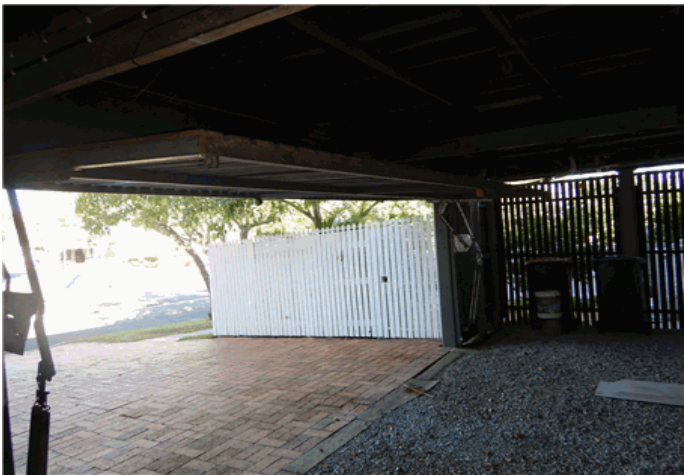
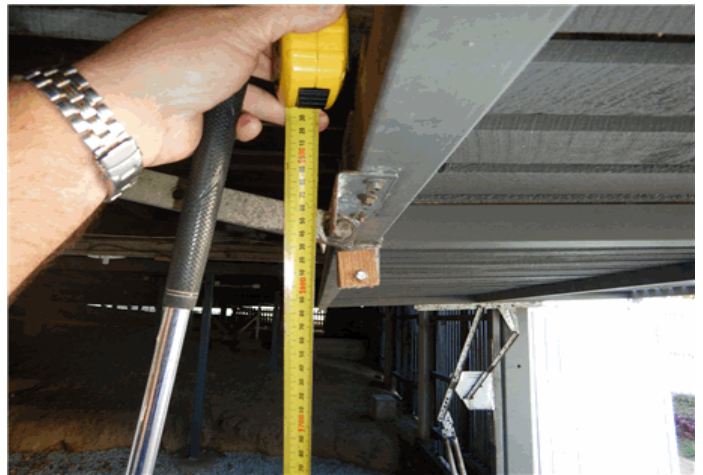
79) Garage

The Garage is a Basic Area with an Automated Vehicle Door, however, the area flooring is gravel and maintenance attention is required.

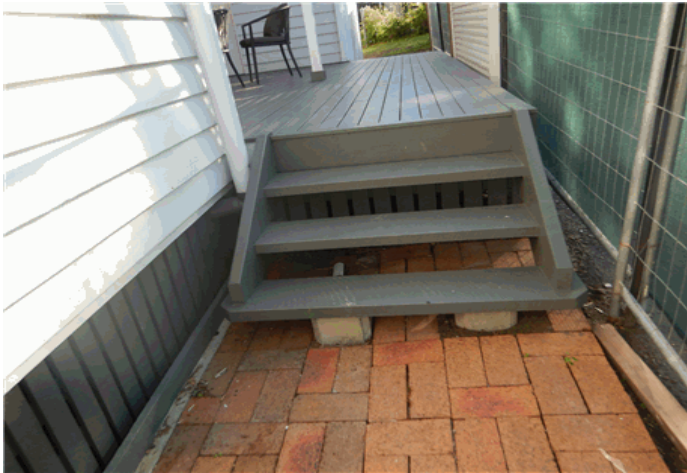
96) Rear Stairs

The External Rear Stairs are in generally a functional condition, however it is noted that there are no Antcappings between the concrete supports and the Steptread, and this will require some maintenance attention in the not so immediate future.

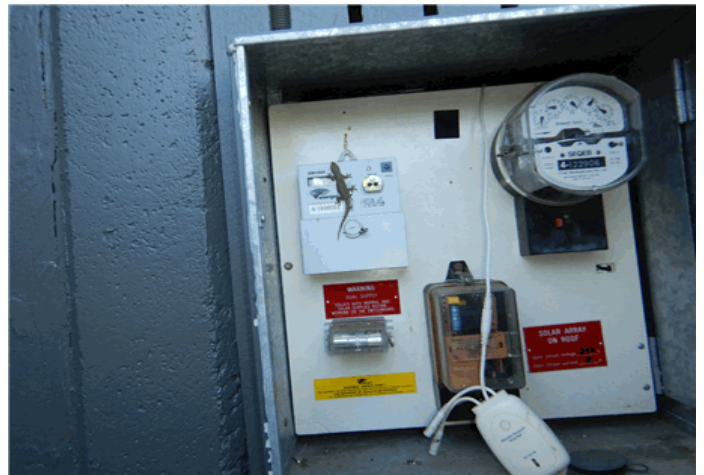
141) Location

The Meter Box is located on the outside Southwest Corner of the Dwelling.

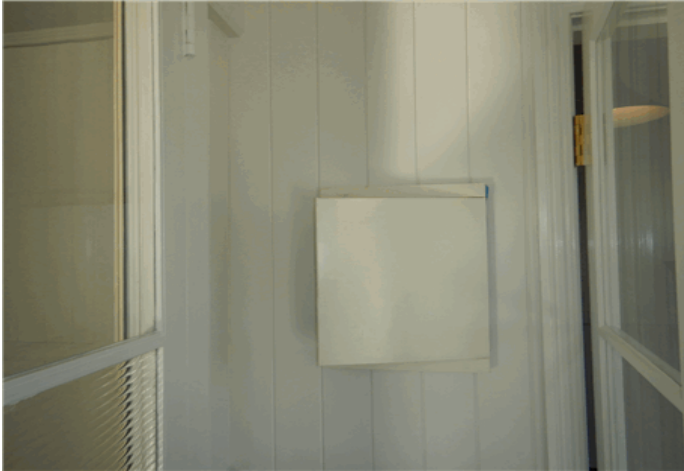
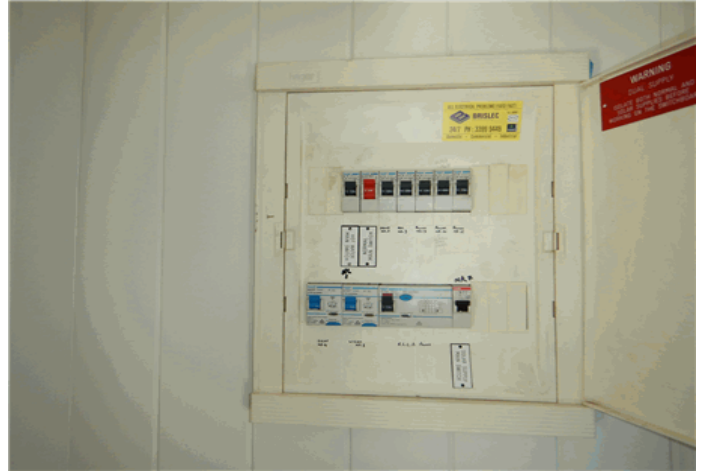
142) Location

The Switchboard is located inside the Upper Level of the Dwelling on the Verandah near the Entry.

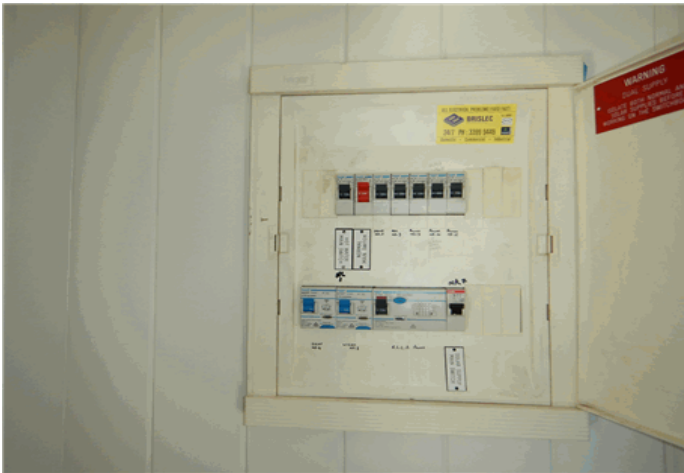
143) Safety Devices

There is a current campaign by the QLD Government for householders to be aware of covering more circuits, in particular, Lighting Circuits protected by Safety Devices and this Property would appear to be adequately protected by Safety Devices.

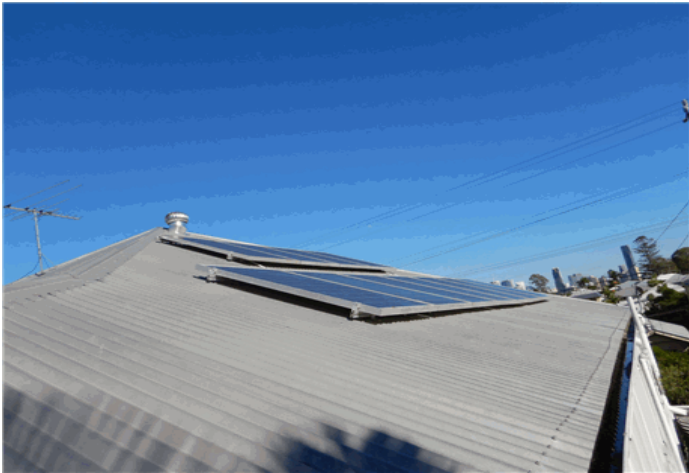
147) Panels This Dwelling does have Solar Panels connected.

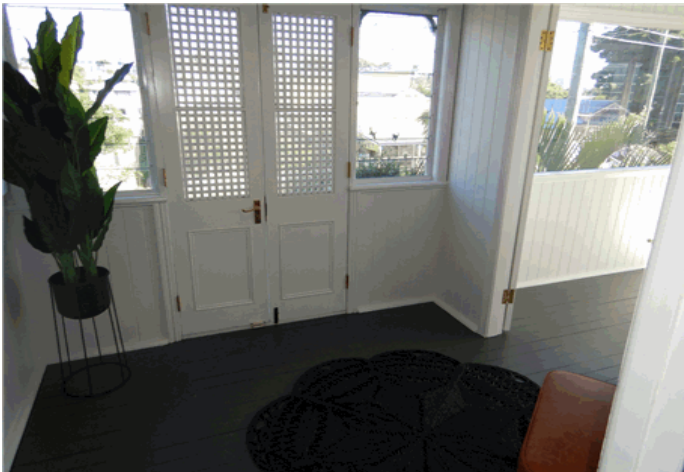
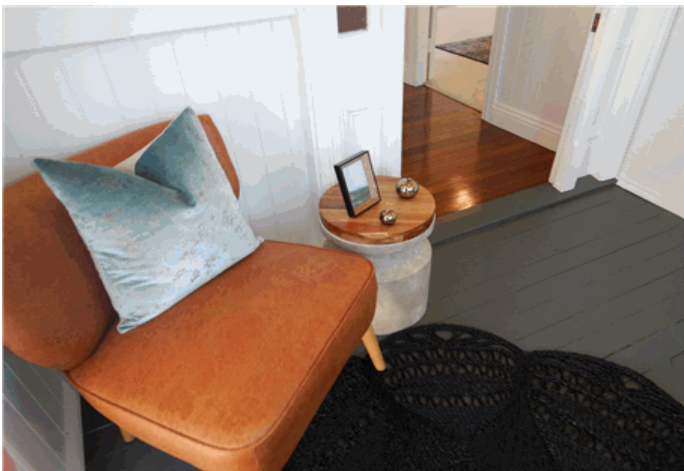
163) Overall Area

The Entry area is considered to be in an acceptable condition.

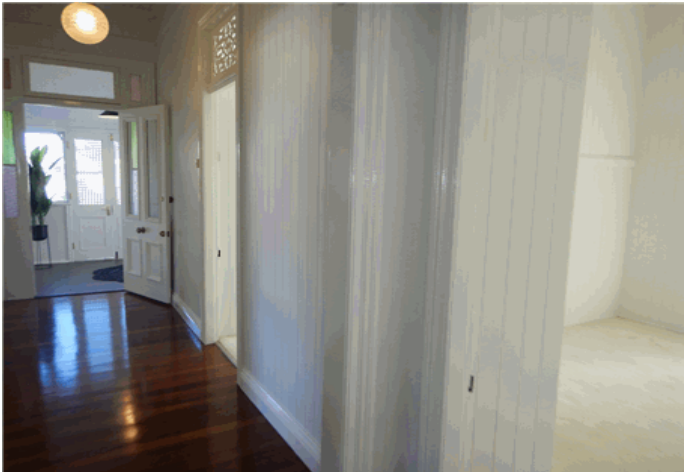
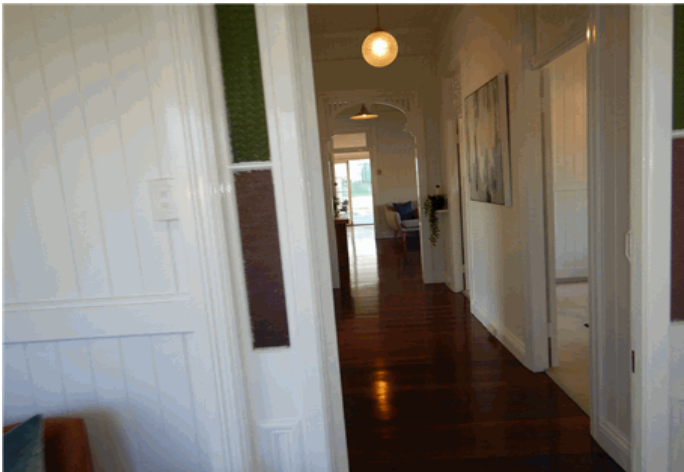
169) Overall Area

The Hallway is in an acceptable condition, however, there was a Light Pendant that has a cable connection cover that has slipped and will require maintenance attention.

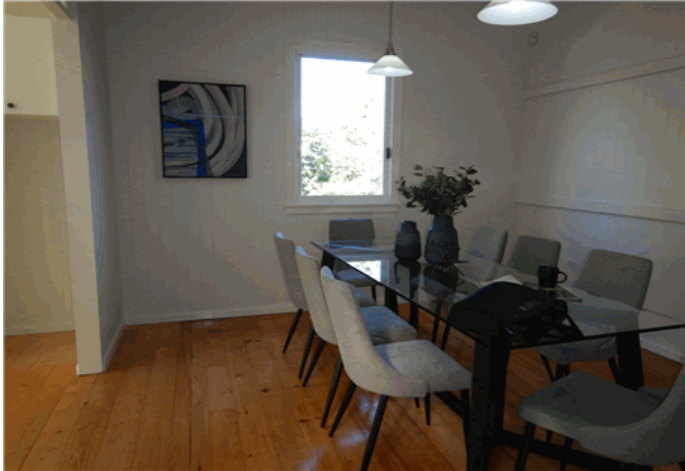
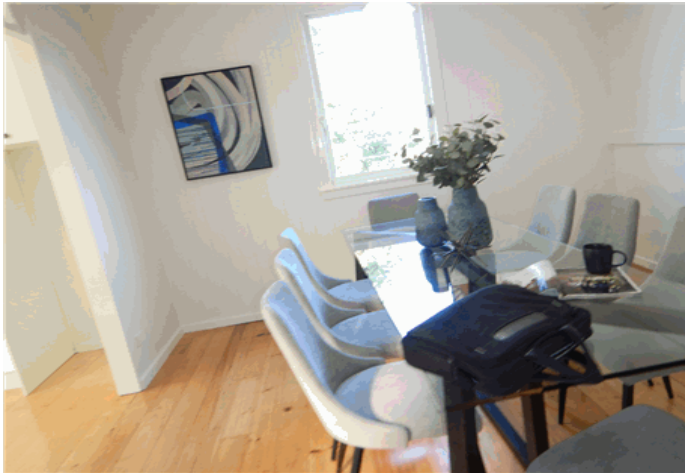
208) Overall Area

The Dining area is in an acceptable condition.

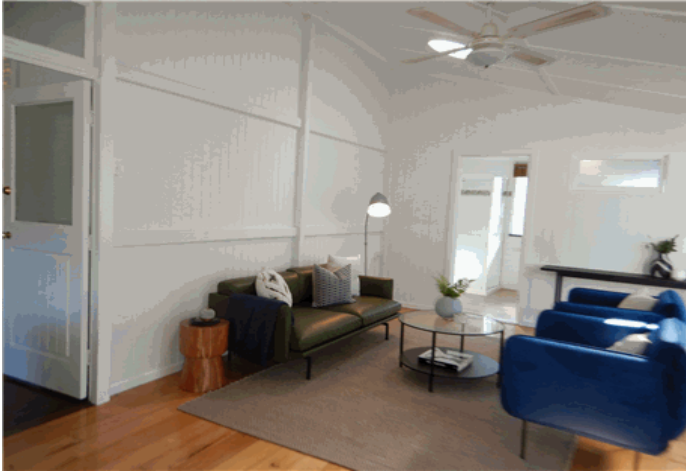
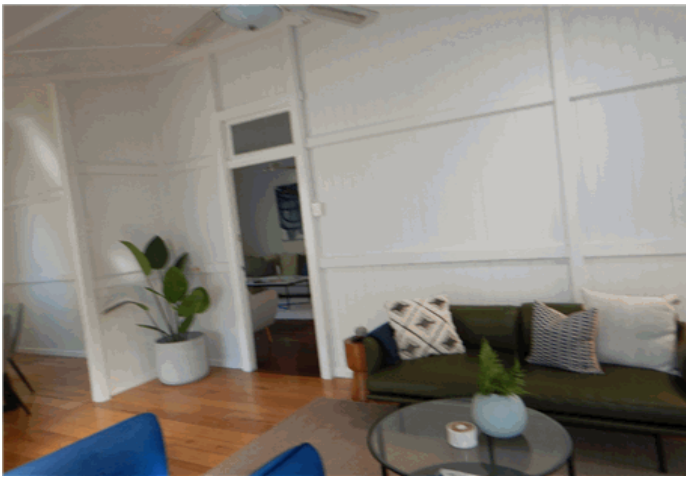
253) Overall Area

The Living area is in a functionally acceptable condition, however, the cement Sheeting used in the Ceilings are a high probability of containing Asbestos Materials.

The probability of a Dwelling containing the presence of Asbestos requires this to be Reported as a **Major Defect** for Health and Safety reasons.

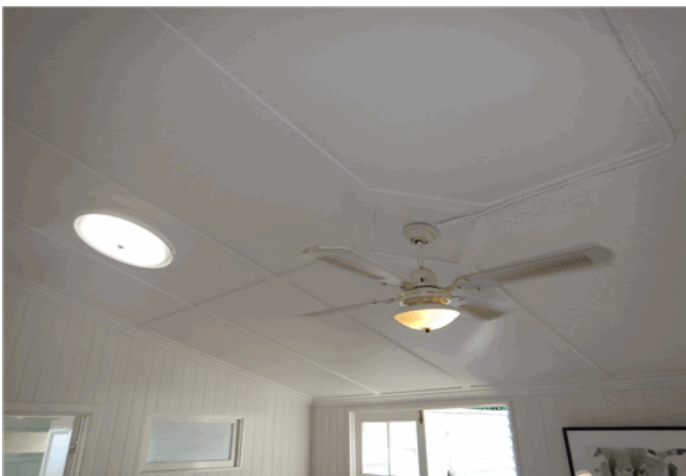
260) Ceiling Fan

The Living Room Fan was in an acceptable condition.

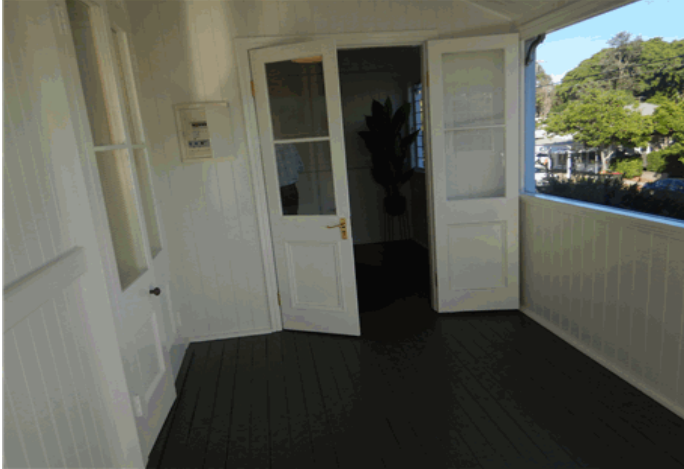
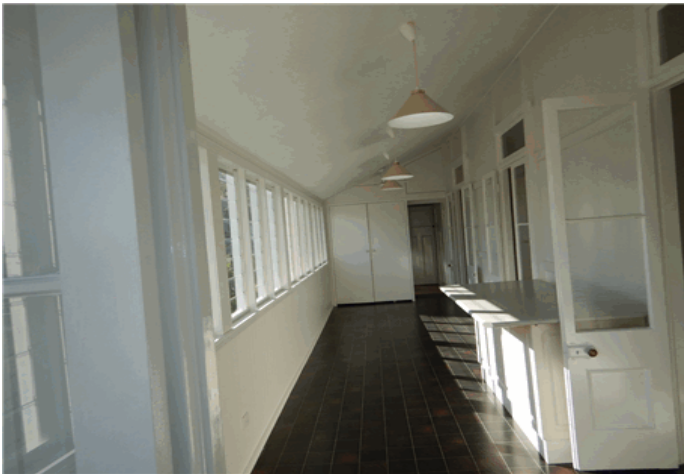
280) Overall Area

The Verandah areas are in an acceptable condition, however, please read the following area specific comments.

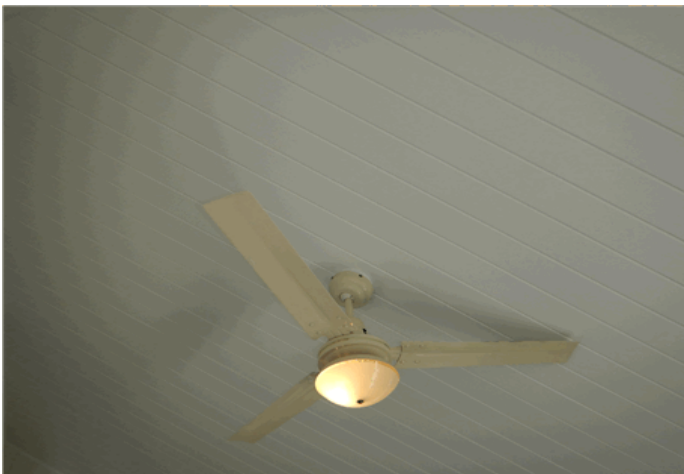
287) Ceiling Fan

The Ceiling Fans in the Verandah Areas are in an acceptable condition.

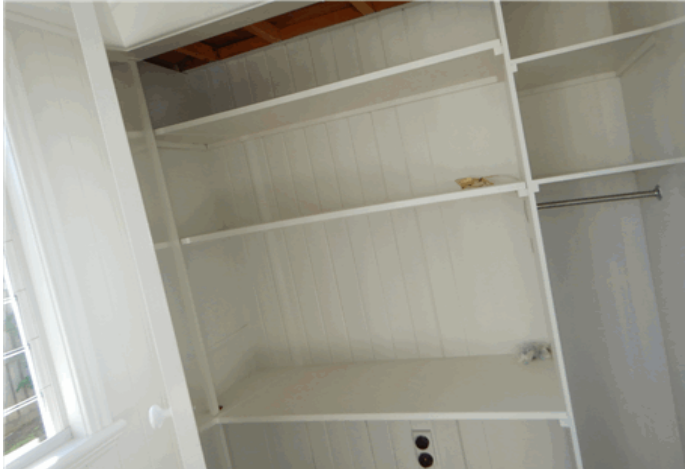
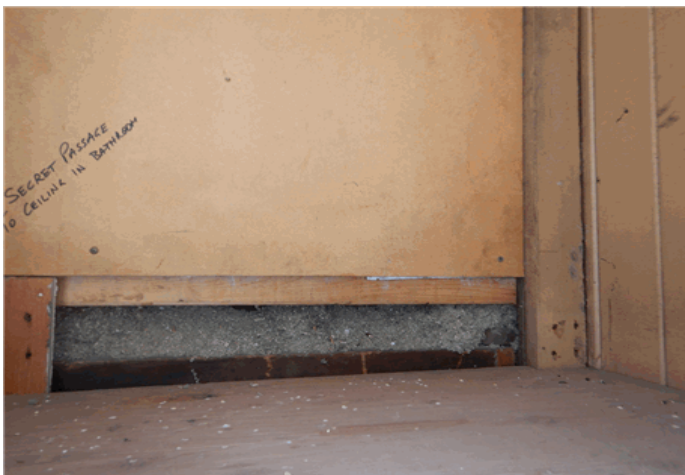
288) Storage

The Verandah Storage cupboards require maintenance attention to a broken Door Clip and to unfinished internal linings.

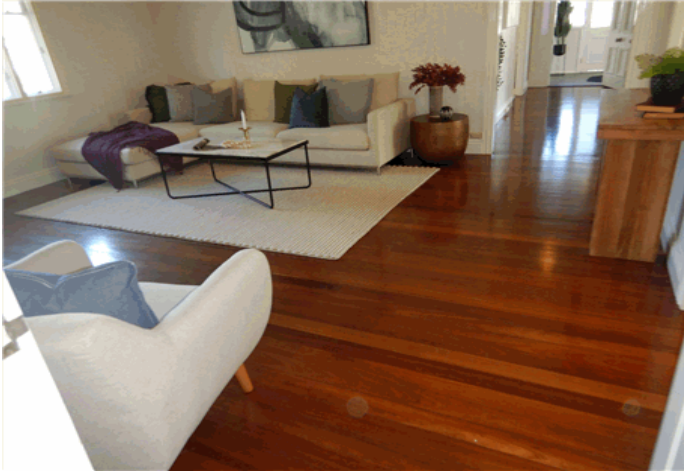
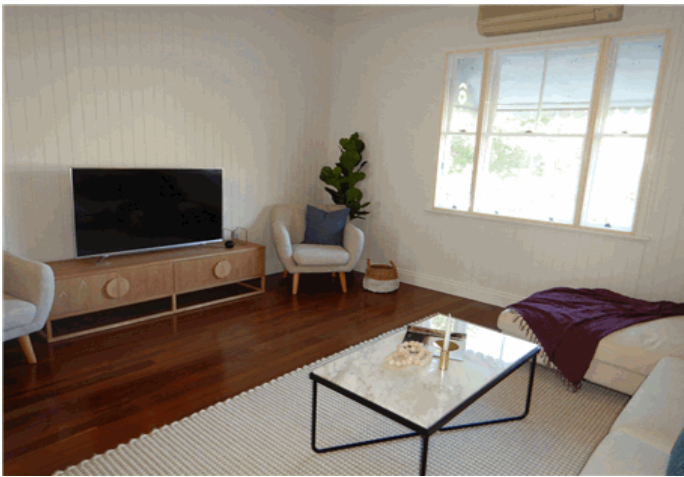
289) Overall Area

The general condition of the Sitting Room was acceptable, however, please read the following area specific comments.

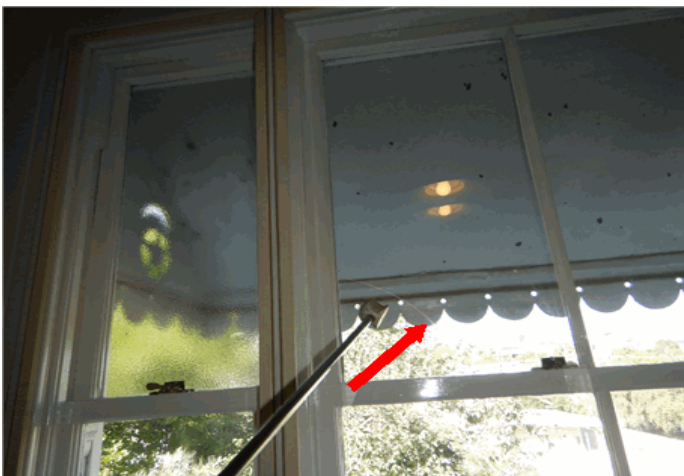
293) Windows

There was a Window in the Living Room that has a cracked Window Pane, see attached photo.

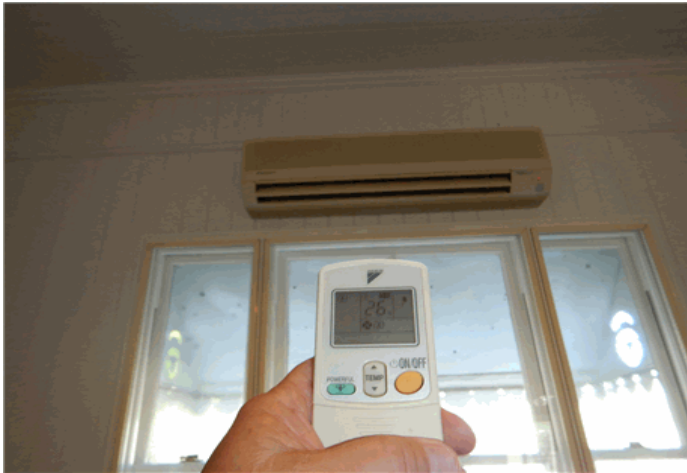
295) Airconditioner

The condition of the Sitting Room Airconditioner was considered to be Acceptable at the time of the Inspection.

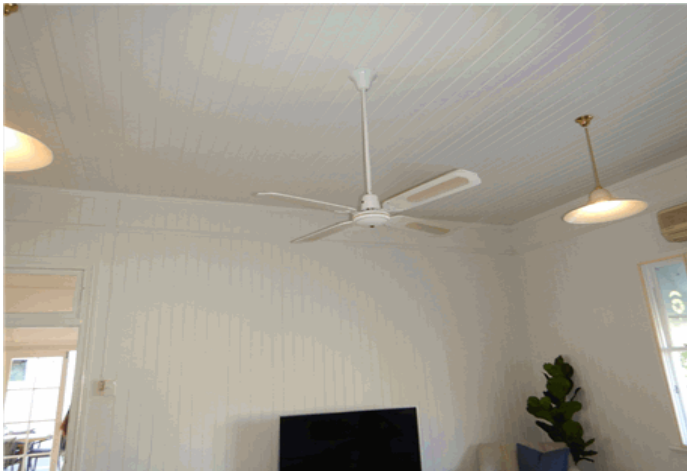
296) Ceiling Fan

The Sitting Room Fan was in an acceptable condition at the time of the Inspection.

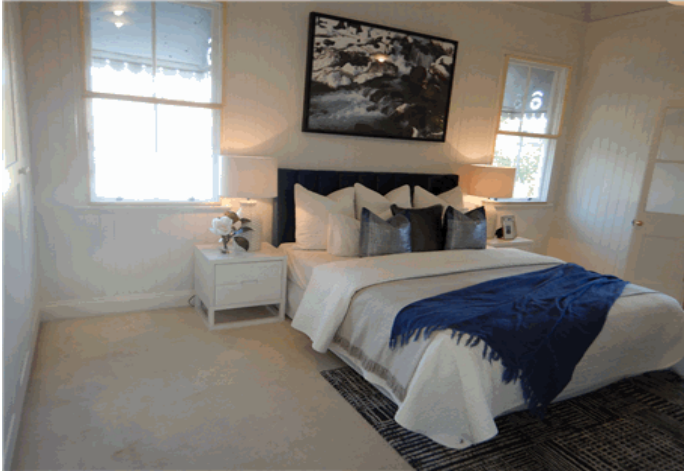
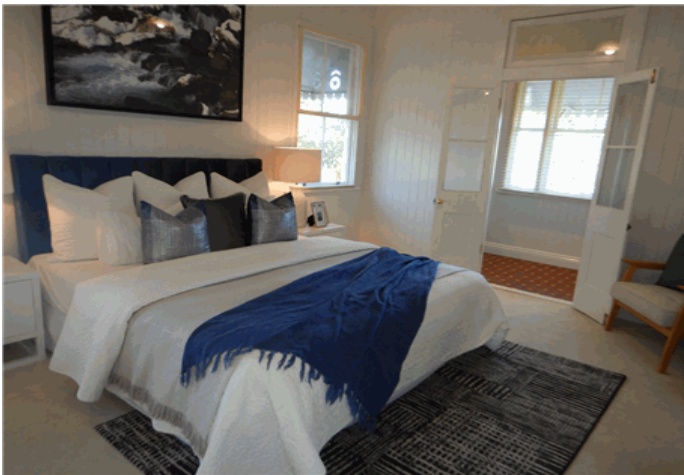
331) Overall Area

The Master Bedroom is generally in an acceptable condition, however, please read the following area specific comments.

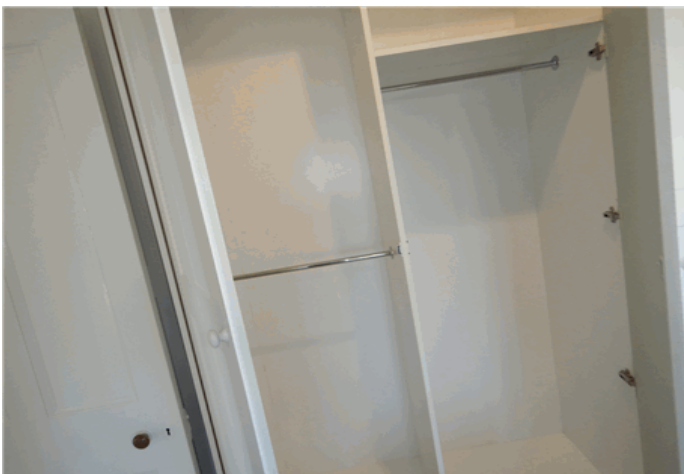
332) Robe

The Master Bedroom Robe is considered to be in an acceptable condition.

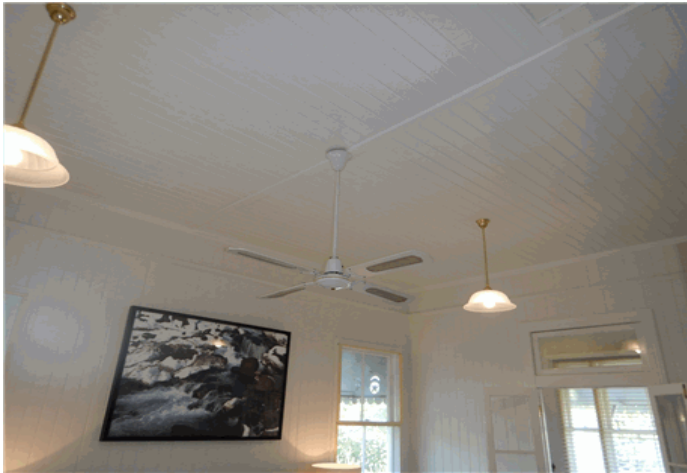
336) Ceiling Fan

It was noted that there was a Ceiling Fan in the Master Bedroom.

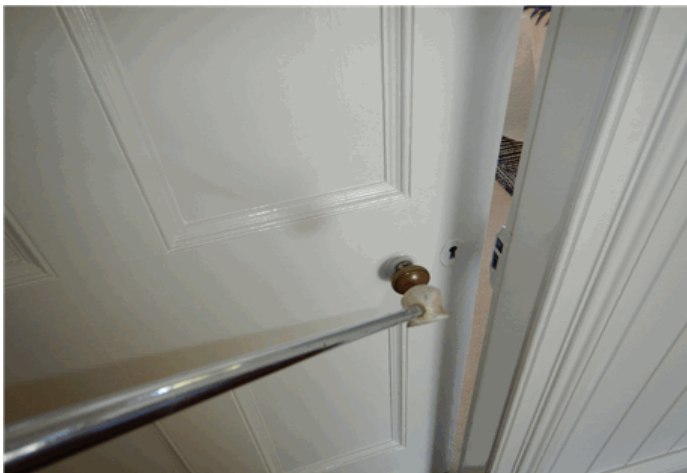
337) Door

The Master Bedroom Door requires some corrective maintenance attention to ensure the Door latches closed.

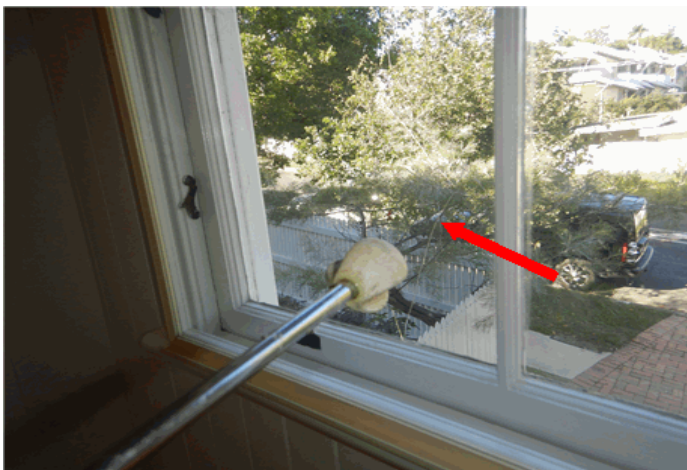
340) Windows

There was a Window in the Master Bedroom that has a cracked Window Pane, see attached photo.

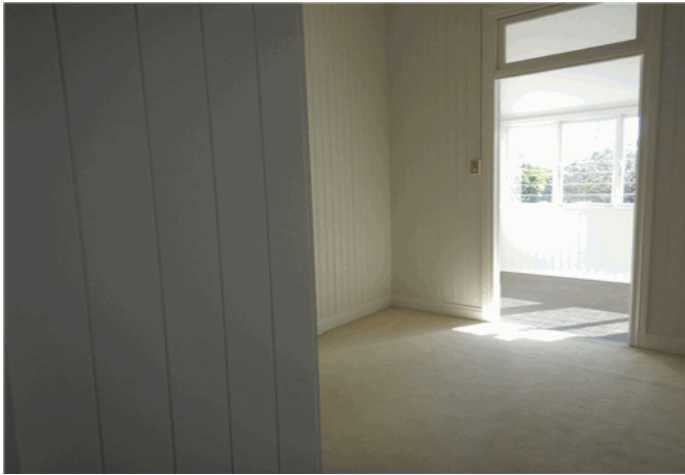
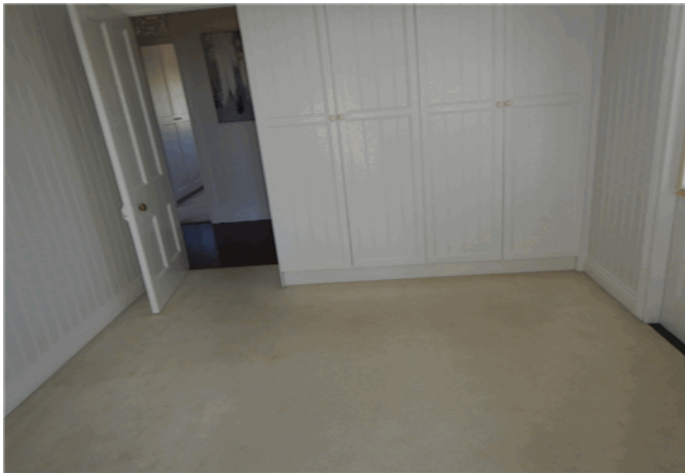
353) Overall Area

The general condition of Bedroom 2 is acceptable.

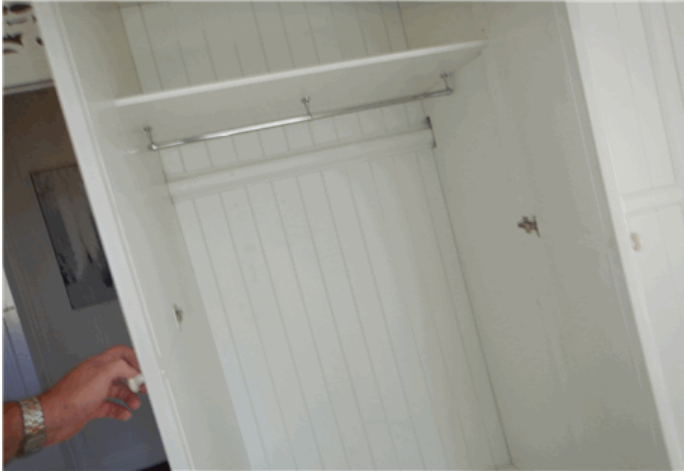
354) Robe

At the time of Inspection the Bedroom 2 Robe was considered to be in an acceptable condition.

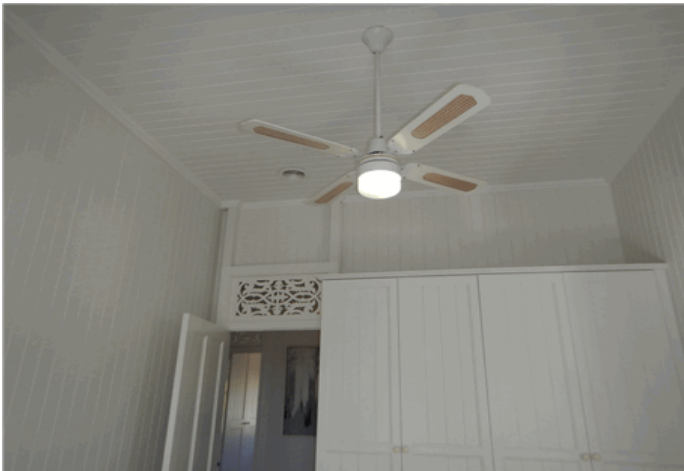
357) Ceiling Fan

The Ceiling Fan in Bedroom 2 was in an acceptable condition at the time of the Inspection.

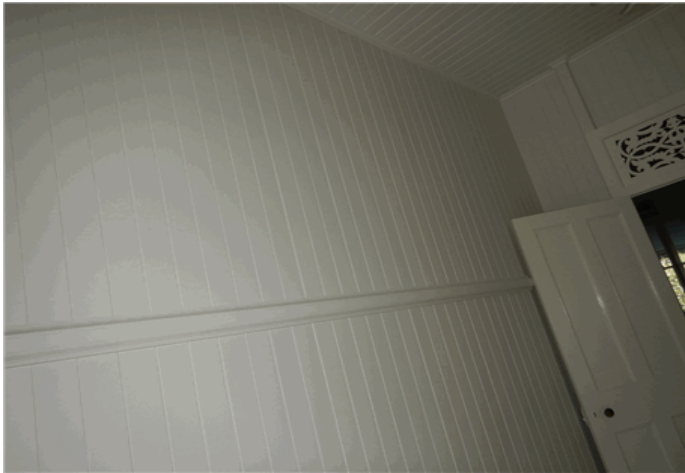
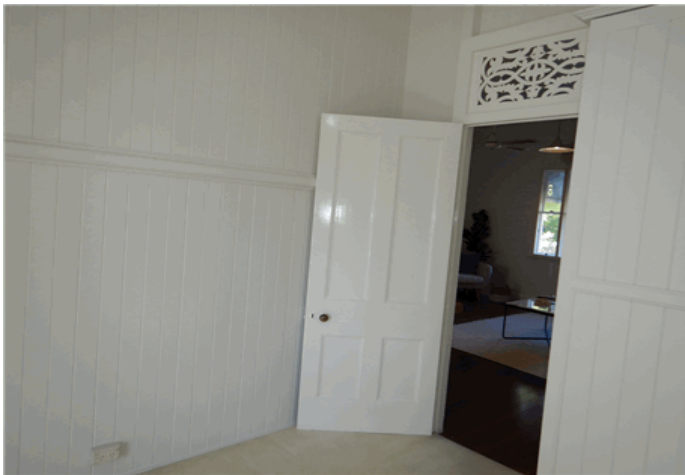
363) Overall Area

Of the visible areas, the general condition of Bedroom 3 is acceptable

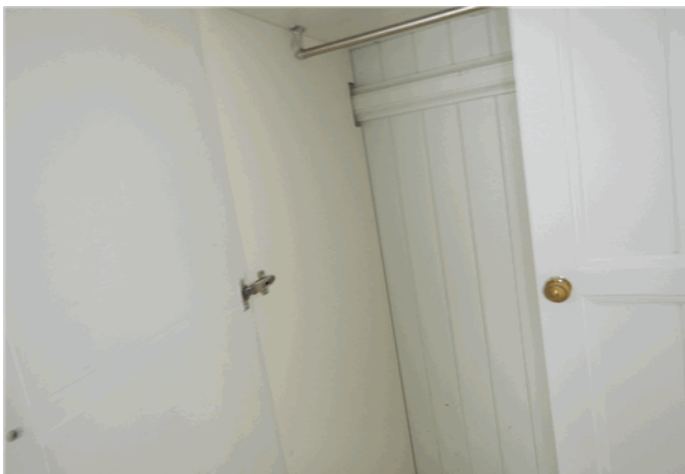
364) Robe

The general condition of the Bedroom 3 Robe is acceptable.

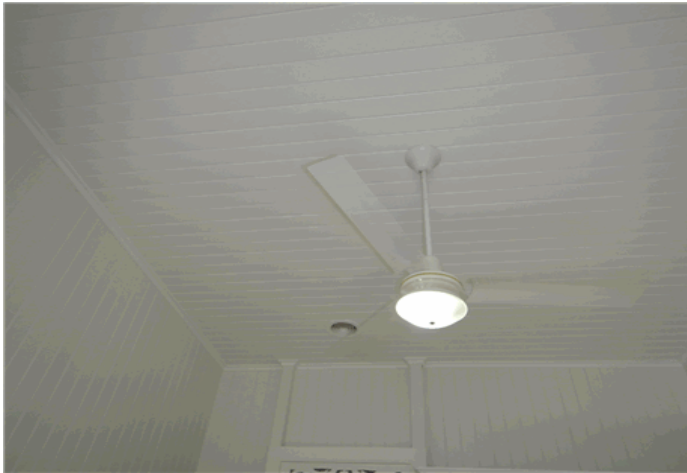
367) Ceiling Fan

The general condition of the Bedroom 3 Ceiling Fan is acceptable.

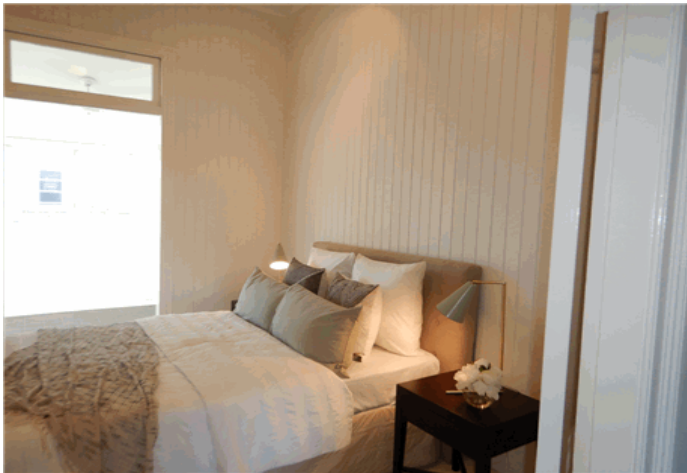
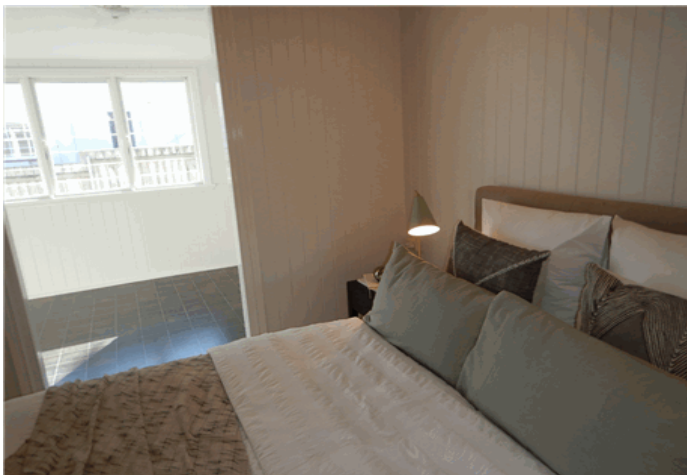
373) Overall Area

Of the visible areas, the general condition of Bedroom 4 is Acceptable.

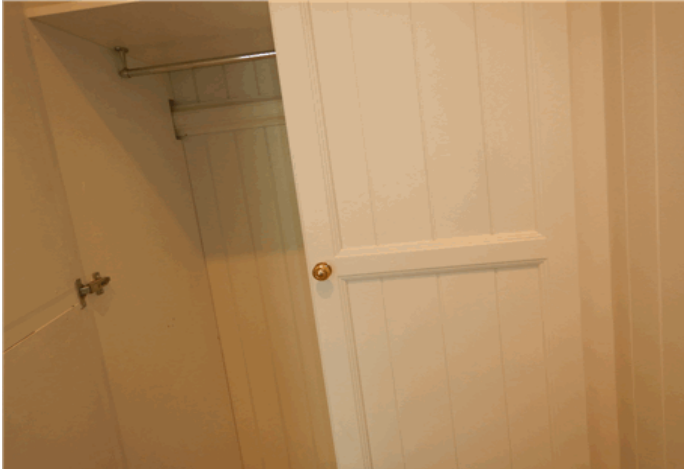
374) Robe

The general condition of the Bedroom 4 Robe is acceptable.

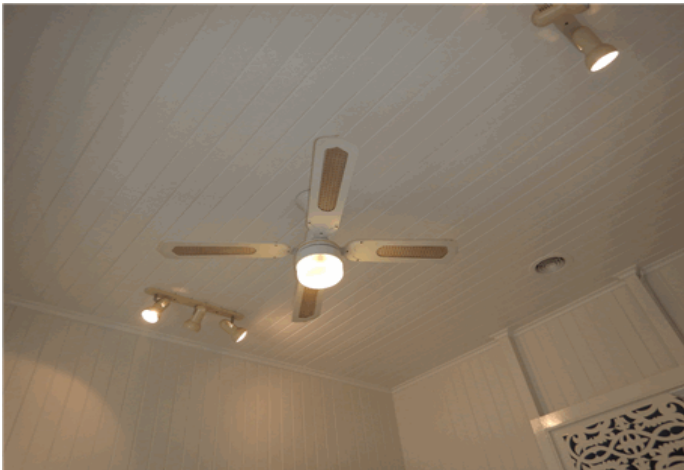
377) Ceiling Fan

The Ceiling Fan in Bedroom 4 was considered to be in an acceptable condition at the time of Inspection.

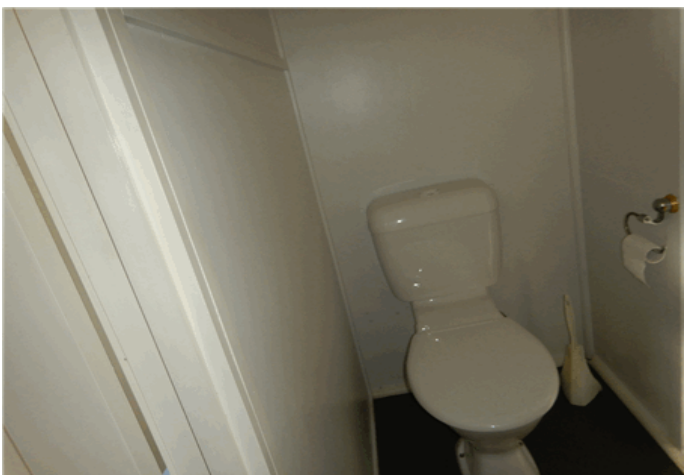
The Laundry Toilet and Shower is considered to be functional, however, it is noted the height in this area is not compliant with the minimum requirement of 2100mm for at least two thirds of the area. As will, it is noted that due to the age of the Dwelling, the Wall and Ceiling Cement Sheeting has a high probability of containing Asbestos Materials.

The probability of a Dwelling containing the presence of Asbestos requires this to be Reported as a **Major Defect** for Health and Safety reasons.

Note: It is always difficult to establish if building materials actually contain Asbestos and it is advised that the only way to be certain, is to have suspected materials Tested by a NATA Accredited Laboratory. If the house was built before the mid 1980s and it has Fibrous Cement Sheeting as either internal or external Cladding, then there is a High Probability that the Sheeting contained Asbestos.

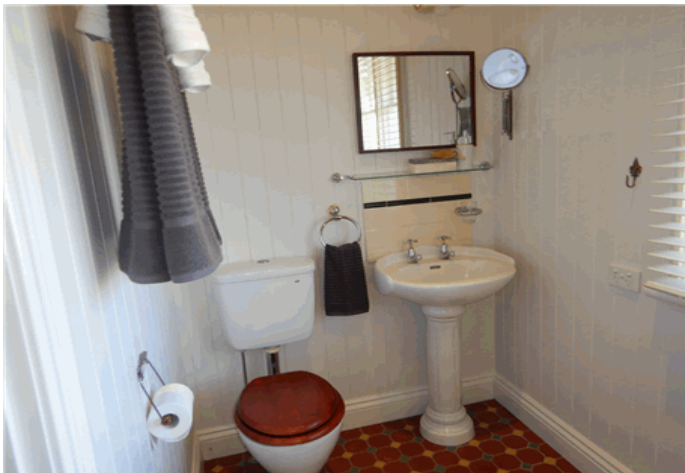
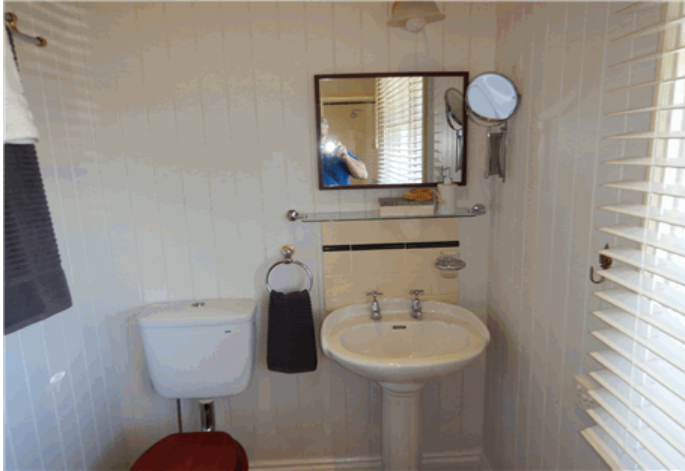
420) Overall Area

The general condition of the Ensuite is acceptable, however, please read the following area specific comments.

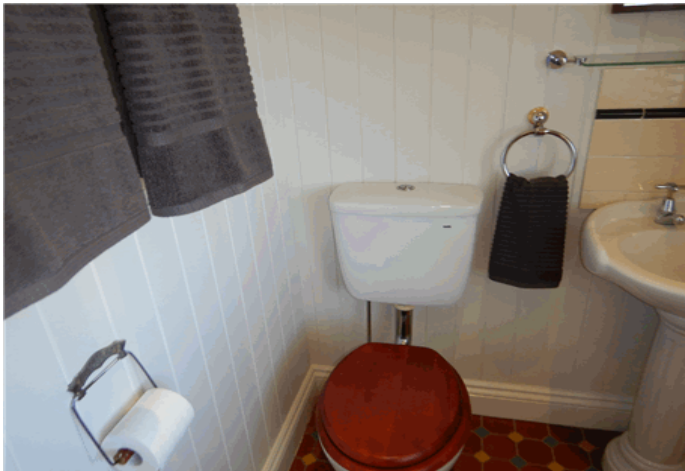
421) Toilet

The general condition of the Ensuite Toilet is acceptable.

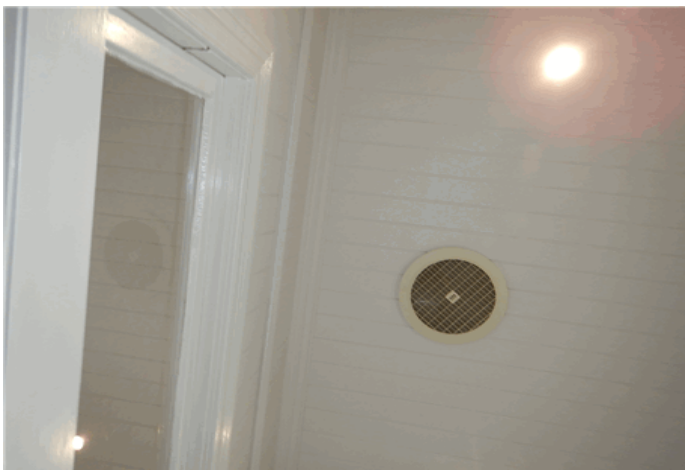
422) Ventilation

An Exhaust Fan is present and functional in the Ensuite.

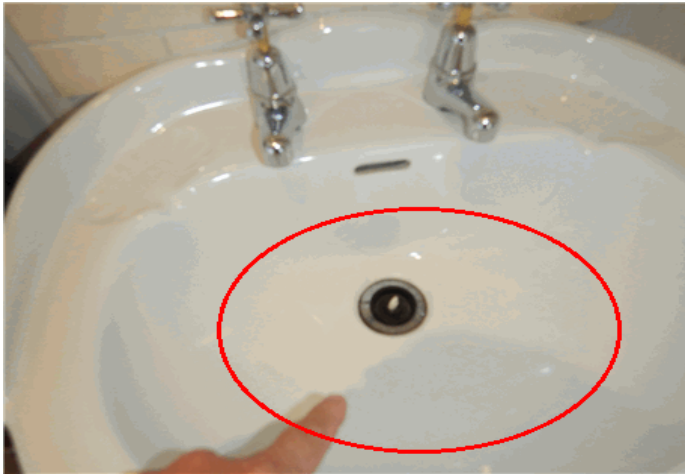
430) Vanity

It was noted that the Vanity Basin was aged and crazed.

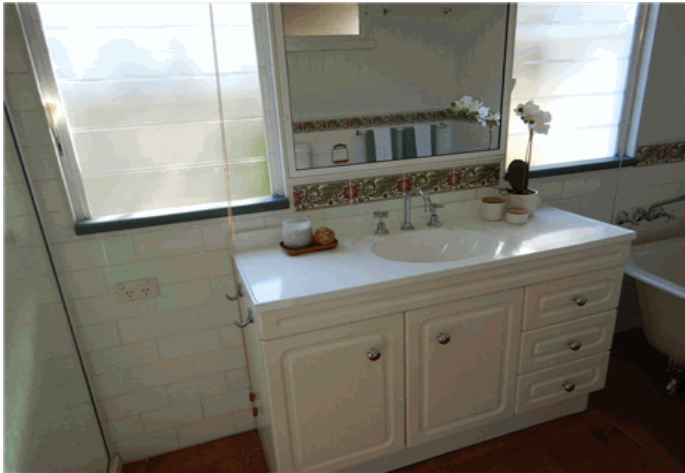
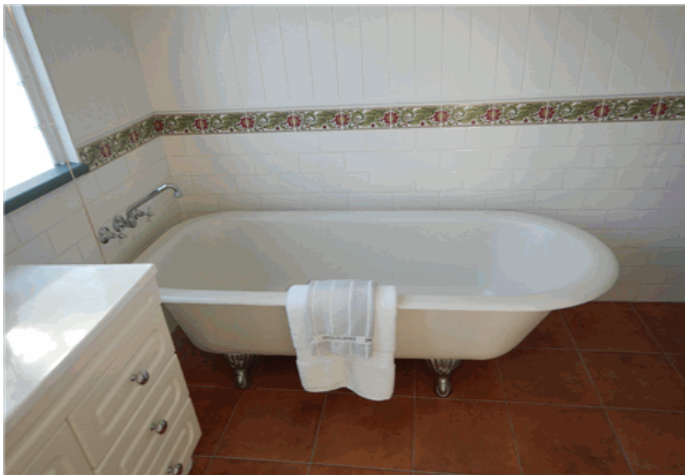
The general condition of the Bathroom is acceptable, however, the Cement Sheeting in the Walls and the Ceiling have a high probability of containing Asbestos Materials. Please read the following area specific comments.

The probability of a Dwelling containing the presence of Asbestos requires this to be Reported as a **Major Defect** for Health and Safety reasons.

Note: It is always difficult to establish if building materials actually contain Asbestos and it is advised that the only way to be certain, is to have suspected materials Tested by a NATA Accredited Laboratory. If the house was built before the mid 1980s and it has Fibrous Cement Sheeting as either internal or external Cladding, then there is a High Probability that the Sheeting contained Asbestos.

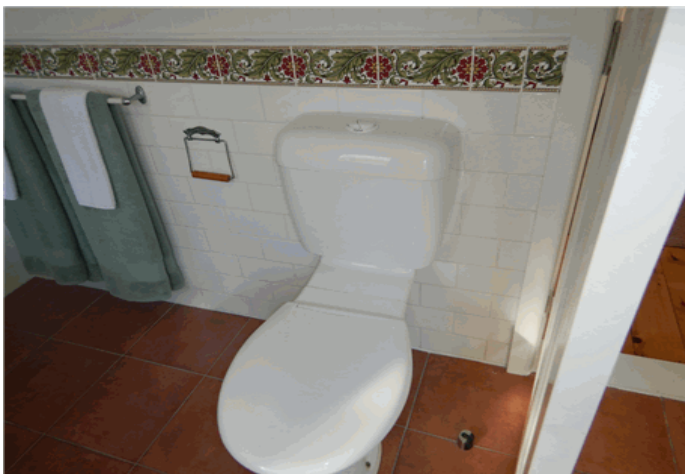
439) Toilet

The general condition of the Bathroom Toilet is acceptable.

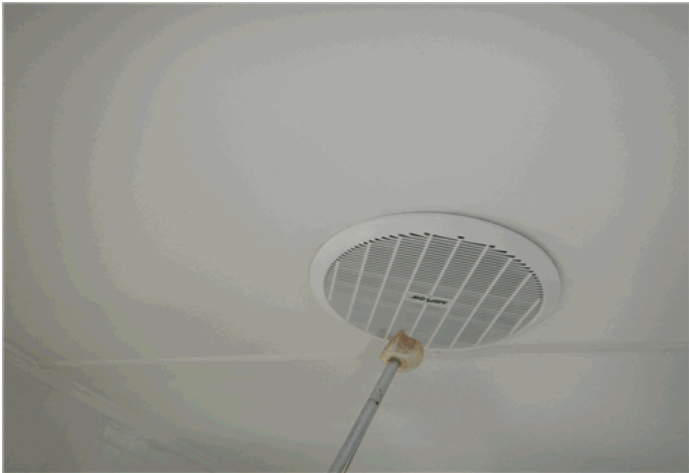
440) Ventilation

The Bathroom Exhaust Fan is noisy - you may need to monitor for possible further deterioration.

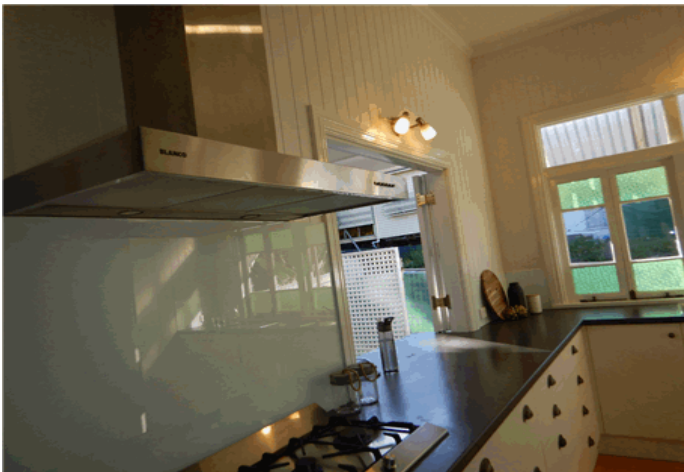
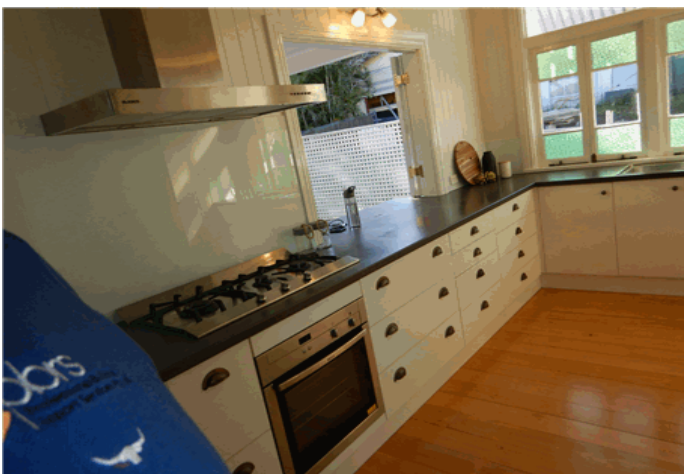
525) Overall Condition

On visual inspection, the general condition of the Kitchen is acceptable, however, please read the comments in the area specific sections to follow.
