Inspection Report

Professional Building Report Services Pty Ltd

PBRs Sample Report 2019

Report Number	PBRSSample2019
Inspection Type	The Inspection is a Pre-Purchase Building and Pest Inspection .
Inspection Date	September 2019
Inspection Time	9.00am
Weather Conditions	The Weather Conditions were Fine and Dry for the time of the Inspection.
Recent Weather Conditions	The Recent Weather Conditions were Showers & Rainy at the time preceeding the building Inspection.

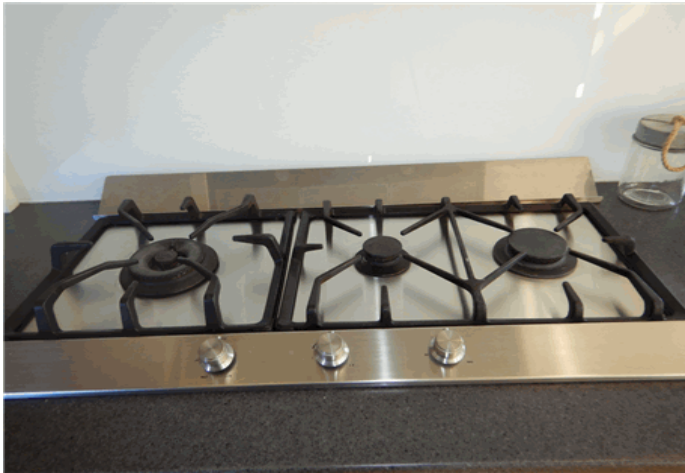
**528) Hotplates**

The Gas Hotplates appear to be in an acceptable condition at the time of Inspection, the Oven as well appears to be in an acceptable condition.

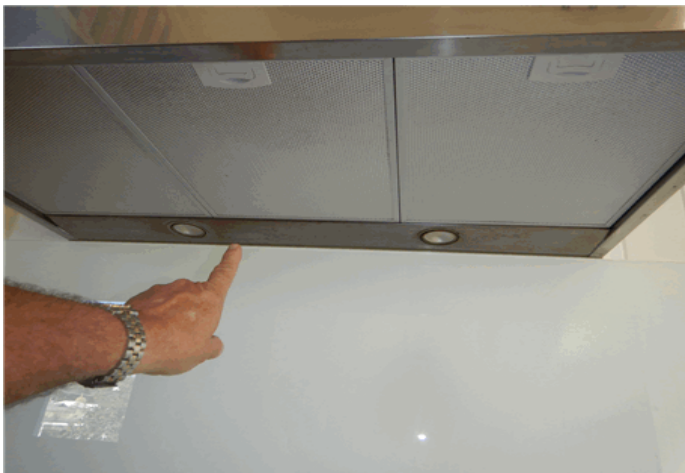
529) Rangehood Exhaust and Light

The Rangehood Exhaust system is aged and in need of some maintenance to remove grease build-up, and as well the lamps were not functional at the time of the Inspection.

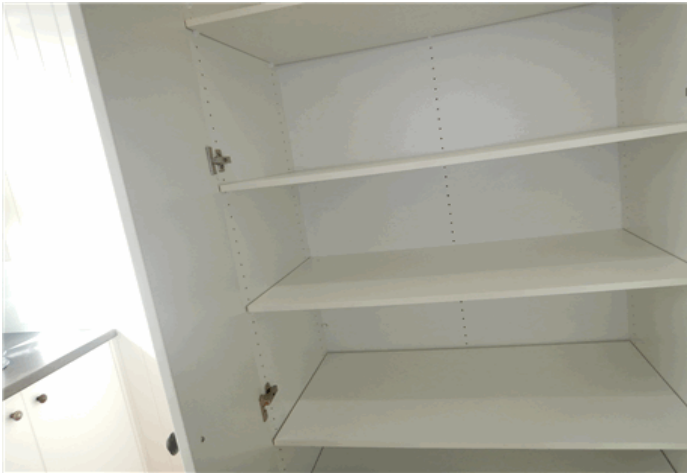
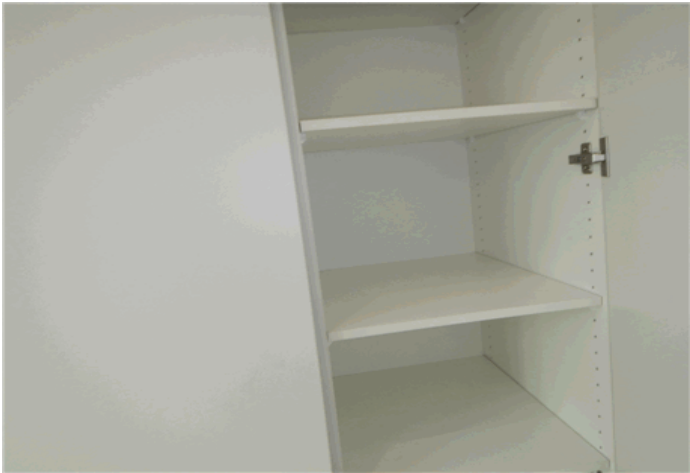
530) Pantry

The Kitchen Pantry was noted as being in an acceptable condition.

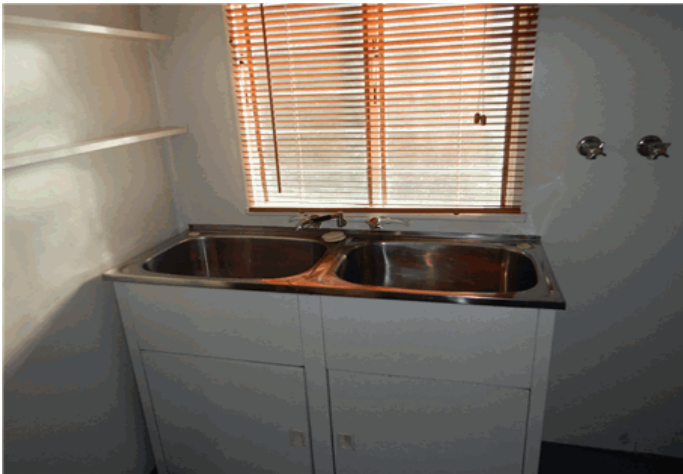
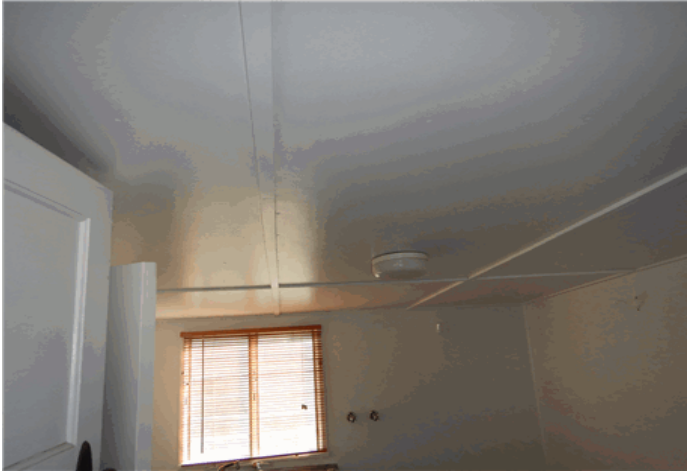
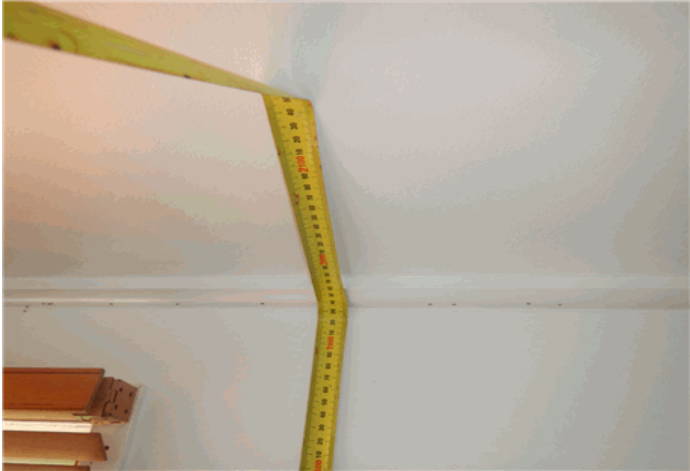
The Laundry is basic and functional, however, it is noted the height in this area is not compliant with the minimum requirement of 2100mm for at least two thirds of the area. As well, it is noted that due to the age of the Dwelling, the Wall and Ceiling Cement Sheeting has a high probability of containing Asbestos Materials.

The probability of a Dwelling containing the presence of Asbestos requires this to be Reported as a **Major Defect** for Health and Safety reasons.

Note: It is always difficult to establish if building materials actually contain Asbestos and it is advised that the only way to be certain, is to have suspected materials Tested by a NATA Accredited Laboratory. If the house was built before the mid 1980s and it has Fibrous Cement Sheeting as either internal or external Cladding, then there is a High Probability that the Sheeting contained Asbestos.

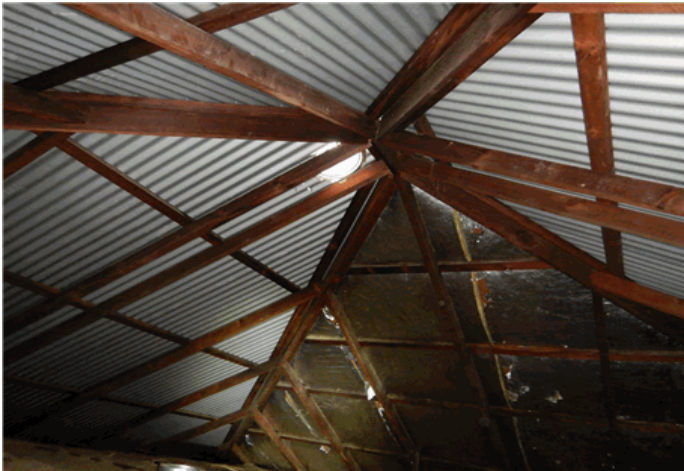
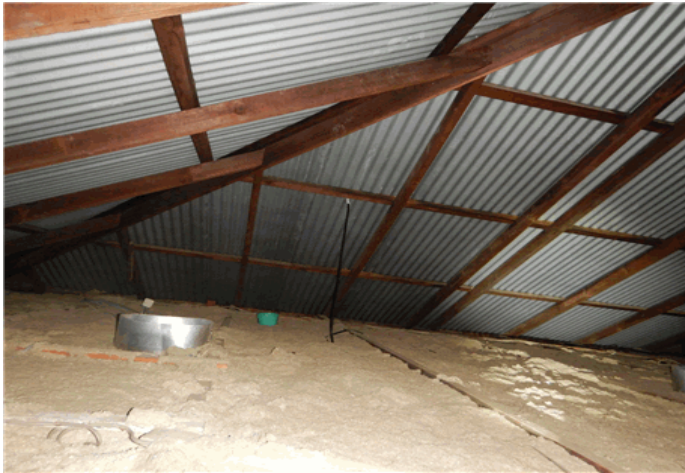
558) Roof

The Roof Frame appears to be in an acceptable condition with no indications of moisture or structural defects.

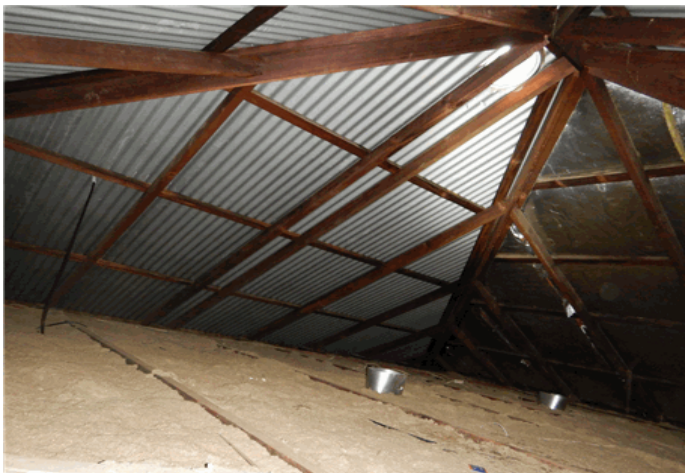
561) Insulation

The Roof Void had Loose Cellulose Spray applied Insulation.

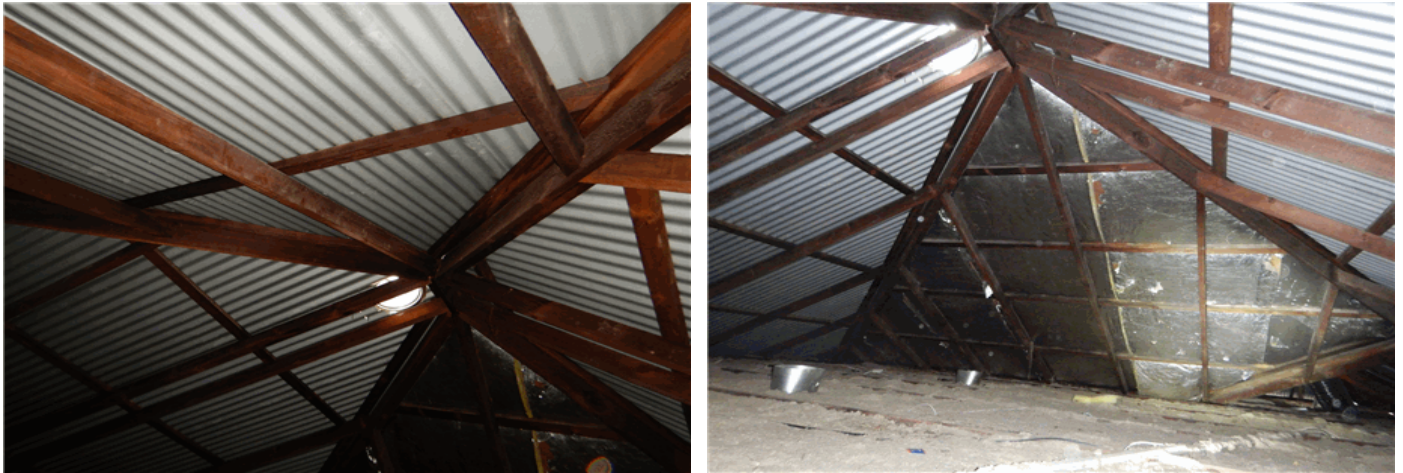
562) Sarking

The Roof Void does have some Sarking, however there is no Sarking under most of the Roof Sheeting.

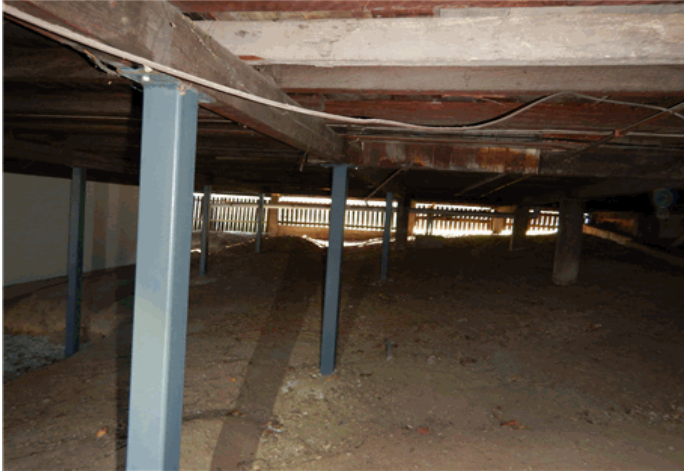
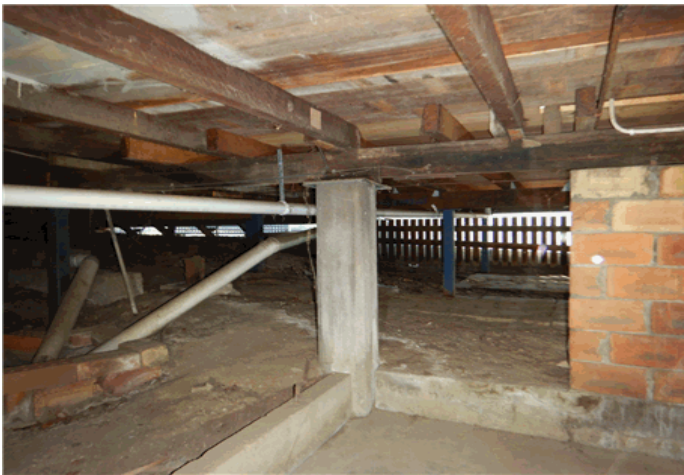
564) Overall Area

On visual inspection, the general condition of the Sub-Floor is acceptable, however, please read the following area specific comments.

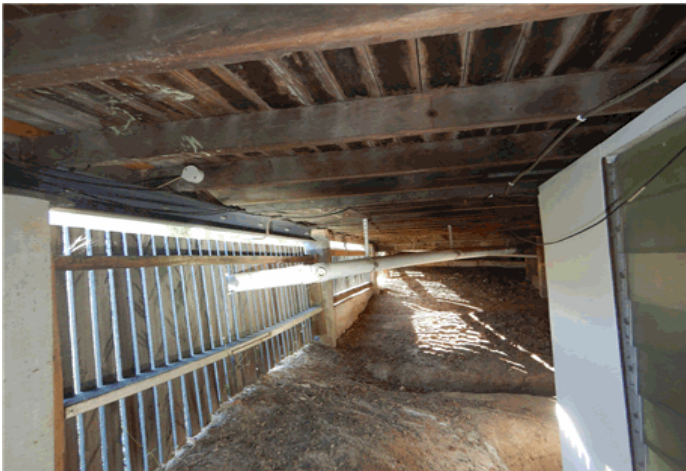
566) Joists and Bearers

All floor Joists and Bearers appeared to be in sound condition.

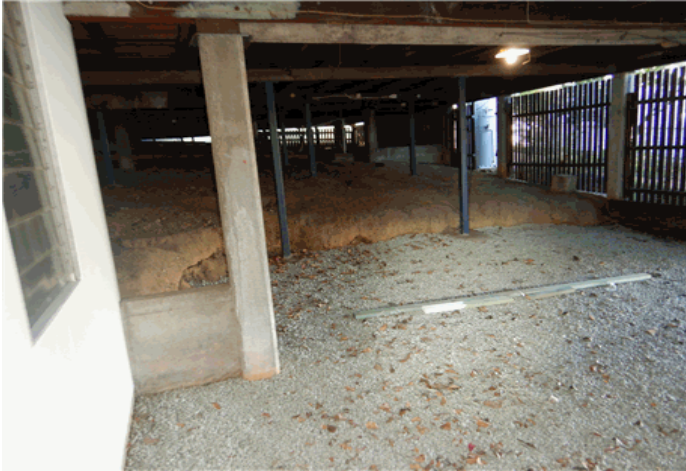
567) Piers and Foundation Walls

The general condition of the Concrete and Steel Post Piers is acceptable for the age, however it is still advised that the Steel Posts will require monitoring and further actions as they suffer any corrosion issues.

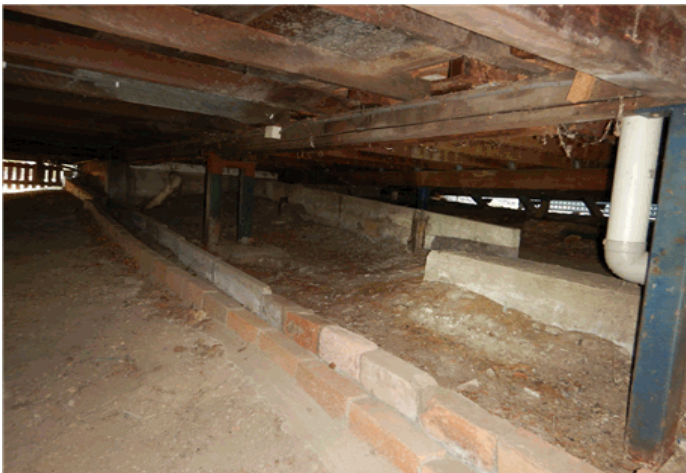
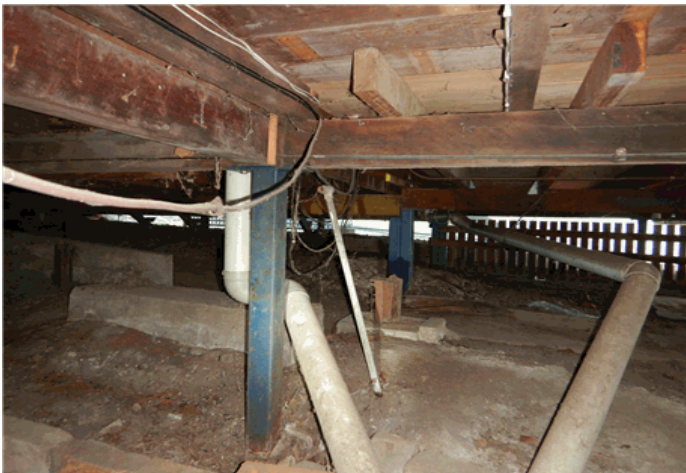
569) Dampness

There are indications of Drainage issues in the past, this will need to be monitored and corrective actions taken when necessary. Drainage Issues are discussed elsewhere in this Report and are reported as a **Major Defect**.

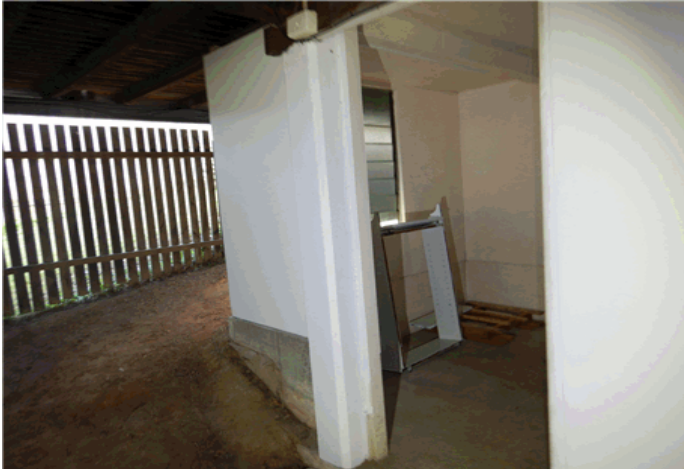
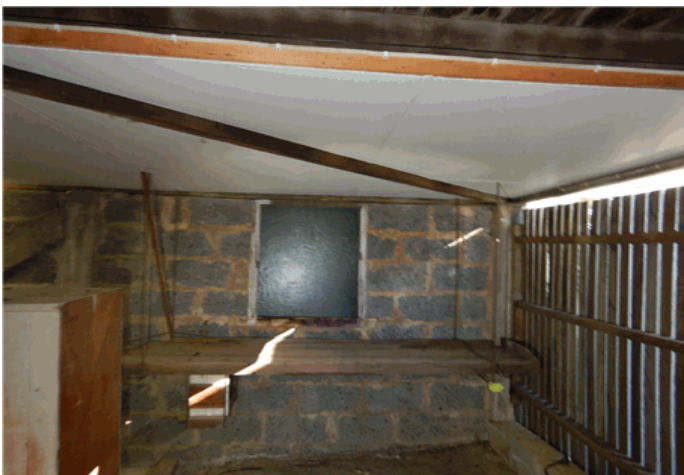
571) Storage

The general condition of the Sub-Floor Storage areas was acceptable.

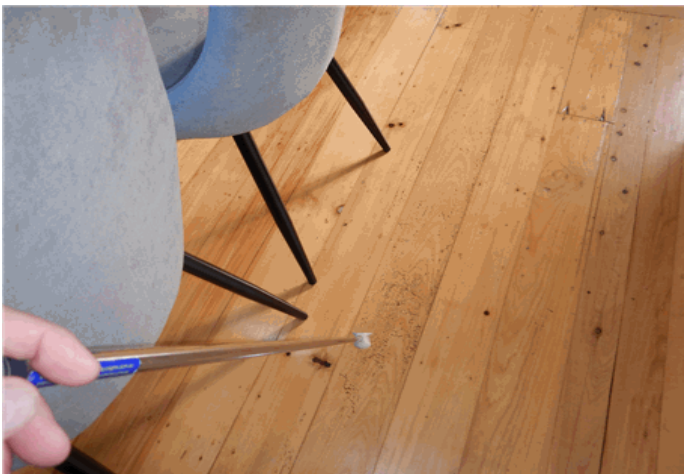
680) Was Visible Evidence of Borer Found

Evidence of past Borer activity in the hoop pine flooring. Many sections of flooring had been replaced and some of the remaining older sections clearly show past Borer activity.

If any evidence or damage has been reported then you must have a building expert determine the full extent of damage and the estimated cost of repairs or timber replacement (See Terms & Limitations). Borer activity is usually determined by the presence of exit holes and/or frass. Since a delay exists between the time of initial infestation and the appearance of these signs, it is possible that some borer activity may exist that is not discernible at the time of inspection.
